WHO DESIGNED THE ILL-FATED ST. FRANCIS DAM?

J. David Rogers, Ph.D., P.E., P.G., F.ASCE
Professor & Karl F. Hasselmann Chair in Geological Engineering
Missouri University of Science & Technology

May 23, 2017

**WORLD ENVIRONMENTAL & WATER RESOURCES
CONGRESS**

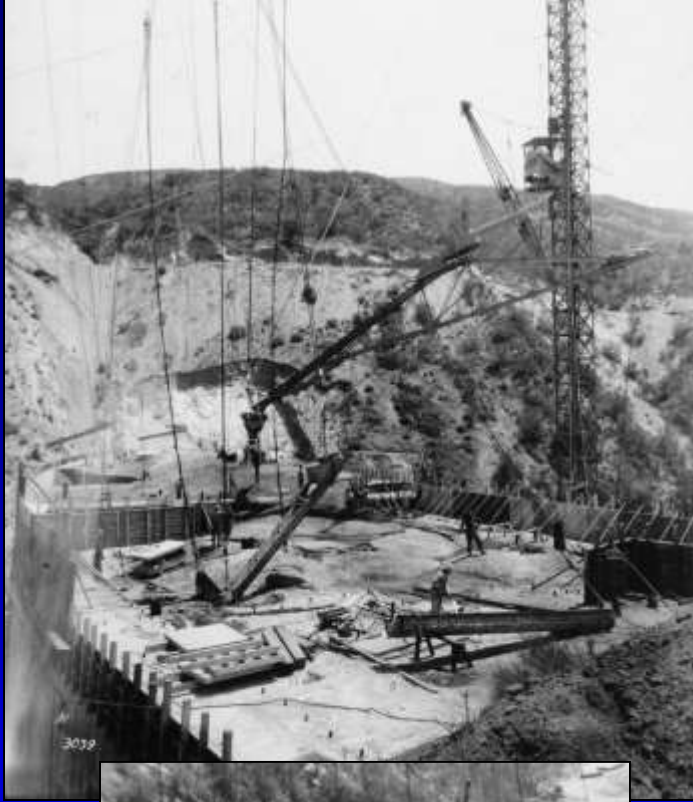
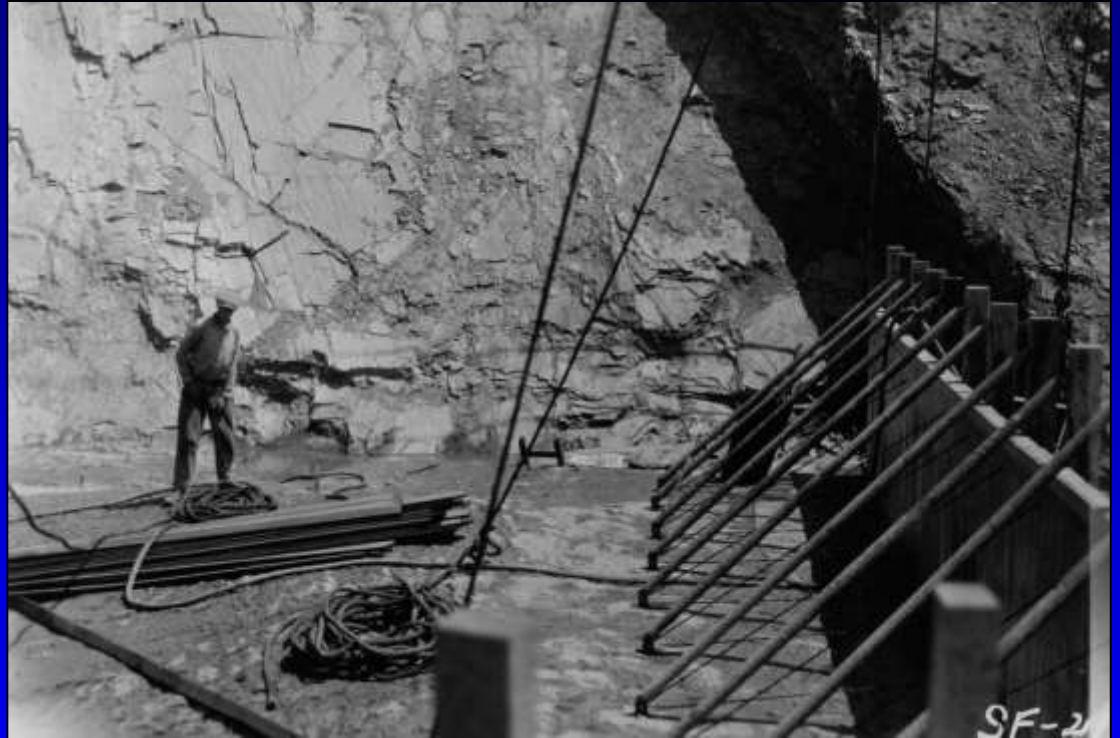
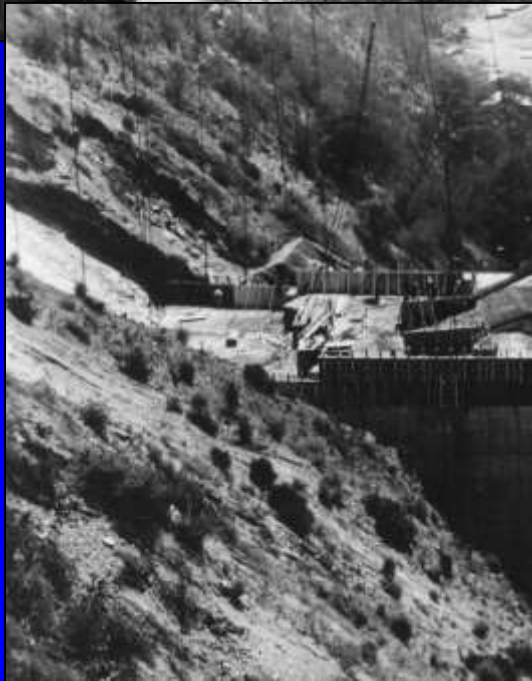
Minimal Abutment Excavation 1924-25

- Views at left show the left abutment excavation into the Pelona Schist – between 6 and 15 ft deep.
- Excavation of the schist and conglomerate on the right abutment averaged only about 4 ft deep.

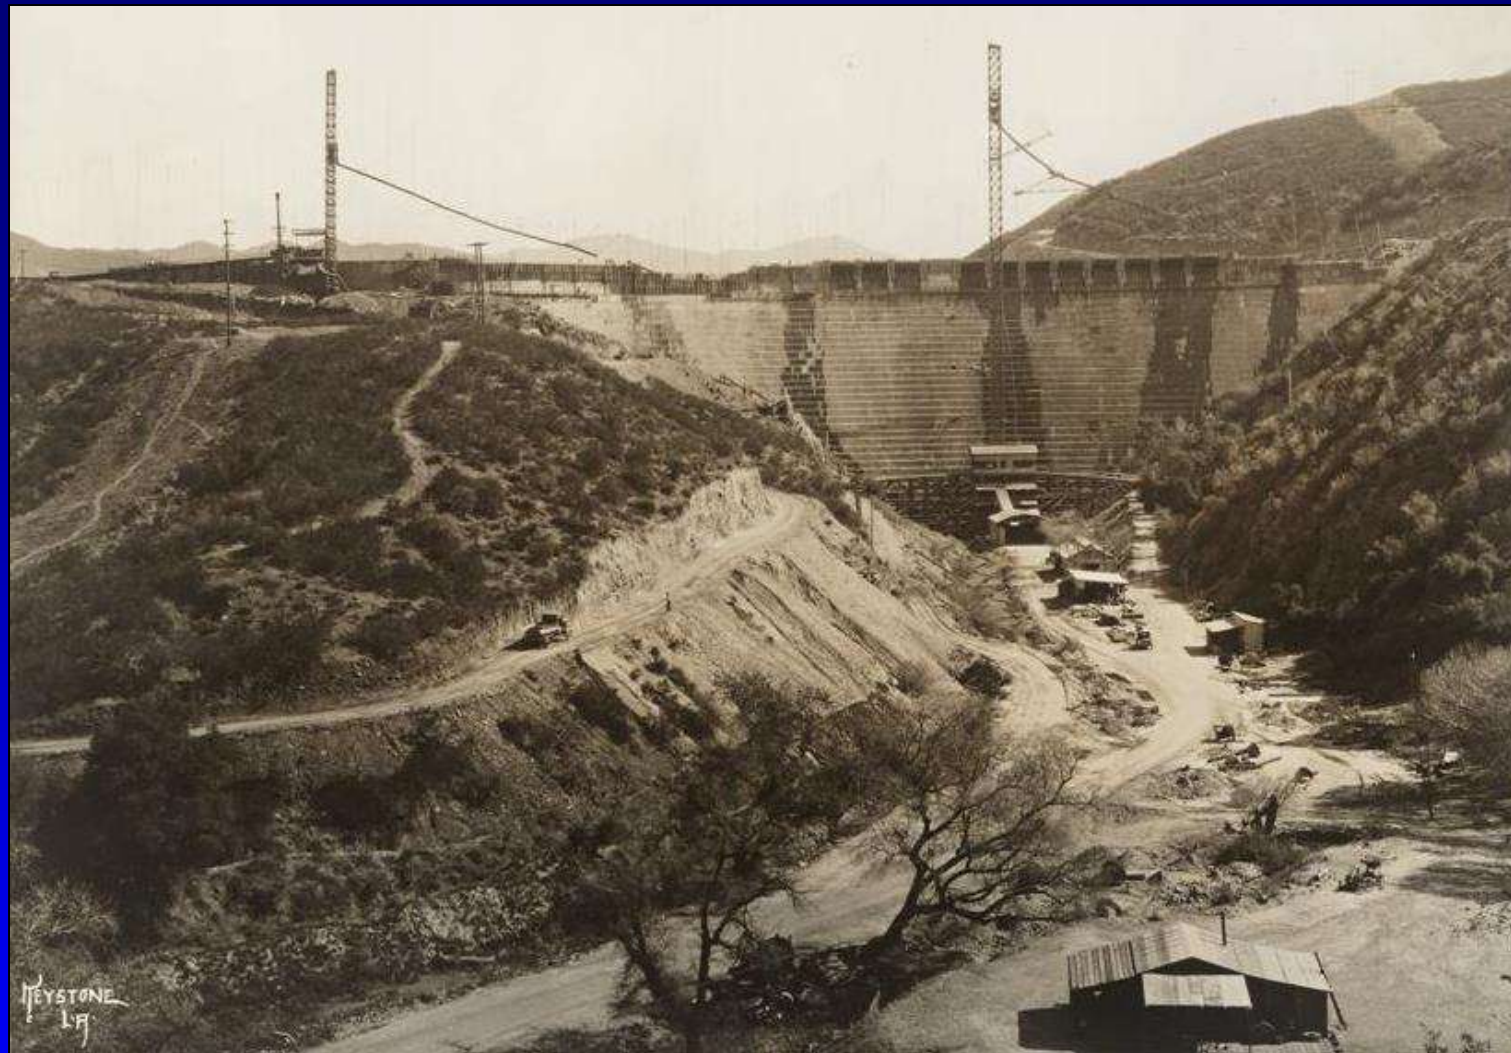
- **The St. Francis Dam, looking upstream during construction. Note the upper and lower concrete batch plants, the towers and the inclined delivery troughs. This handling scheme resulted in aggregate separation during placement of mass concrete**

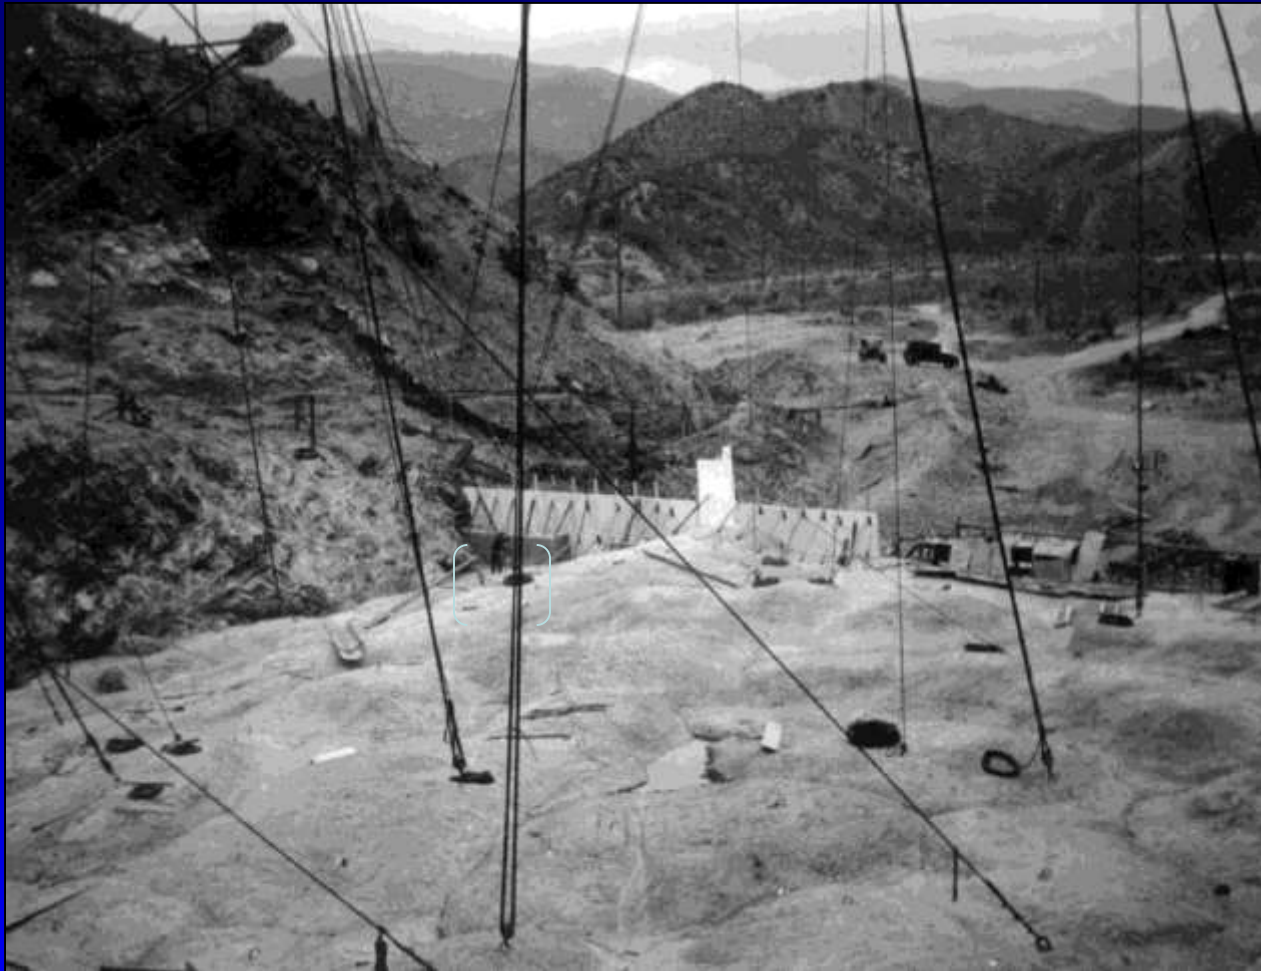
- **Construction of the St. Francis Dam began in July 1924.**
- **This shows the first forms being placed for the upstream heel of the dam, against the 8 ft high cofferdam wall. Note “pillows” of mass concrete and absence of cold pour joints to accommodate contraction.**

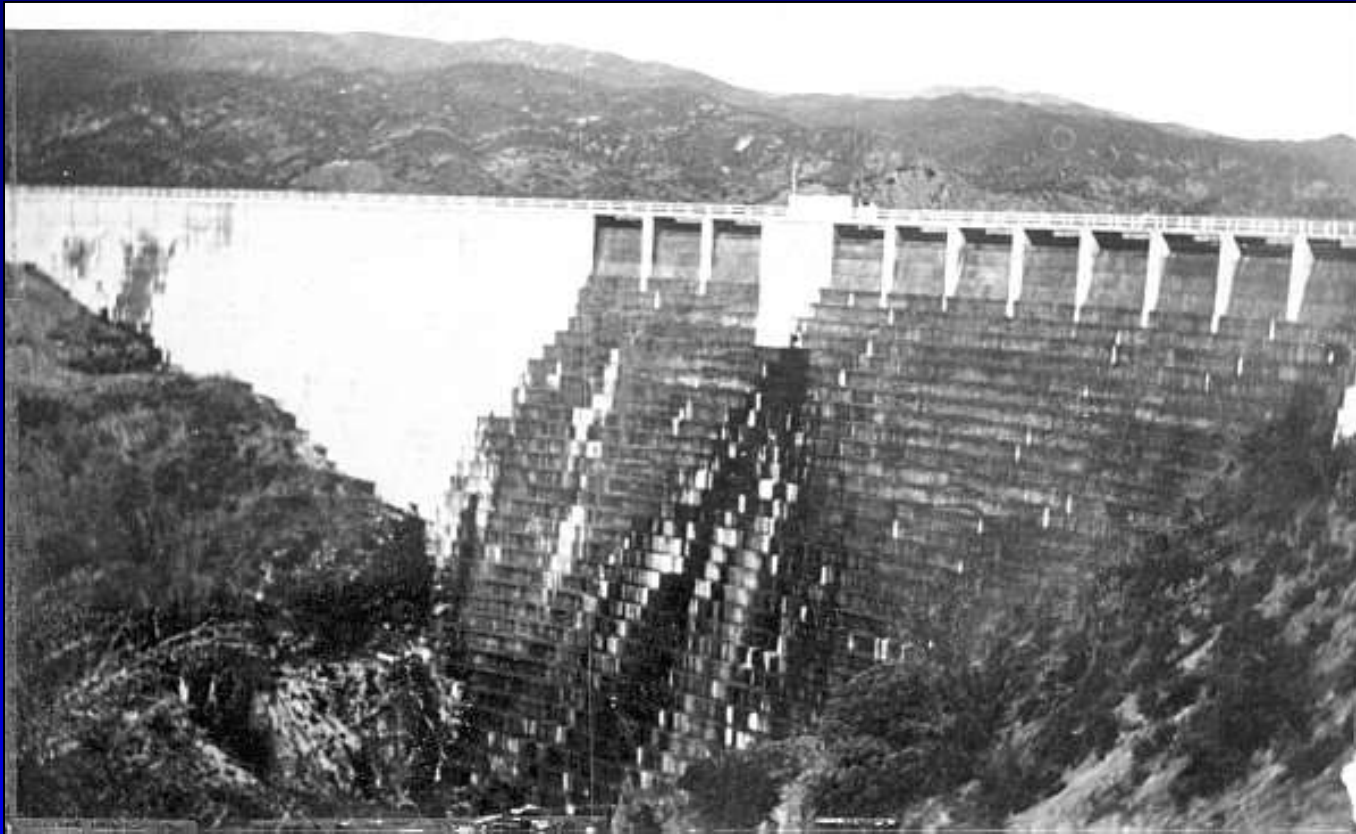
- The reservoir was brought to within 3 inches of spillway crest for the first time on Wednesday March 7, 1928. All city reservoirs were full by the following Sunday, March 11th.
- Damkeeper Tony Harnischfeger called Mulholland on the morning of the 12th to report spillage of “*dirty water*” from the right abutment area.
- That morning about 2 cfs spillage was coming over the spillway panels from wind-whipped waves, shown here around noon on March 12th.

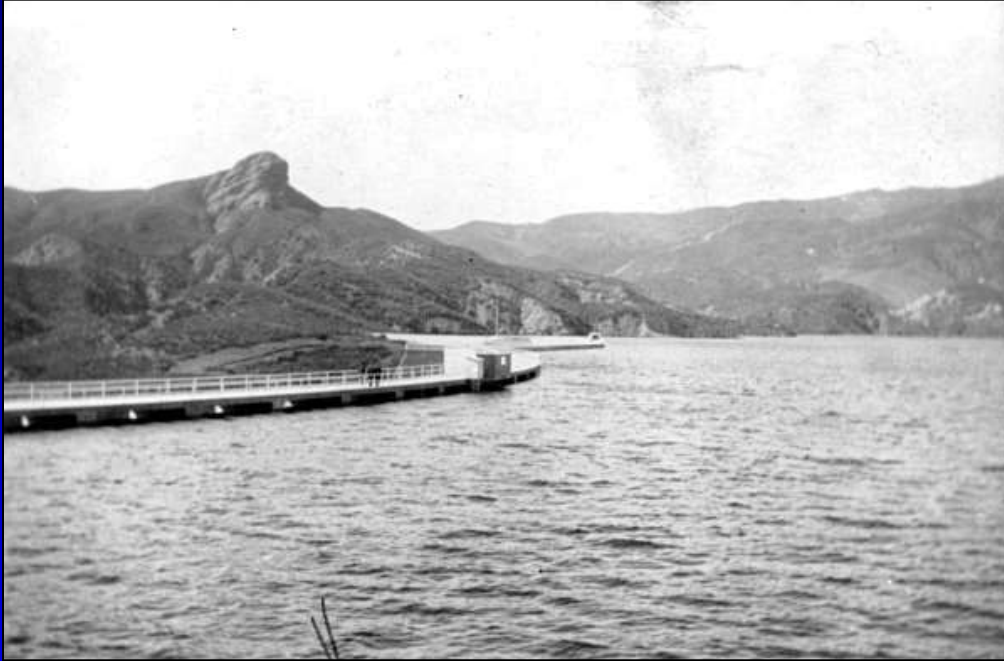
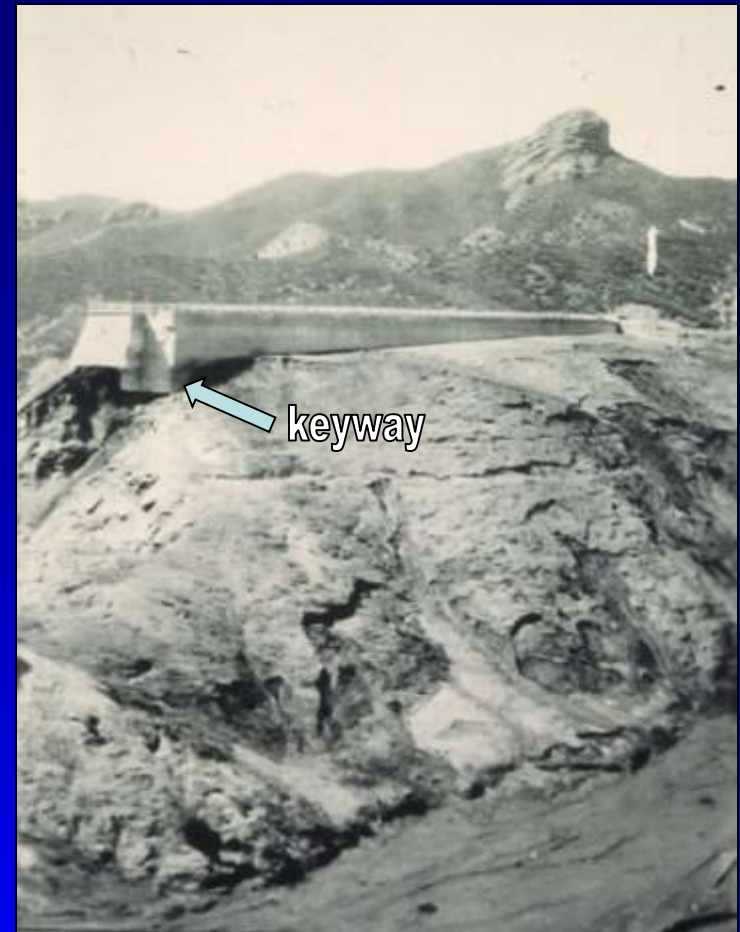
Before and After

- Comparative views taken of the dam's upstream face and right abutment 12 hours before the failure (at left) and the day after (right)
- Note exposed keyway beneath right abutment dike

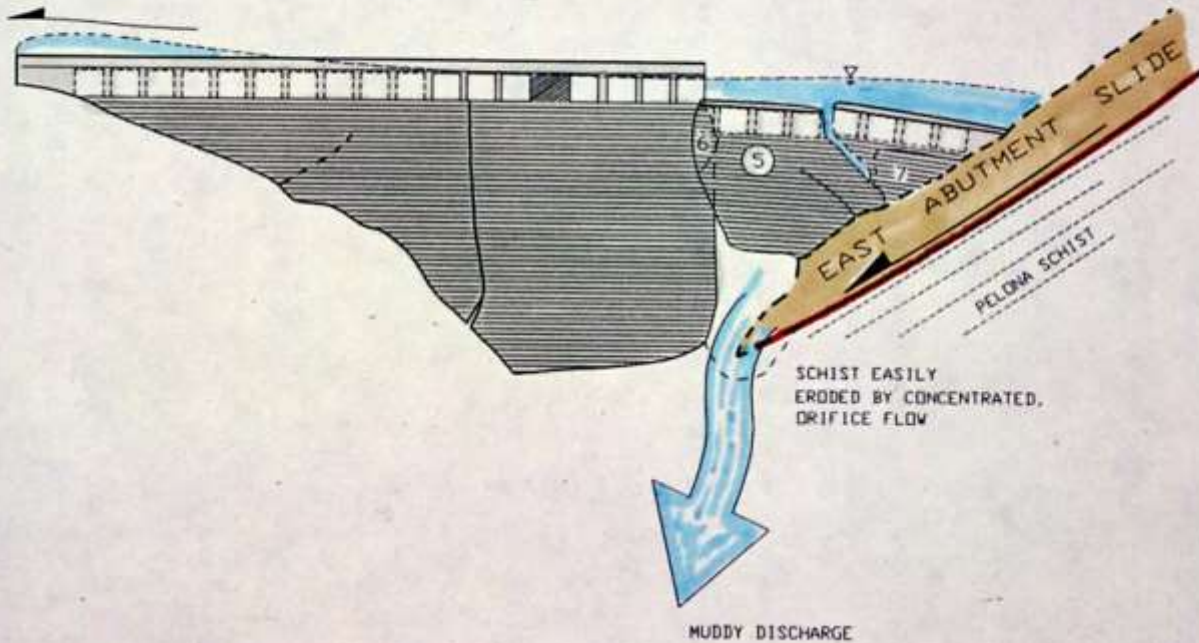
Landslide- induced seich

AT 11:57 1/2 PM EAST ABUTMENT SLIDES
INTO RESERVOIR, CUTTING EDISON POWER LINES

LANDSLIDE-DRIVEN WAVE SWEEPS
ONTO SHORELINE, 4' ABOVE HIGH RESERVOIR LEVEL

- Around 11:57-1/2 PM a massive landslide of the dam's eastern abutment initiated, severing the SCE 70 Kv Lancaster power lines.
- The entirety of the dam's left abutment was carried across the downstream face of the main dam.
- A landslide-driven displacement wave washed flotsam 4 ft above the reservoir high water line, 3/4 mile to the north

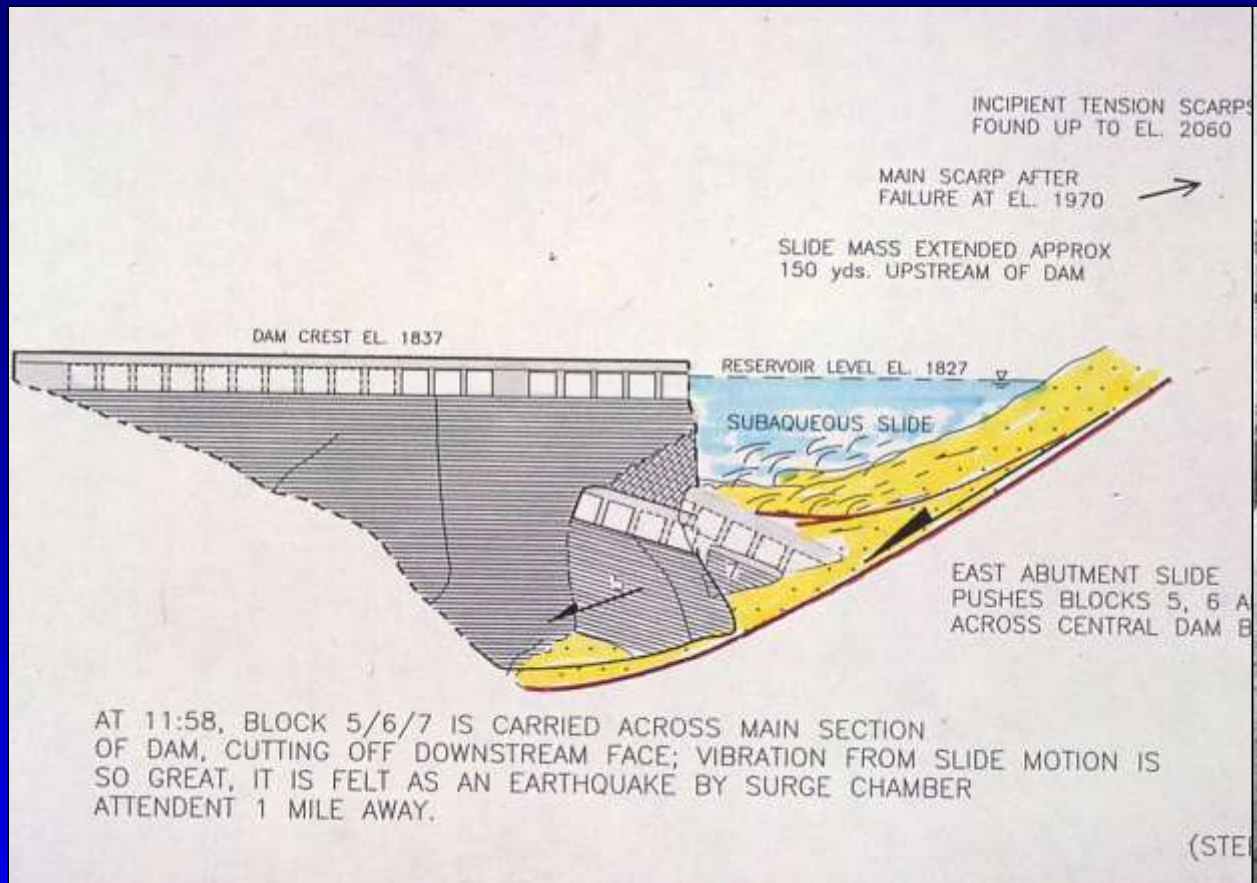
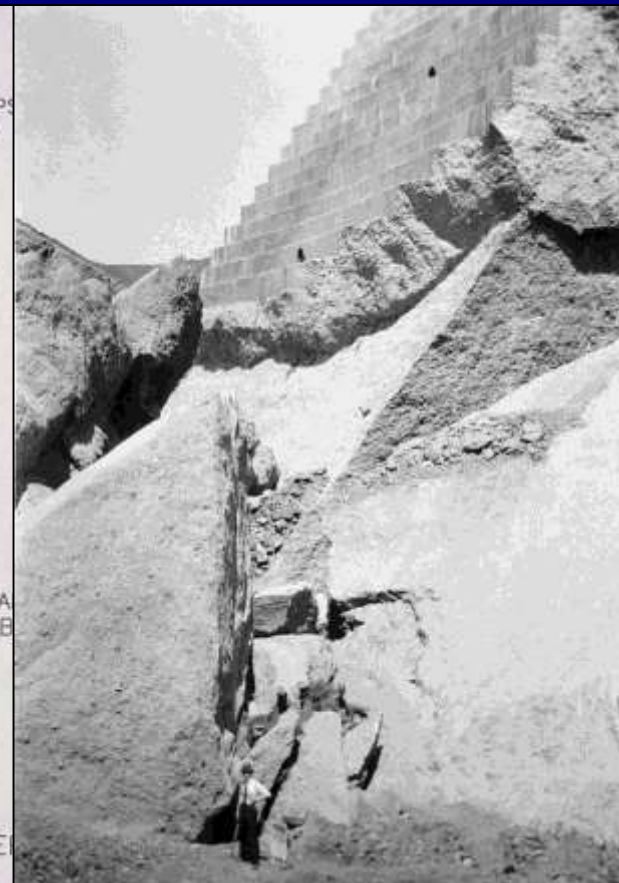
- The mobilized landslide debris (shown in yellow) carried the dam's left abutment section across the canyon, these heavy blocks sheared off 10 to 20 feet of the dam's stepped concrete face (seen at right).

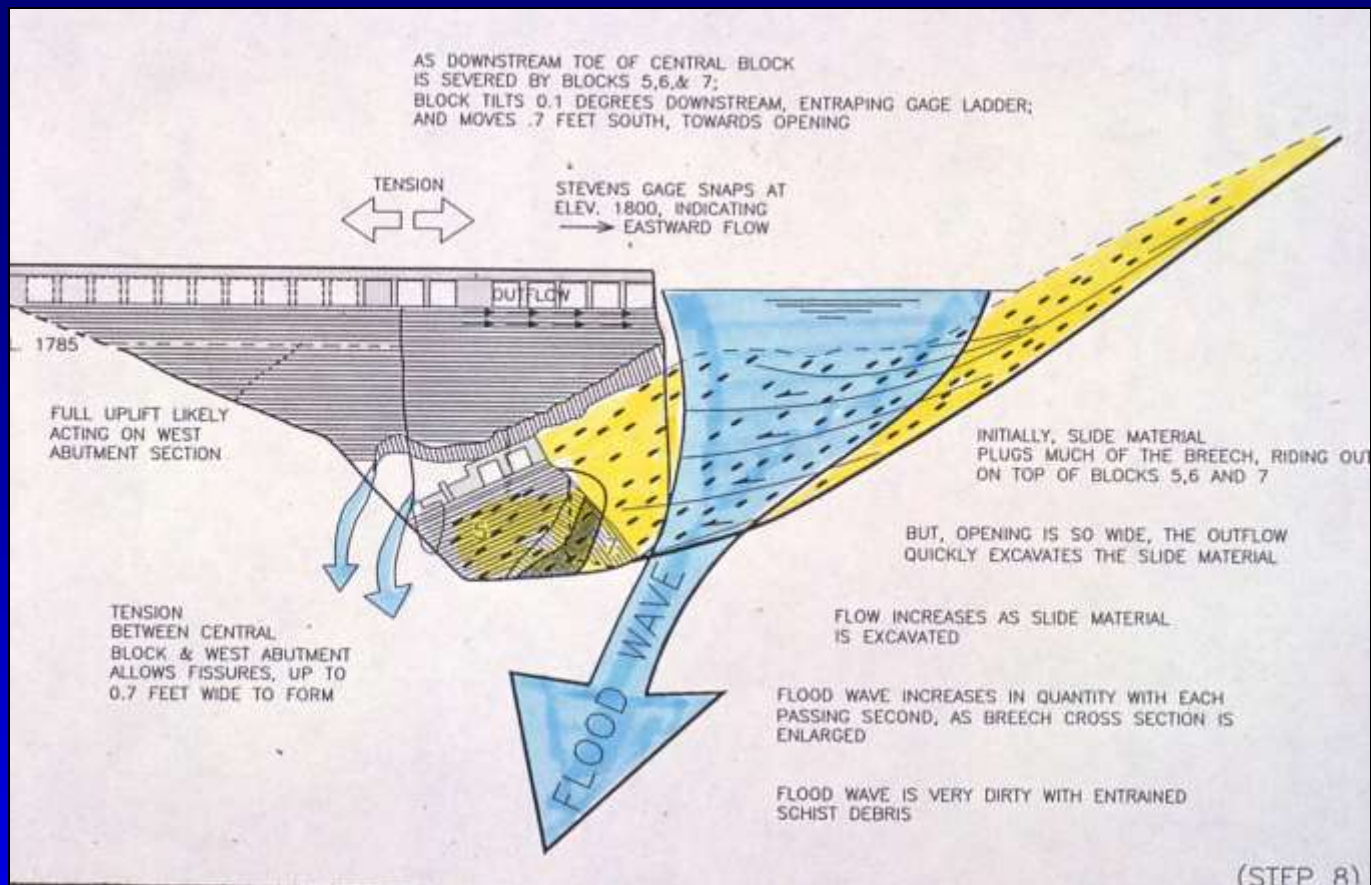
- The landslide debris dam was rapidly eroded by the outpouring water, in five to seven minutes
- The out-rushing flow bent the cylindrical stilling well of the Stevens Gage towards the left abutment
- Block 5 originally turned upward, against the right abutment

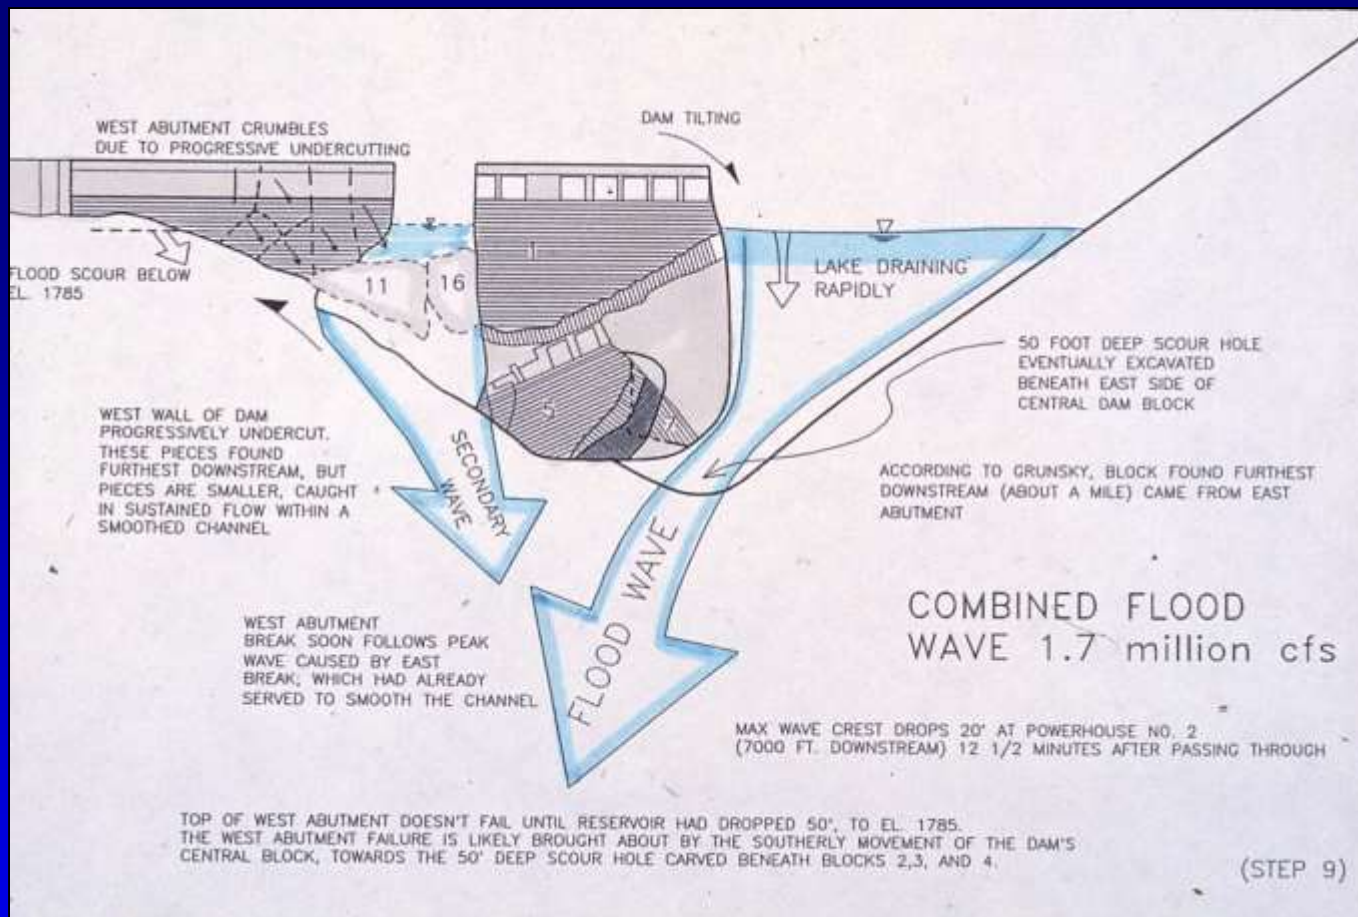
- As the left side of the main dam was undercut, the middle monolith tilted slightly and rotated, allowing water to enter the shrinkage crack along the west side of Block 1
- This triggered a chain-reaction failure of the right abutment, after the reservoir level had dropped 70 to 80 feet.

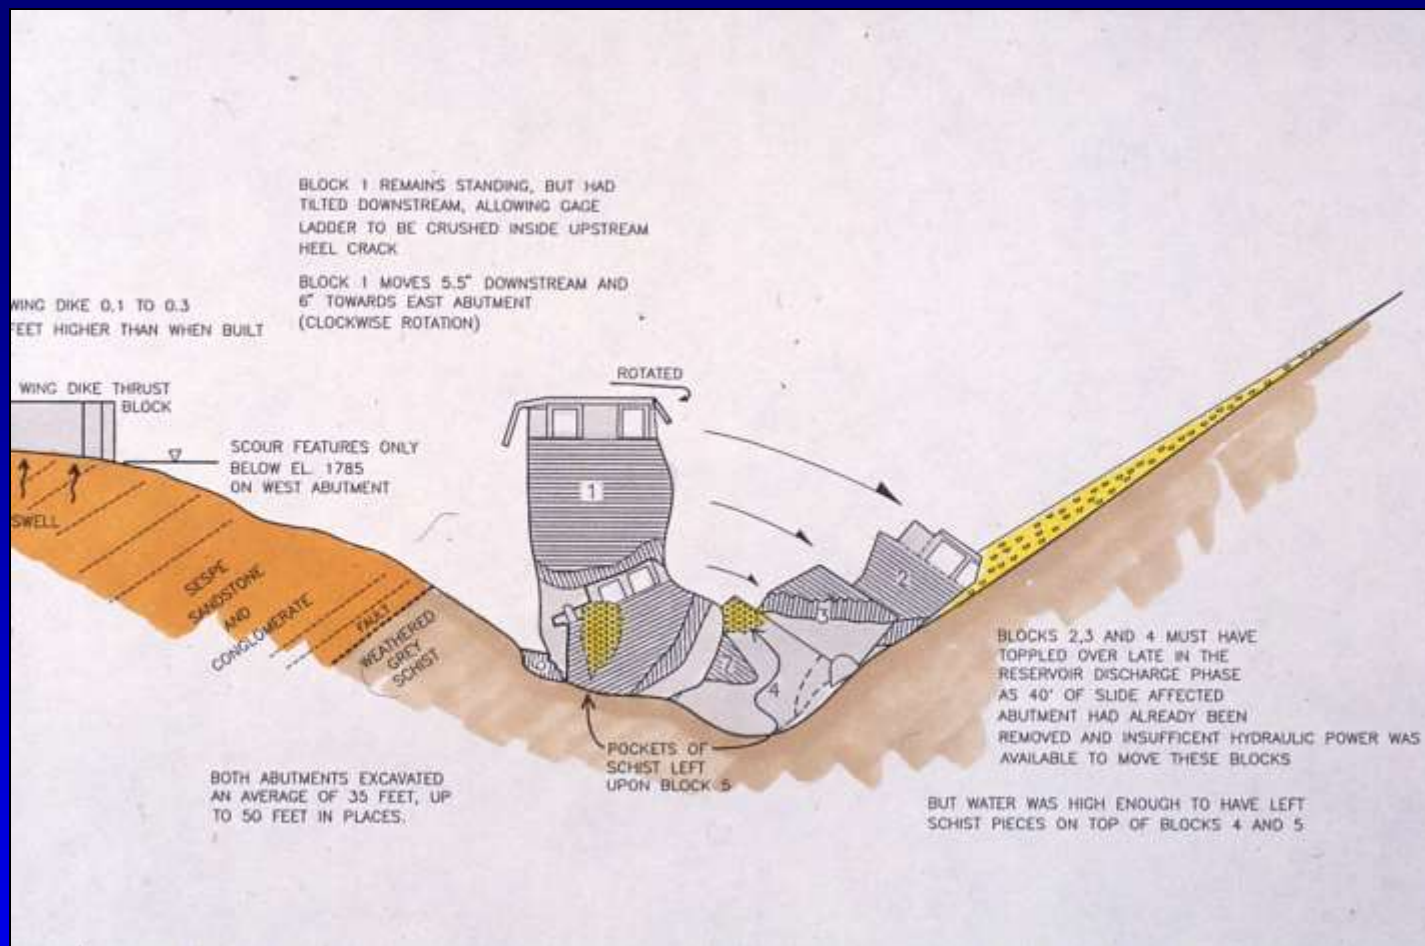
- When the reservoir was about 16 feet deep, the left half of the main dam topped backward at an angle of 54 degrees, after being undercut by the outbreak flood.
- The depth of this down cutting was about 35 vertical feet!
- Patches of schist detritus were left upon Blocks 5 and 7 (shown in yellow)

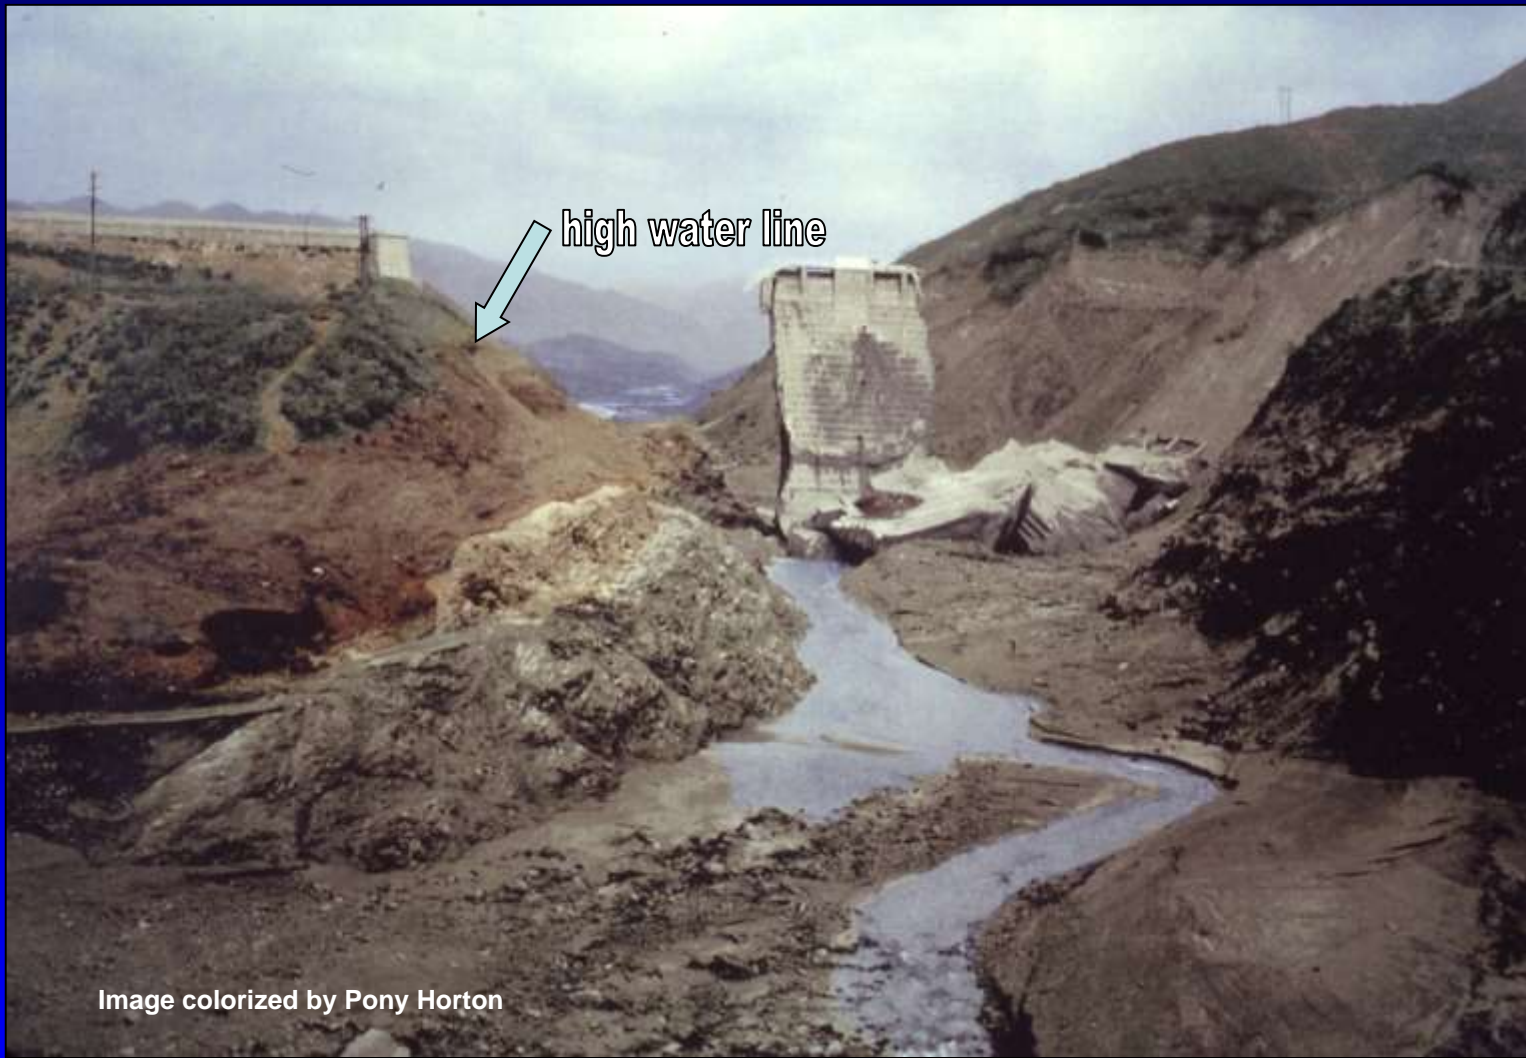
- **How the dam site appeared the following morning.**
- **Note the high water line was noticeably lower downstream of the right abutment (arrow)**

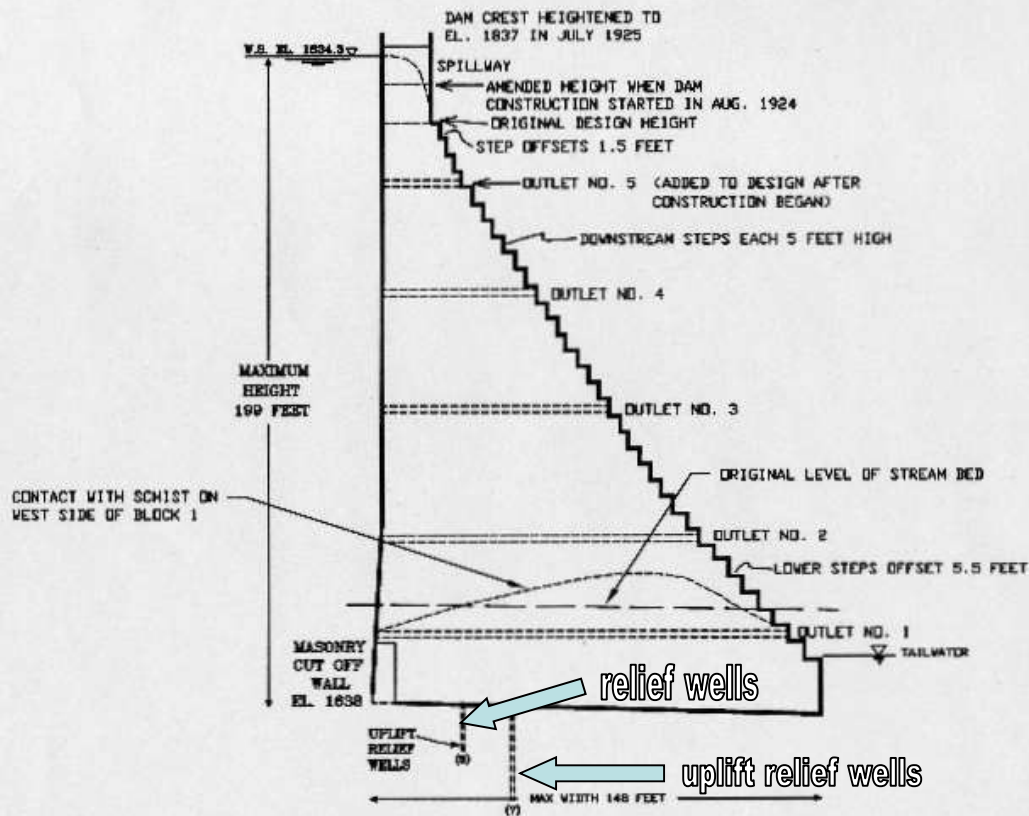
ELEVATION VIEW OF ST. FRANCIS DAM
TAKEN THROUGH SURVIVING BLOCK 1

- In most of the masonry dams designed before 1928, subdrainage was limited to the maximum sections, and often ignored on the sloping abutments.
- The 1959 failure of the Malpasset arch dam in France pointed to the vulnerability of concrete arch dams to uplift, especially, on steeply-sloping abutments.

• The main section of the St. Francis Dam was constructed with 10 uplift relief wells, set in two rows, as shown here. Both of the sloping abutments (without uplift relief) failed, on two different rock types.

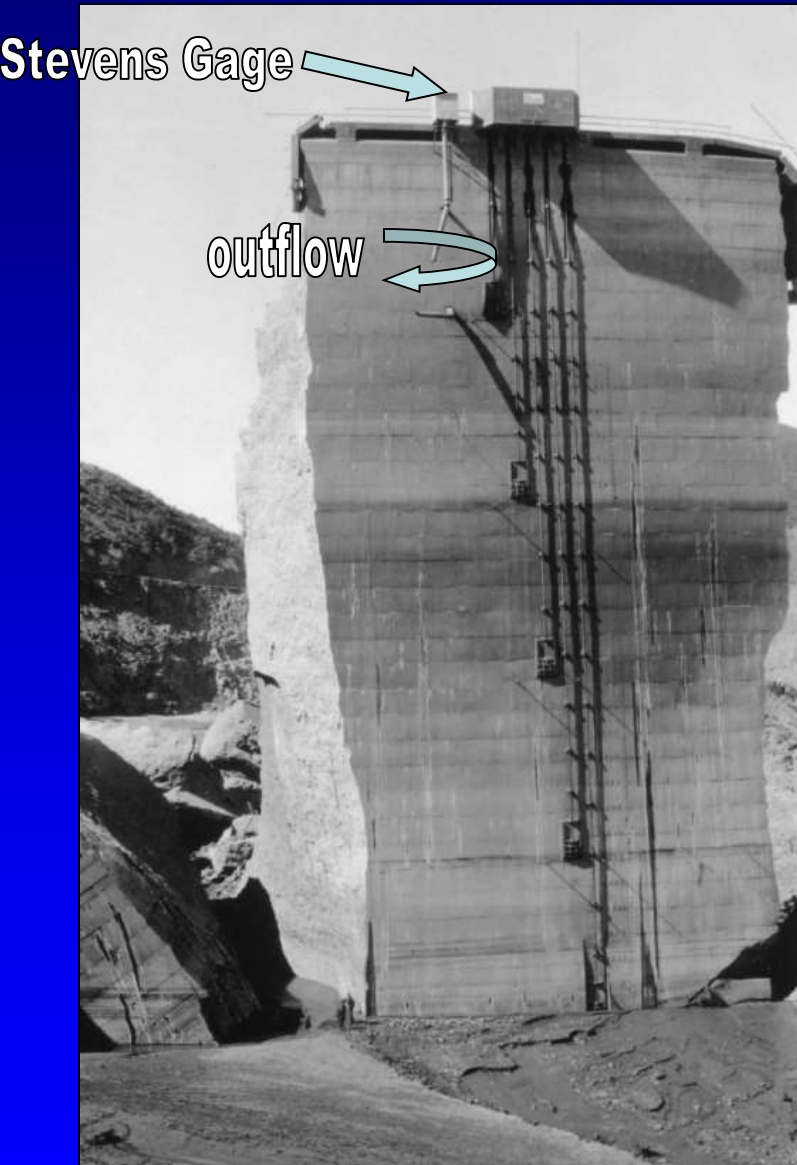
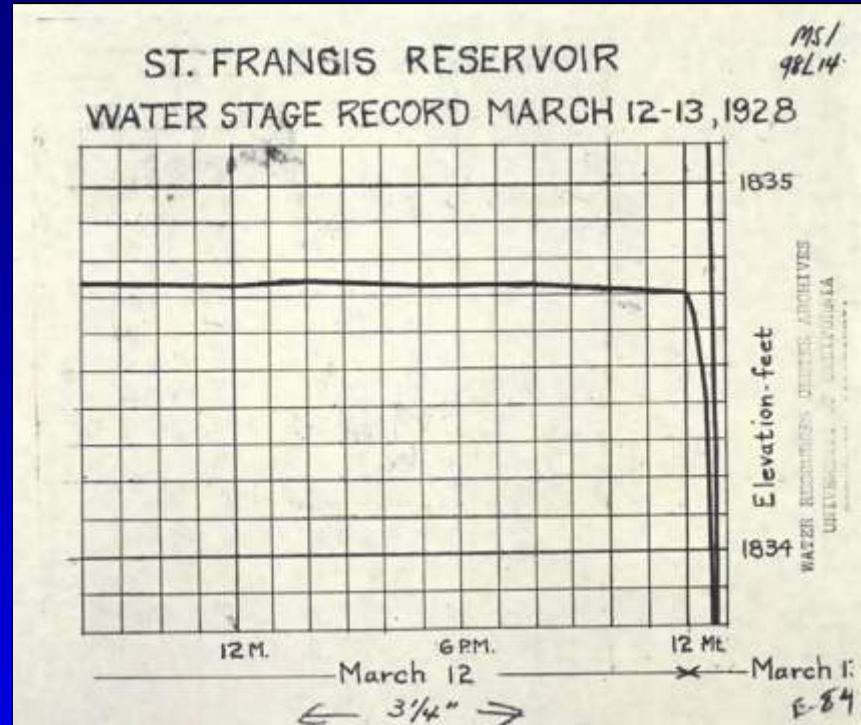
The Stevens Stage Record

A Stevens reservoir level recorder was mounted on the crest of Block 1 (left view). It recorded a slight drop of the reservoir, beginning around 8 PM, then an increasingly sharp drop beginning around 12 Midnight. The timing mechanism may have been slightly ahead of schedule.

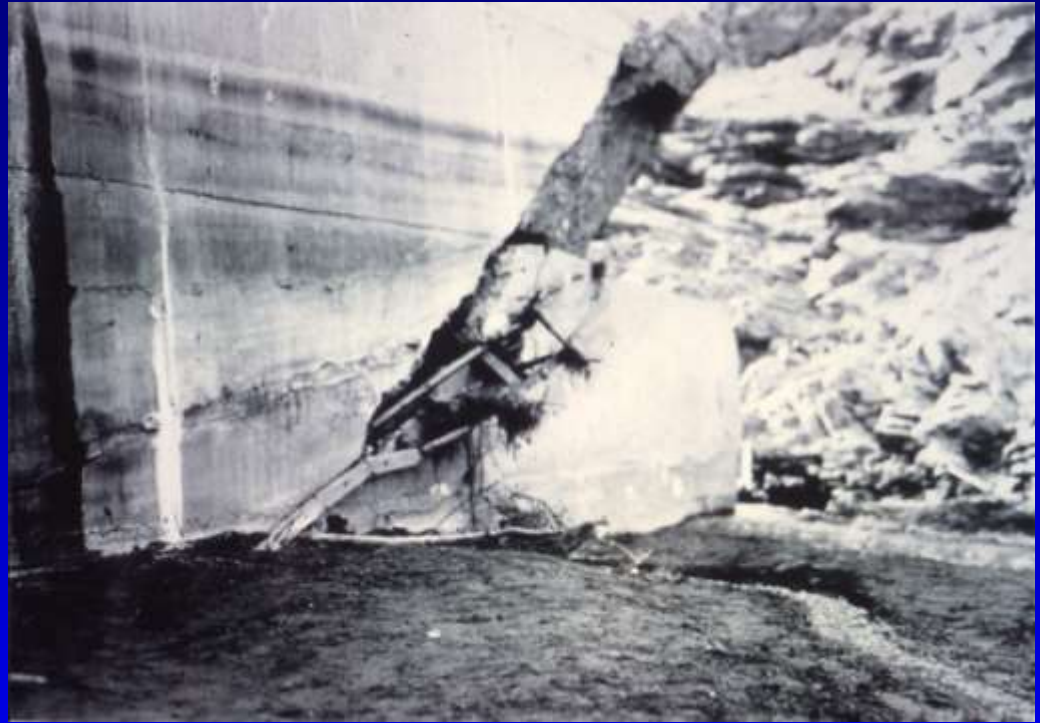
Grunsky's Ladder

- **San Francisco consulting engineer Carl Grunsky discovered the crushed remains of the wooden ladder attached to the dam's upstream face, wedged in a tension crack at the dam's upstream heel. The dam's heel was in tension, which would cause cantilever instability.**

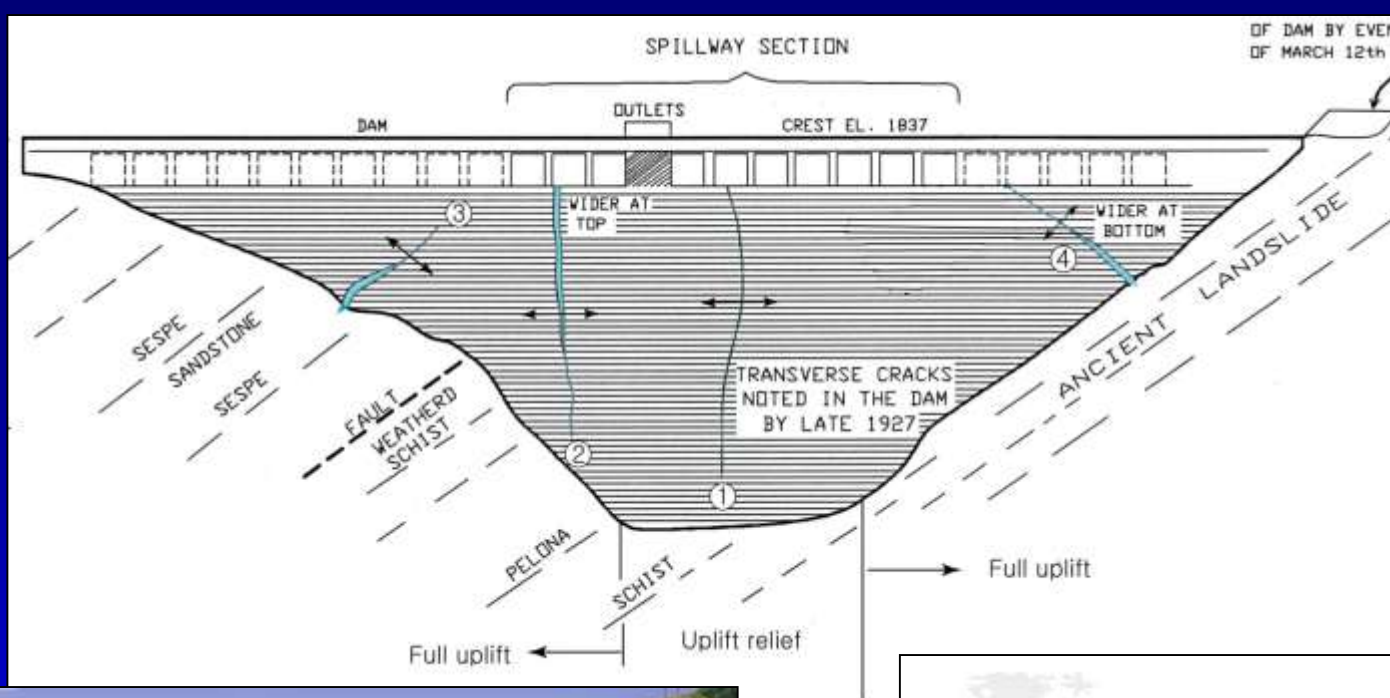
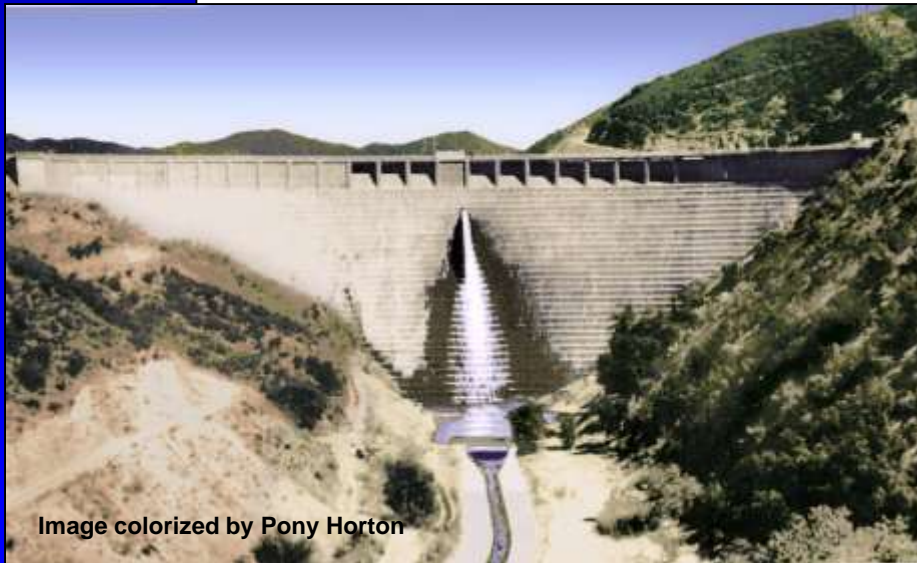
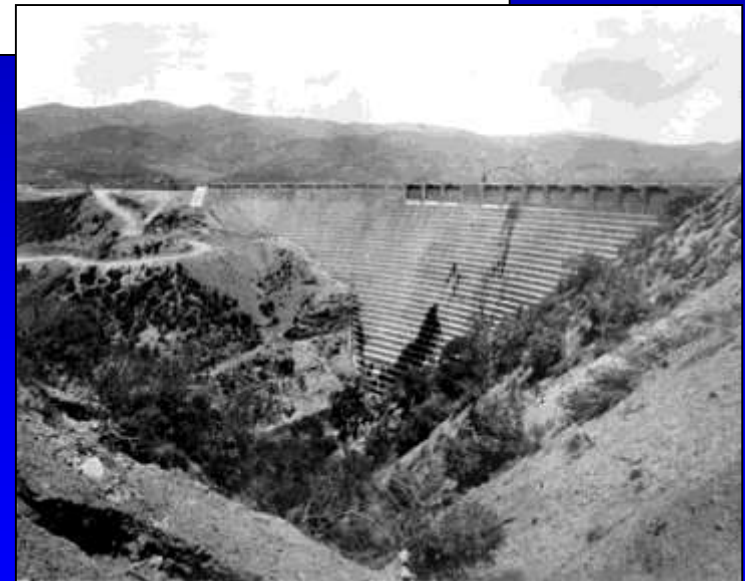
During the first year of operation several large tension cracks formed transverse to the dam's axis. These were likely in response to the cement heat of hydration, which would have been considerable for 130,000 yds³ of mass concrete.

Four prominent contraction joints leaked noticeable volumes of water in the main dam as the lake level rose.

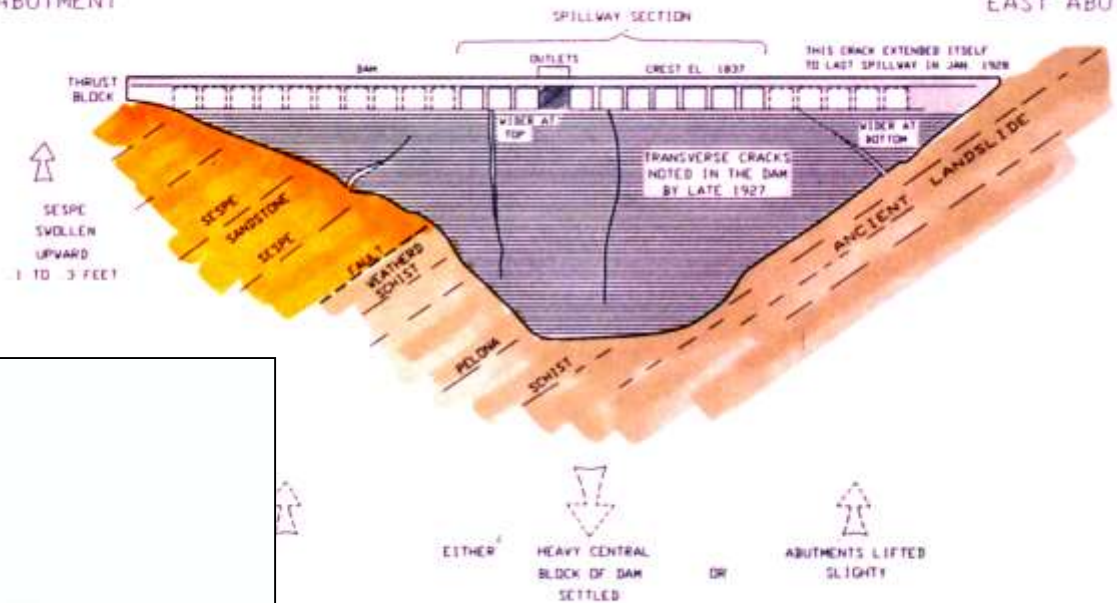
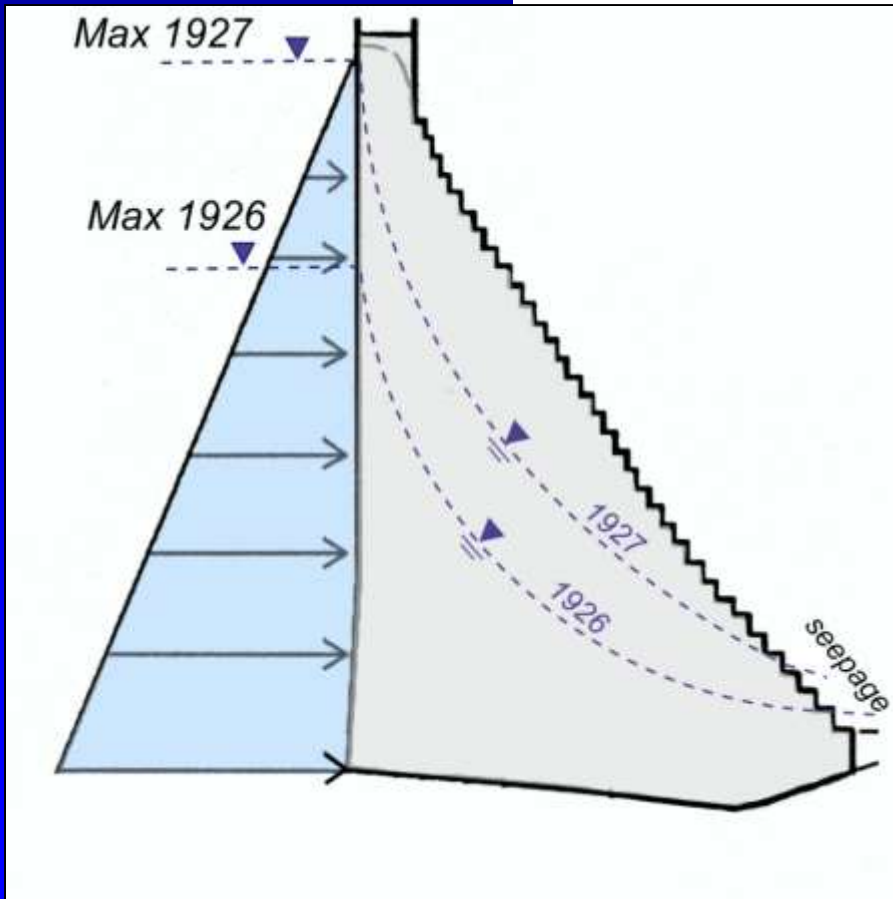
RESERVOIR TOPPED OUT AT EL. 1834.75 ON MARCH 10, 1928.
MULHOLLAND AND VAN NORMAN INSPECT THE DAM ON MONDAY MARCH 12, 1928

During the high water stand of 1927 seepage increased markedly through the downstream face, along four prominent shrinkage cracks in the dam.
