WHO DESIGNED THE ILL-FATED ST. FRANCIS DAM?

J. David Rogers, Ph.D., P.E., P.G., F.ASCE
Professor & Karl F. Hasselmann Chair in Geological Engineering
Missouri University of Science & Technology

May 23, 2017

**WORLD ENVIRONMENTAL & WATER RESOURCES
CONGRESS**

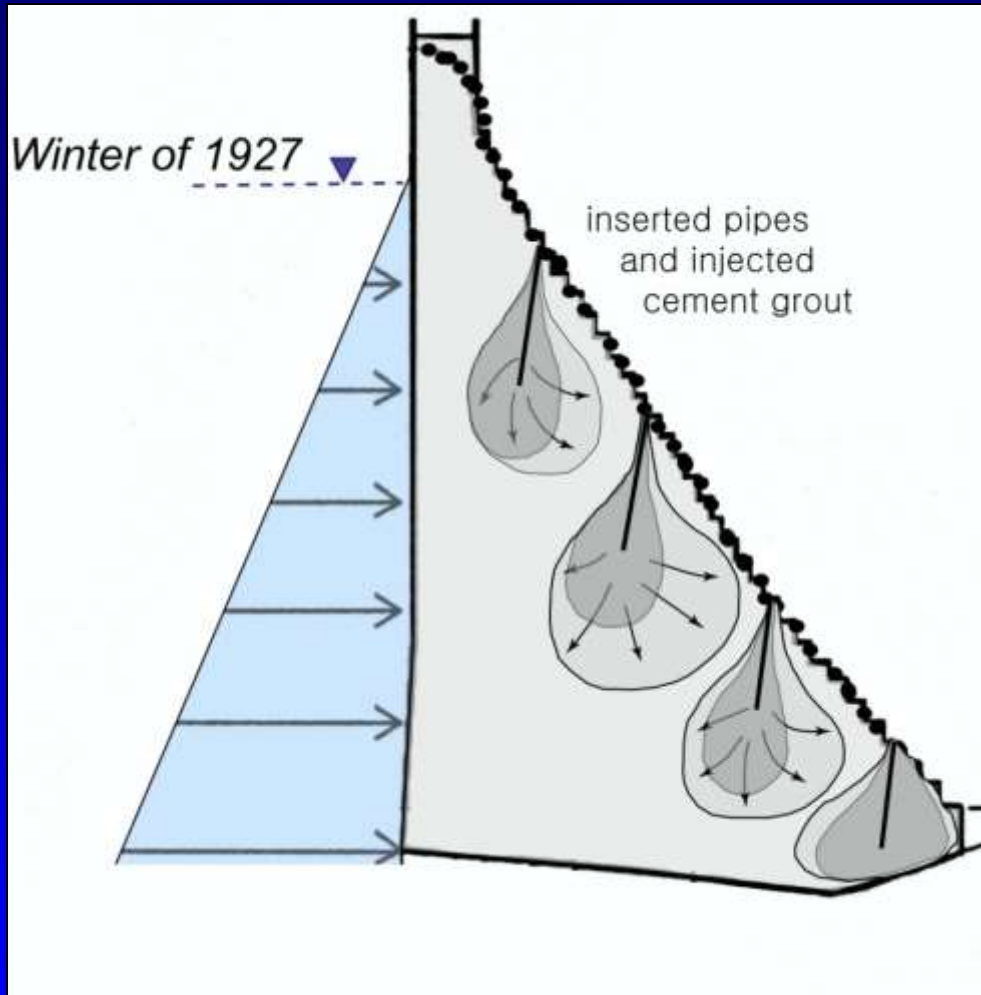
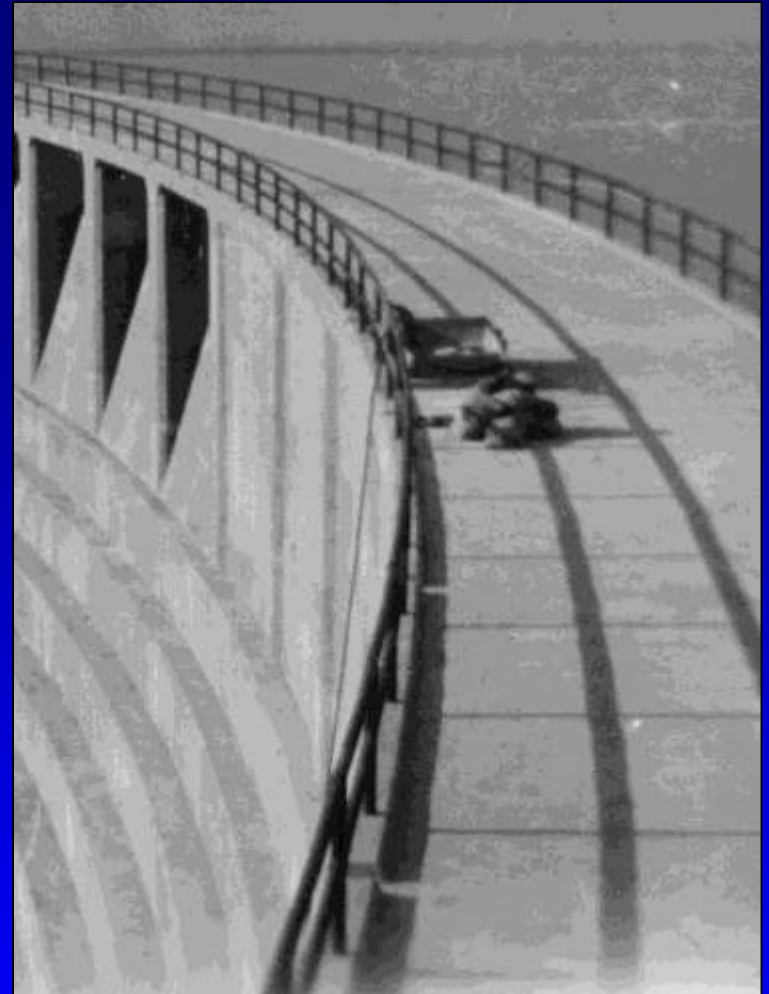
In January-February 1928 Mulholland ordered the four prominent cracks to be caulked with oakum, to prevent loss of cement grout injected into these cracks.

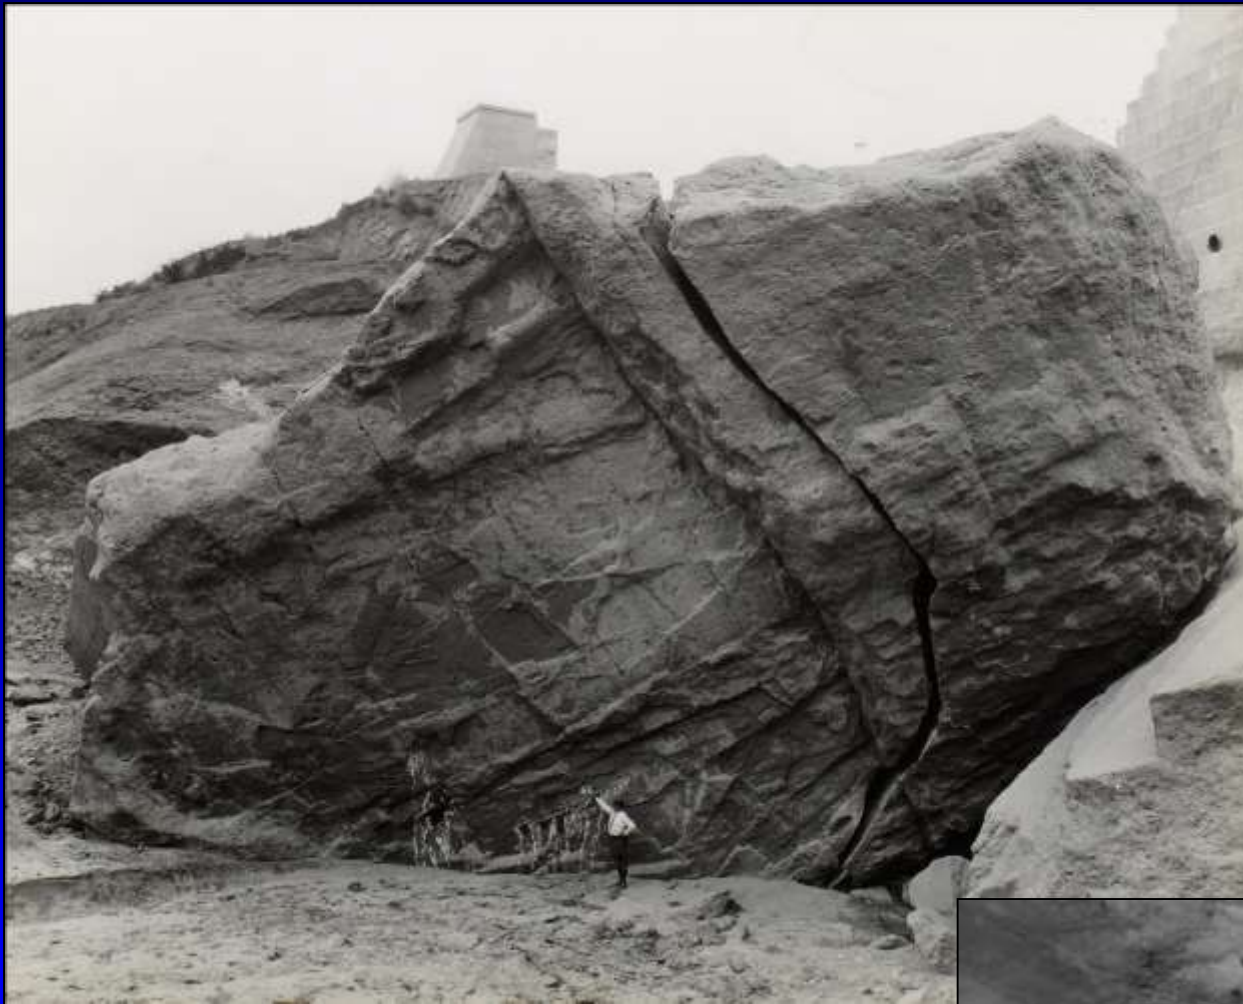
If the transverse shrinkage cracks were sealed at the dam's downstream face, full hydrostatic pressure would be expected to develop BETWEEN adjacent blocks of the dam.

**Prominent
shrinkage
crack
observed
cutting
through Block
5, observed
after the
failure**

**The oakum caulking can be
discerned on the post-failure
images as dark lines across
the dam's downstream face**
