Who Designed the Ill-Fated St. Francis Dam?

J. David Rogers, Ph.D., P.E., P.G., F.ASCE¹

Abstract

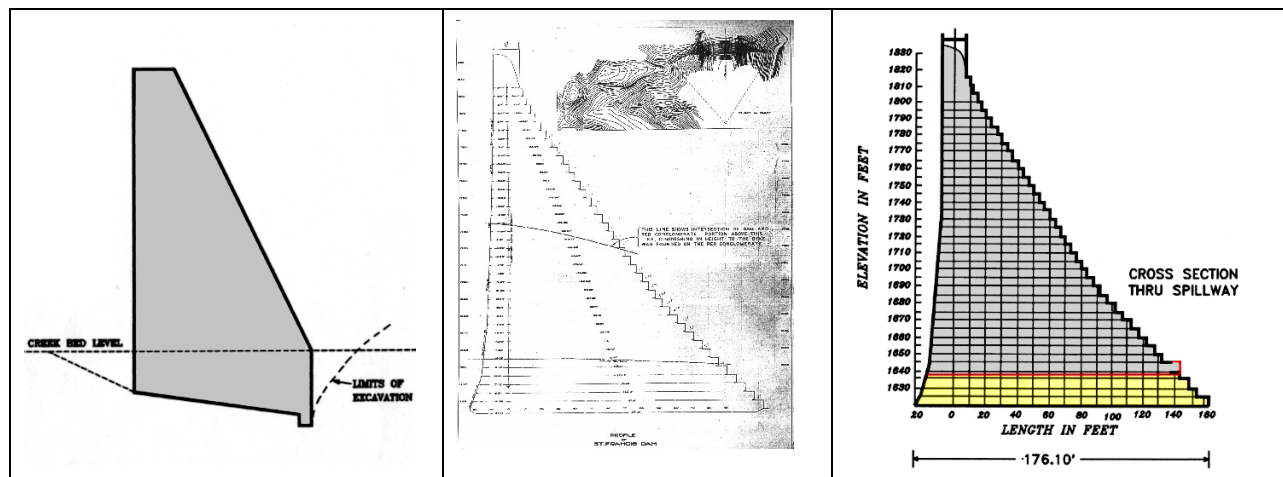
Figure 1. Left pane shows the original maximum section through the St Francis Dam, made in July 1923. Middle pane shows the as-built drawing released by BWWS after the failure, showing a flared toe, up to 175 ft wide at elevation 1625. The right pane shows the actual limits of the dam in red, with a base width of 148 ft.

The dam was subsequently raised 20 vertical feet, about 11% of its original height (175 ft) without any corresponding adjustment of the dam's base width. The elevation of the stream bed was about 1655 ft, and the maximum depth of excavation was about 16 ft, to an elevation of

1639 ft. The last step is clearly observed in construction photos at the time (Outland, 1977), five feet below Outlet No. 1, at an elevation of 1645 ft. The cross section presented by BWWS to all of the investigative panels after the failure was not an accurate portrayal of the dam's maximum section, especially with regards to estimating the factor of safety with regards to cantilever overturning (even ignoring uplift).

These discrepancies resulted in erroneous evaluations of the dam's static stability by most of the investigative panels in 1928 (Rogers, 1992; 1995). Rogers and McMahon (1993) showed that the dam's maximum section became unstable in cantilever overturning when the reservoir rose to elevation 1830 ft, seven feet below the spillway sill. Although ignored in the original design, the arch stresses began exceeding 7000 pounds per square foot (psf) at elevation 1822 ft, increasing to 10,000 psf at elevation 1830, five feet below spillway crest. The reservoir had been brought up to within 4 ft of the spillway for 17 days in mid-May 1927, but was not filled to capacity until March 2, 1928, 10 days prior to the failure (Fig. 2).

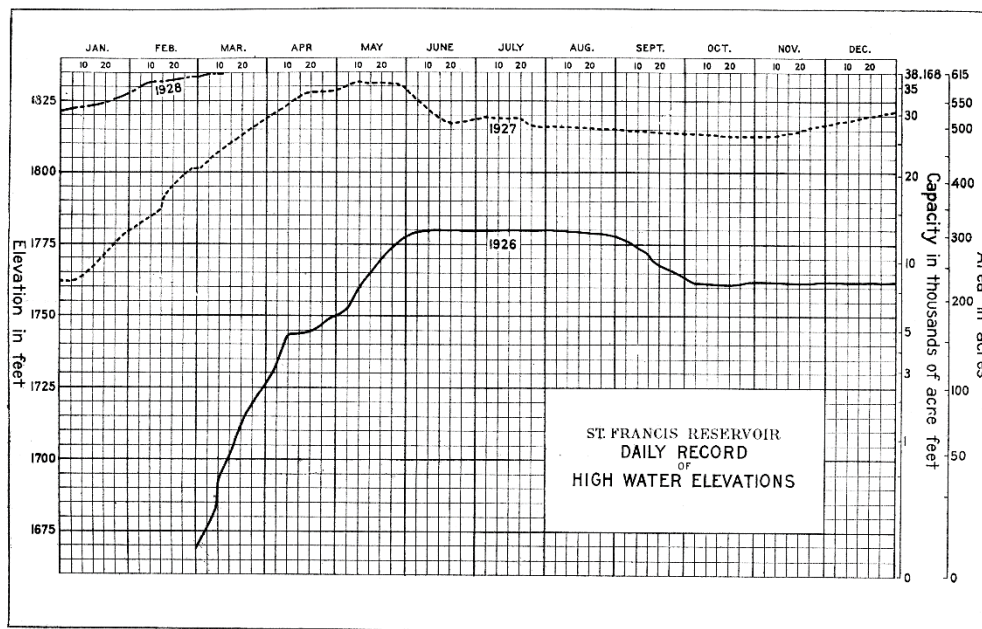
Figure 2. Daily record of reservoir elevations between March 1, 1926 and March 13, 1928. Note the reservoir was not filled to capacity until March 2, 1928, 10 days before the failure (Committee Report for the State, 1928).

The dam collapsed 10 days after the reservoir's initial filling, to within three inches of the spillway sill. This condition would have represented the maximum pore water pressure being applied to the dam mass and its foundations.

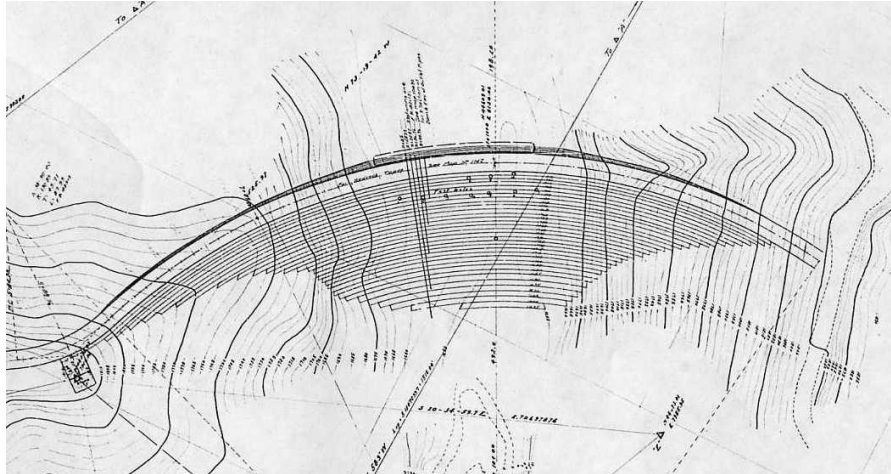
Records preserved in the LADWP Archives suggest that 10 shallow borings were made in the channel of San Francisquito Creek to probe the depth of the channel gravels (Fig. 3). These were drilled in two parallel lines, along the dam's axis, three being 4 m deep and the remaining seven being 8 m deep. These are the same holes utilized as uplift relief wells beneath the upstream third of the main dam. The sloping abutments and wing dike were not explored by anything more than open trenches at the time of construction and were bereft of any uplift relief.

Figure 3. Plan of the dam dated November 1924, with the locations of the 10 test holes that were converted to uplift relief wells, split into rows of three shallow and seven deeper holes (LADWP).

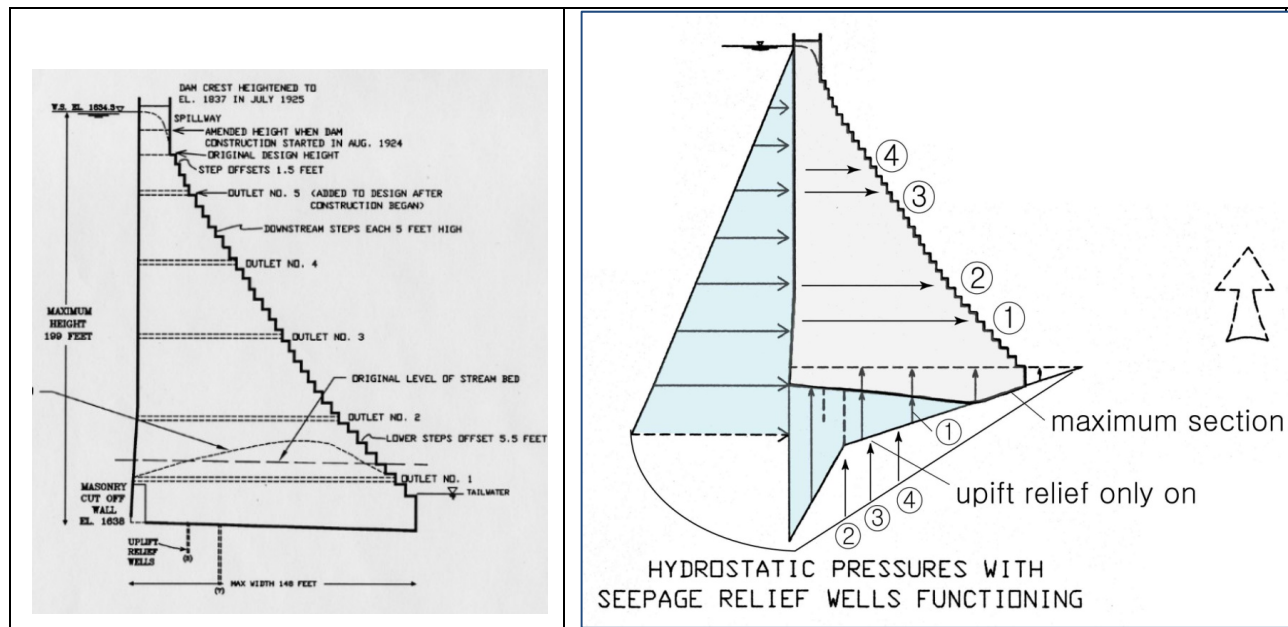
side of the central section of the dam,” but Hurlbut’s answers suggest BWWS ignored the issue of uplift relief on the steeply sloping abutments. It was the two sloping abutments of the dam that failed catastrophically, not the main section. The enormity of this problem was not revisited in any significant detail until the untimely failure of the Malpasset arch dam in 1959.

Figure 4. Left pane is a maximum cross section through the dam showing the locations of the 10 uplift relief wells beneath the upstream third (Rogers, 1995). Right pane shows the likely impact of uplift relief beneath the dam’s main section, prior to caulking of the transverse shrinkage cracks in early 1928.

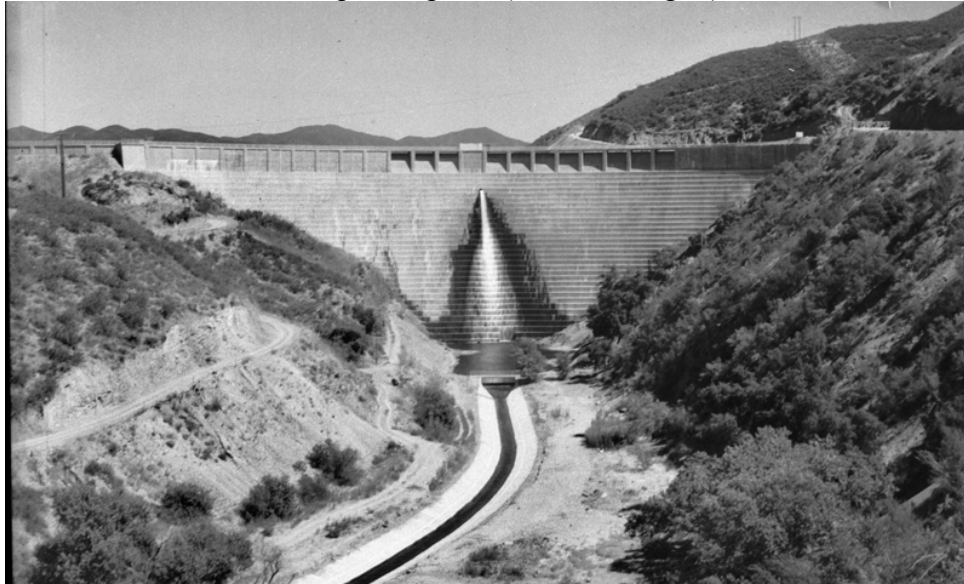
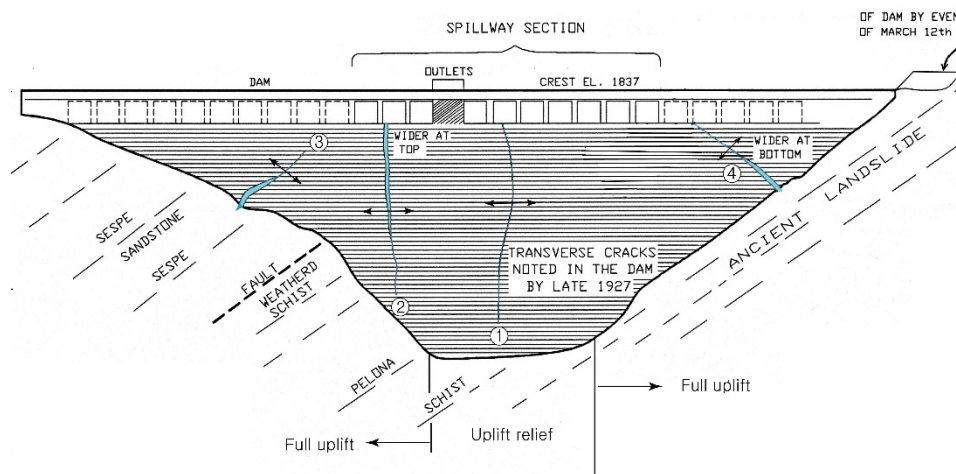
Significant shrinkage cracks developed in the St. Francis Dam as the mass concrete cured (BWWS employed a 4-sacks of cement per cubic yard mixture, the same as the US Bureau of Reclamation). BWWS Chief Surveyor James E. Phillips testified that “*the first prominent shrinkage crack was about 75 to 100 feet east of the right abutment thrust block.*” Another crack

developed “58 to 60 feet west of the gates” [outlet pipes], and another crack approximately the same distance on the other side, and one at about the “quarter point” of the main dam. Another transverse crack formed at the other quarter point (shown in Fig. 5).

Figure 5. Stepped downstream face of the St. Francis Dam, as viewed looking upstream. Four prominent shrinkage cracks developed, shown in the lower diagram. These were caulked with oakum on the downstream face and grouted in early 1928 (author’s collection).

Phillips stated that “*these cracks extended all of the way through the dam.*” He noted that the apertures of most of the shrinkage cracks were initially between $1/8^{\text{th}}$ and $3/16^{\text{th}}$ of an inch at the crest of the dam (Fig. 6). What engineers didn’t understand at the time was that the width was inconsequential; it was the transverse connectivity with the dam’s upstream face that impacted internal stability.

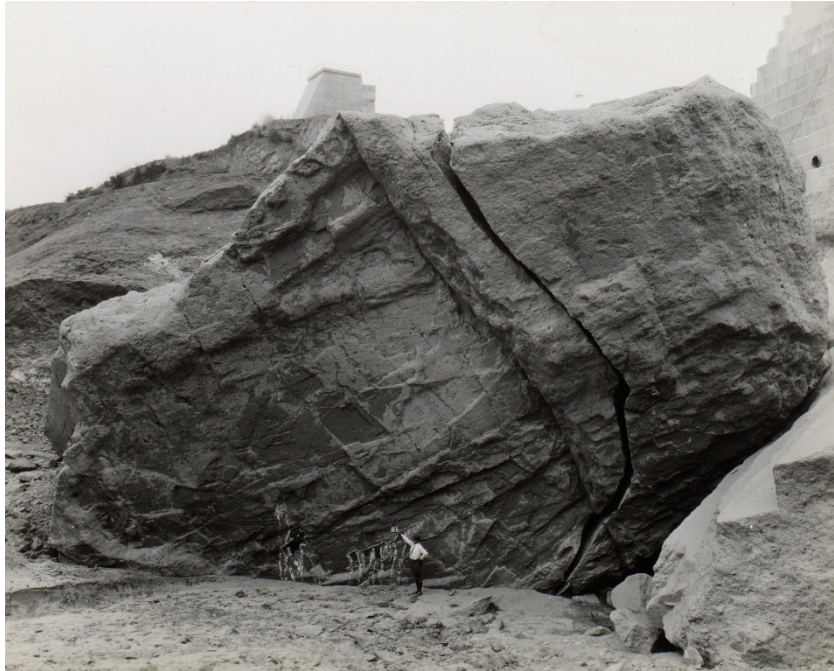
Figure 6. Upturned base of block #7, from the crest of the dam’s left abutment. The open fissure is transverse shrinkage crack #4, shown in the lower half of Figure 1 (Mayberry et al., 1928).

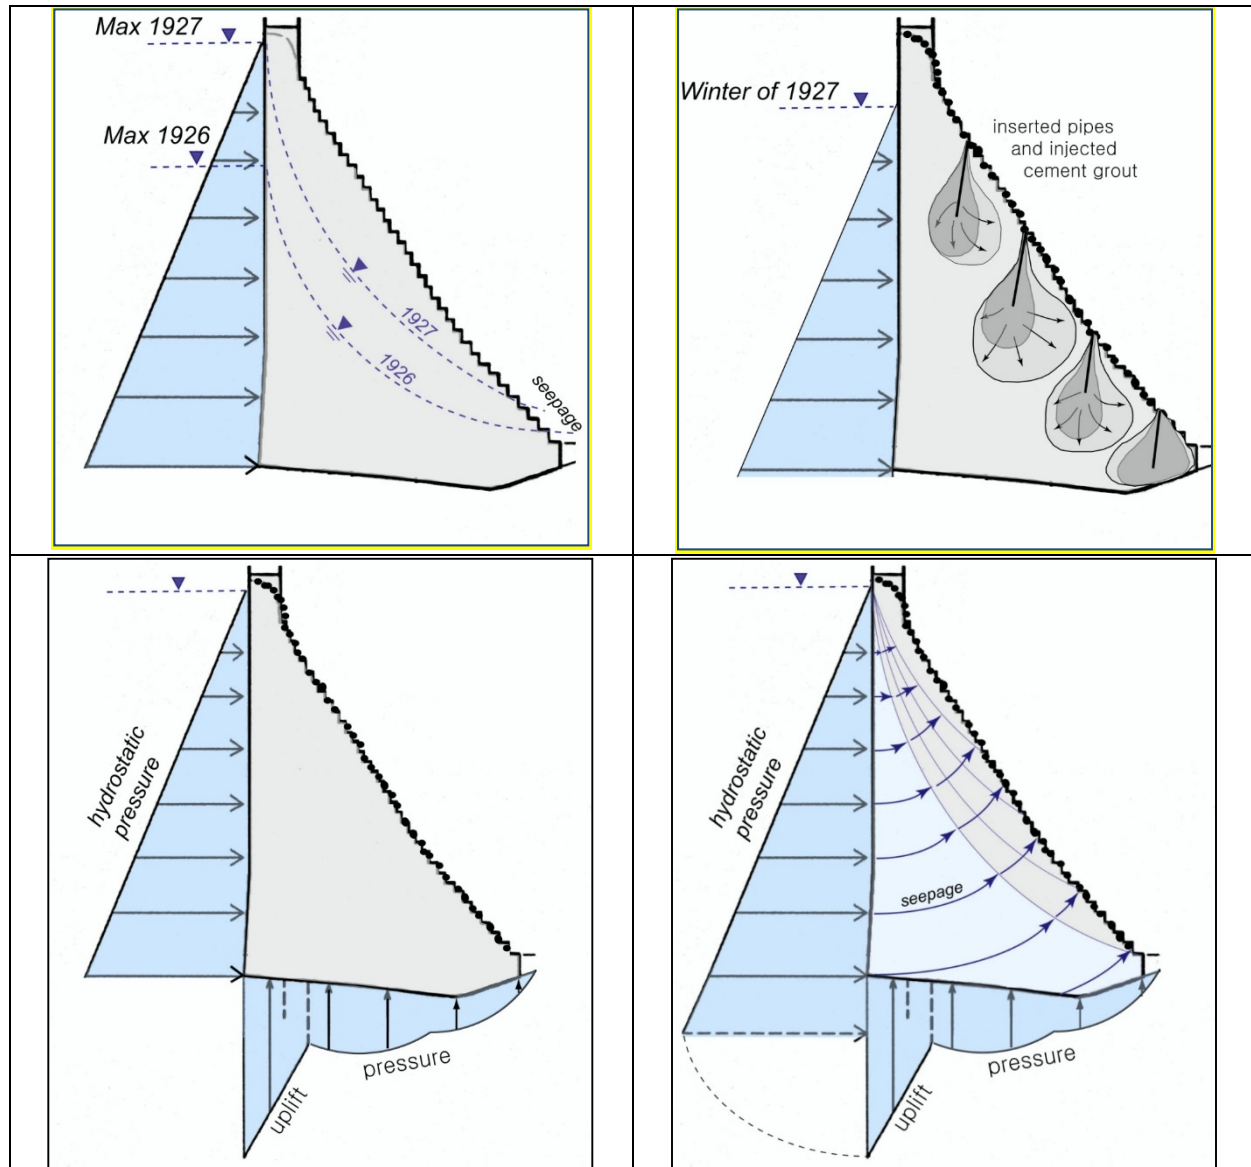
Phillips went on to describe how the shrinkage cracks were caulked with oakum; a mixture of hemp or jute fiber that was often smeared with tar, creosote, or asphalt to caulk seams in wooden ships and packing pipe joints. He noted that BWWS crews drilled holes into the dam

and “grouted the big cracks.” The oakum was placed on the downstream face of these cracks to keep the cement grout from “running out,” as sketched in Fig. 7.

Figure 7. Plugging of the dam's contraction joints on the downstream face could have had disastrous consequences by creating full reservoir pressure against the interior faces of the main dam, especially if the grouting behind the face was anything less than a 100% seal. This was a detail apparently missed by all of the post-failure reviews in 1928.

William Mulholland's decision to caulk and grout the transverse shrinkage cracks in January and February 1928 (Fig. 7) likely triggered the dam's untimely demise a few weeks later. Mulholland's goal was to save precious water being lost through the cracks, but caulking the fissures with oakum on the downstream face served to trap reservoir water pressure within the dam itself, a potentially catastrophic situation because it would have hastened internal instability. This condition is born out to a noticeable degree in the downstream tilt of about one degree, recorded by the Steven's Gage on Block 1 of the dam, beginning around 8:30 PM on March 12th, 3-1/2 hours before the failure (Rogers 1995; 2007). Few people at the time understood the destabilizing impacts of pore water pressure beneath concrete arch dams, which were altered radically by the failure of Malpasset Dam in France in 1959.

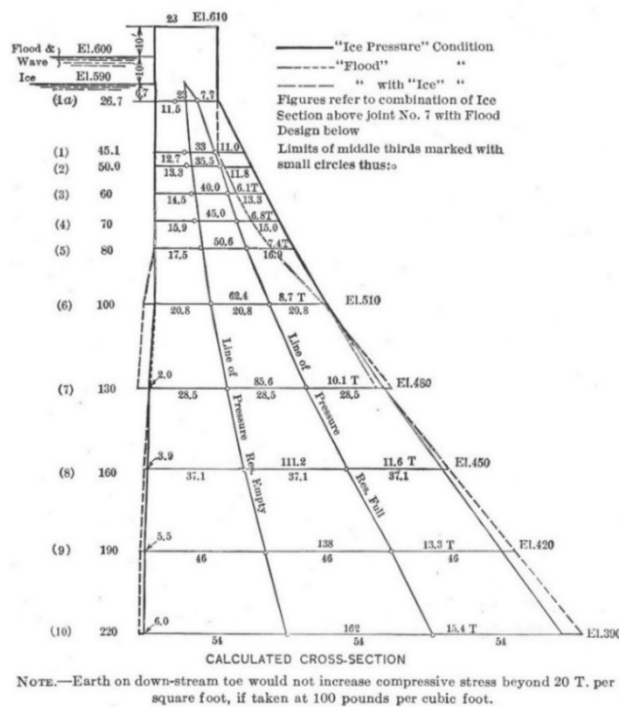
Figure 8. Example of the “stress diagrams” described by Edgar Bayley, taken from *Masonry Dam Design, 2nd Edition* by Morrison & Brodie (1916). This shows a maximum compressive stress of 20 tons per square foot (tsf) along the ‘Line of Pressure-Reservoir Full.’ These were the same values used by Bayley in the design of Hollywood Dam, which were then applied to St. Francis Dam.
