San Francisquito Canyon Dam Disaster

(California)

Report to His Excellency
Gov. George W. P. Hunt

BY
GUY L. JONES
MEMBER OF ARIZONA LEGISLATURE

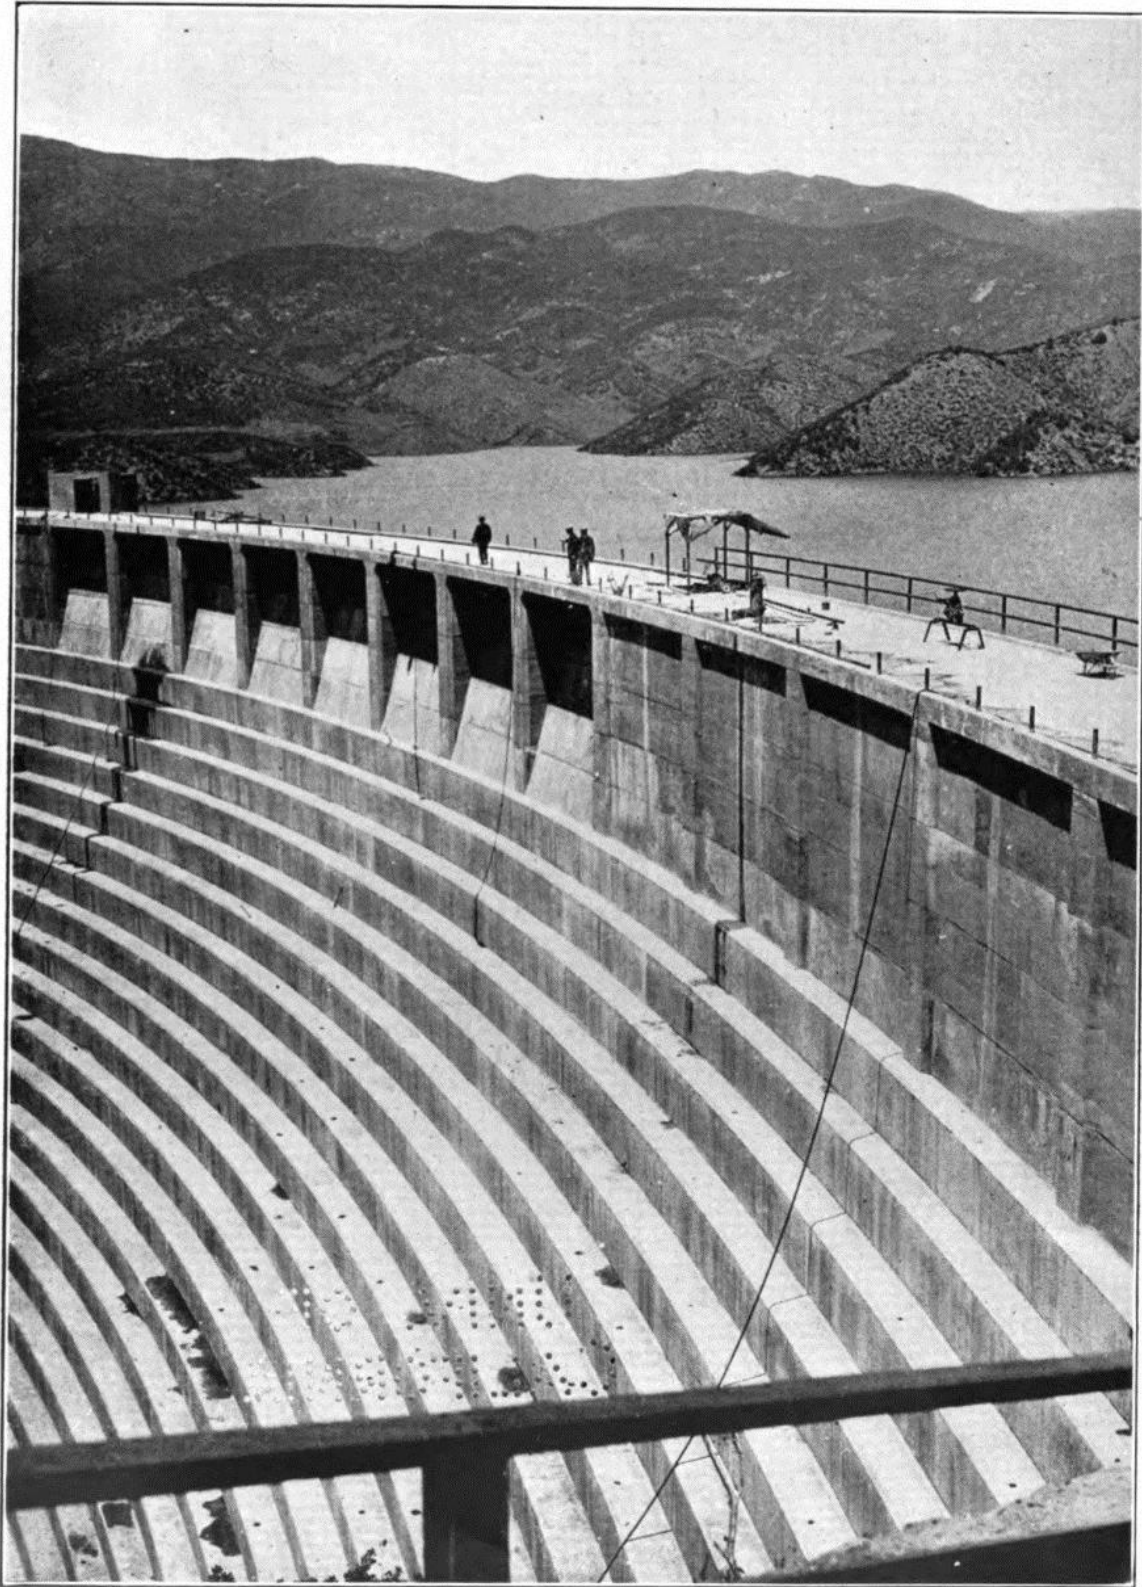
The dam while filling four months before the disaster, showing the tremendous strength of the solid concrete, gravity type, arched upstream dam.

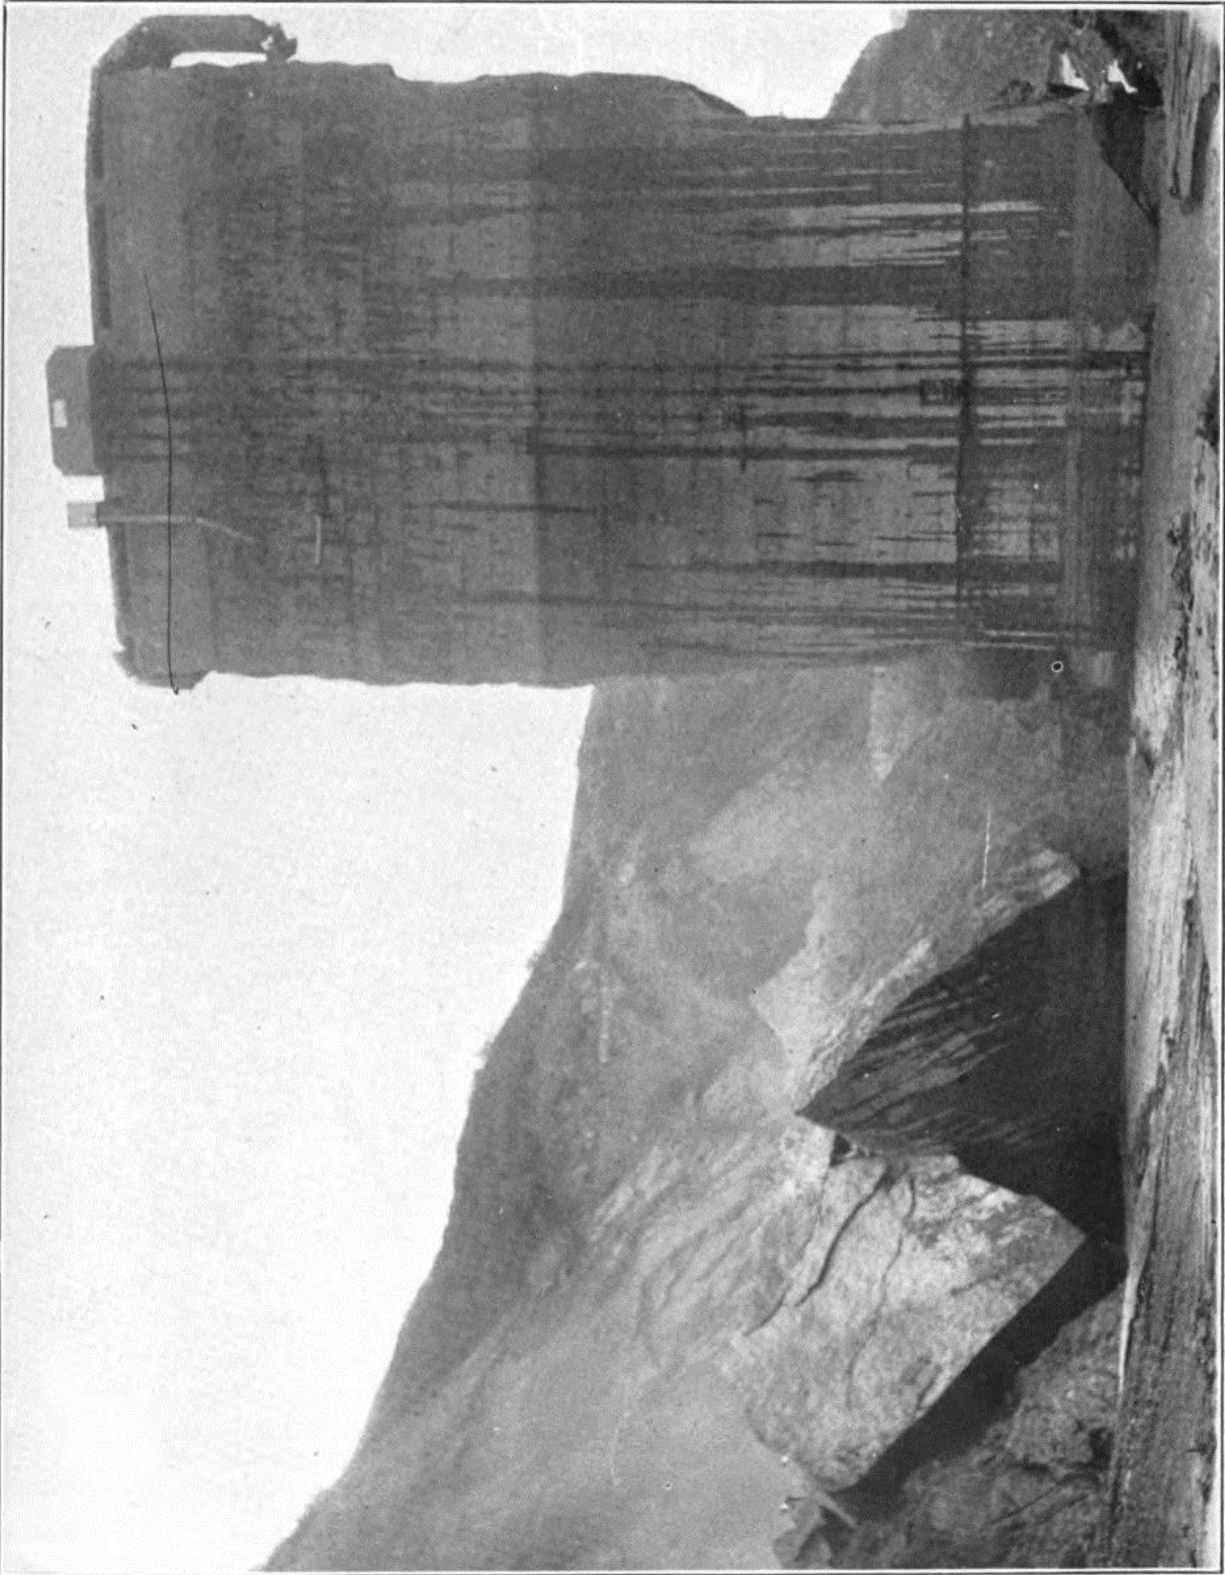
Standing section looking downstream. View taken from reservoir bed. At left, sections of east wing can be seen lying upstream from face of standing section. At right, what appears to be fracture at base is profile of bedrock where west slope began.

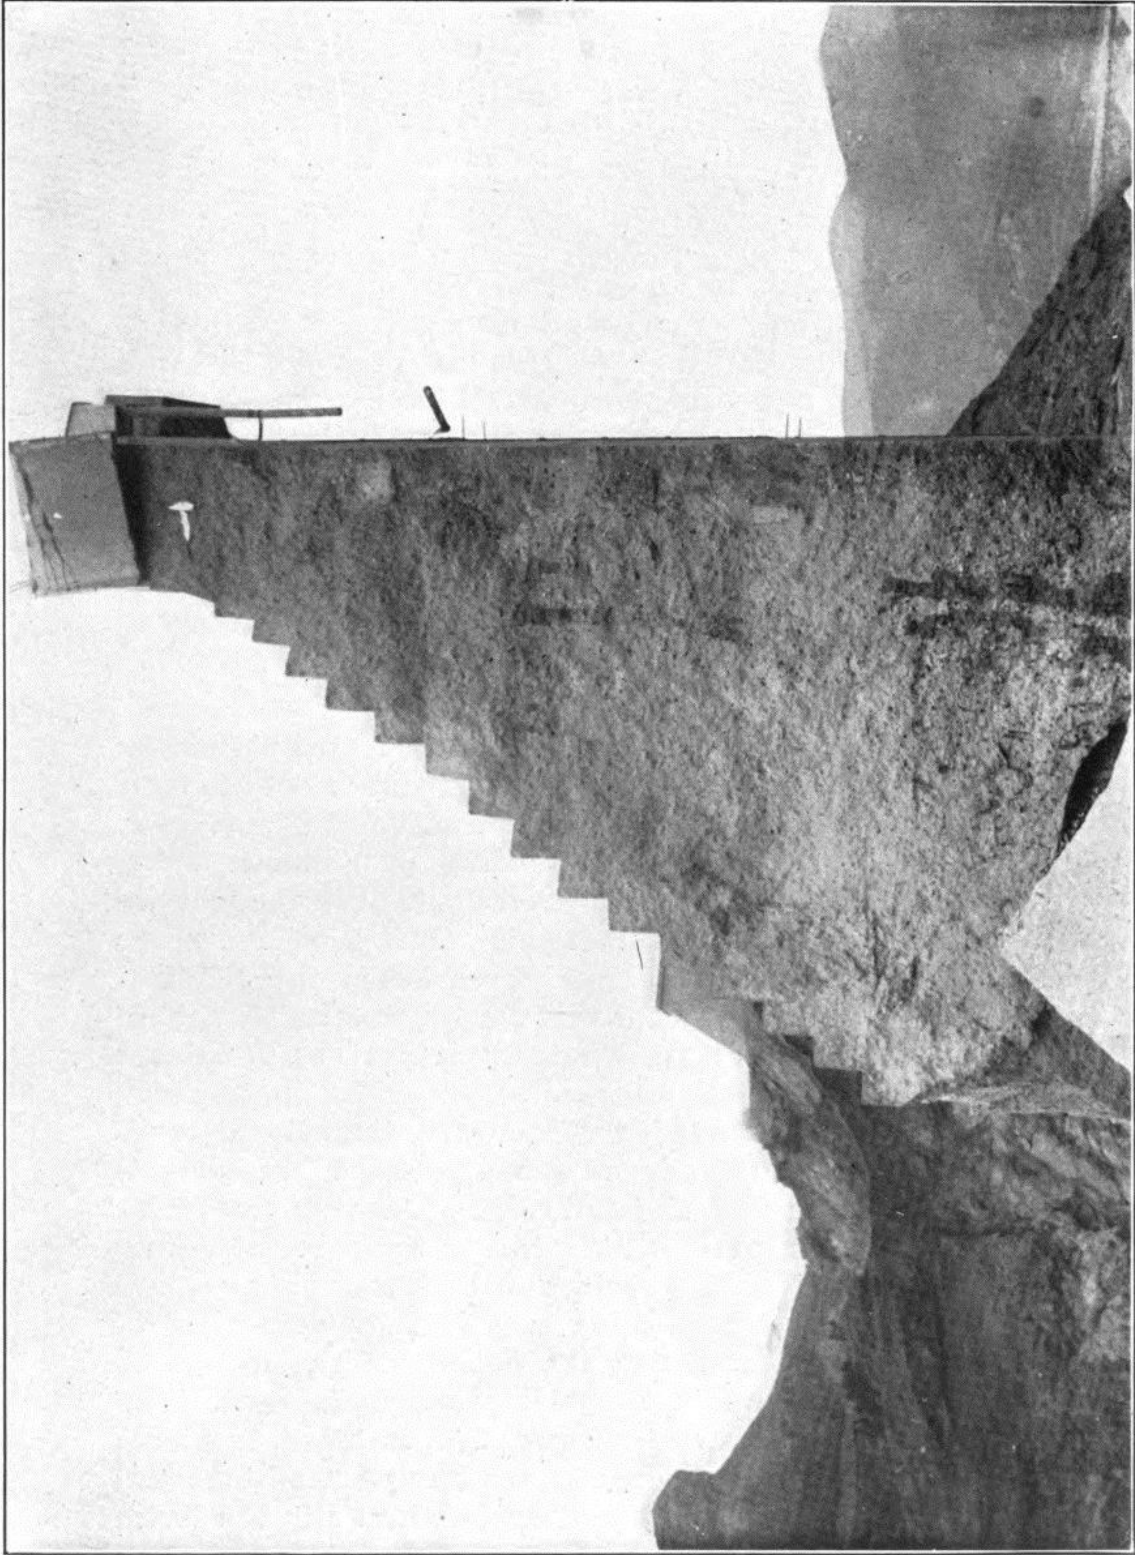
View of standing section looking across site of dam from east, showing how the downstream toe was broken off.

6. Examination of the foundation material supporting the sector of the dam now standing, shows a fracture in the schist upon which this sector rests, indicating that the break which permitted the downstream movement, occurred in the foundation materials and not in the concrete of which the dam was constructed.

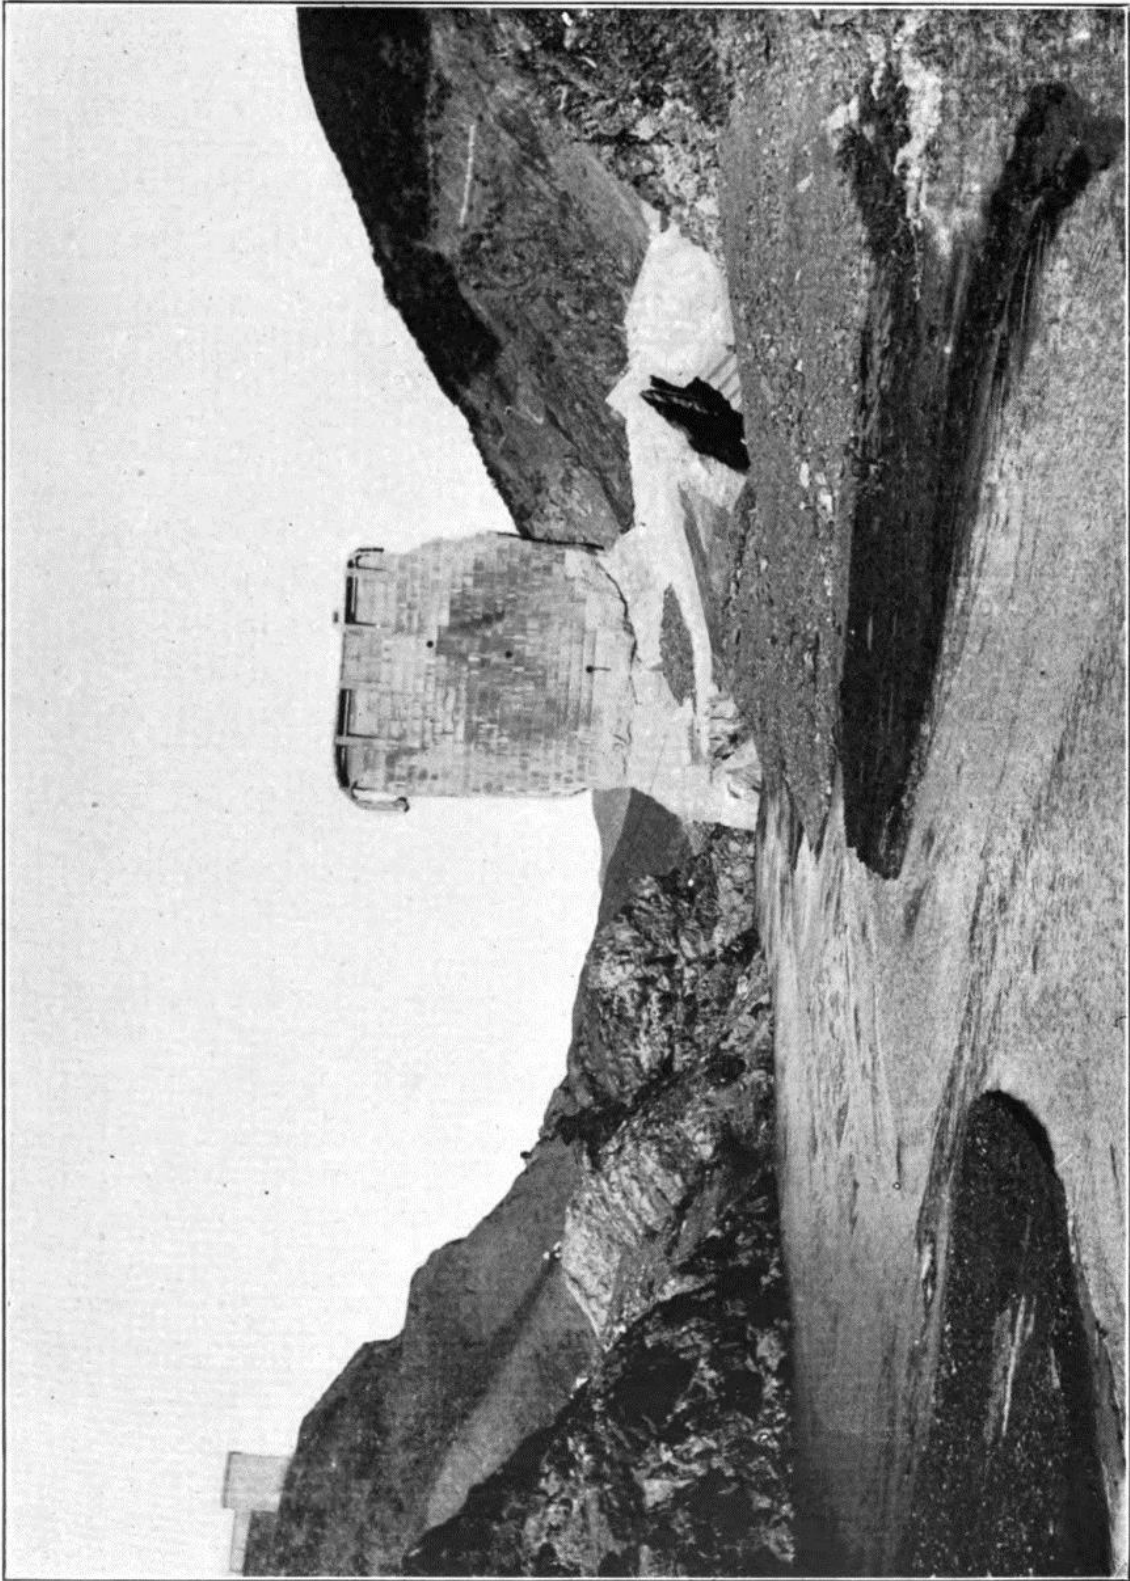
A view of standing section, looking upstream the following morning. The line which looks like a horizontal crack is not a crack through the structure, but is the top line of fragments lying behind the standing section.

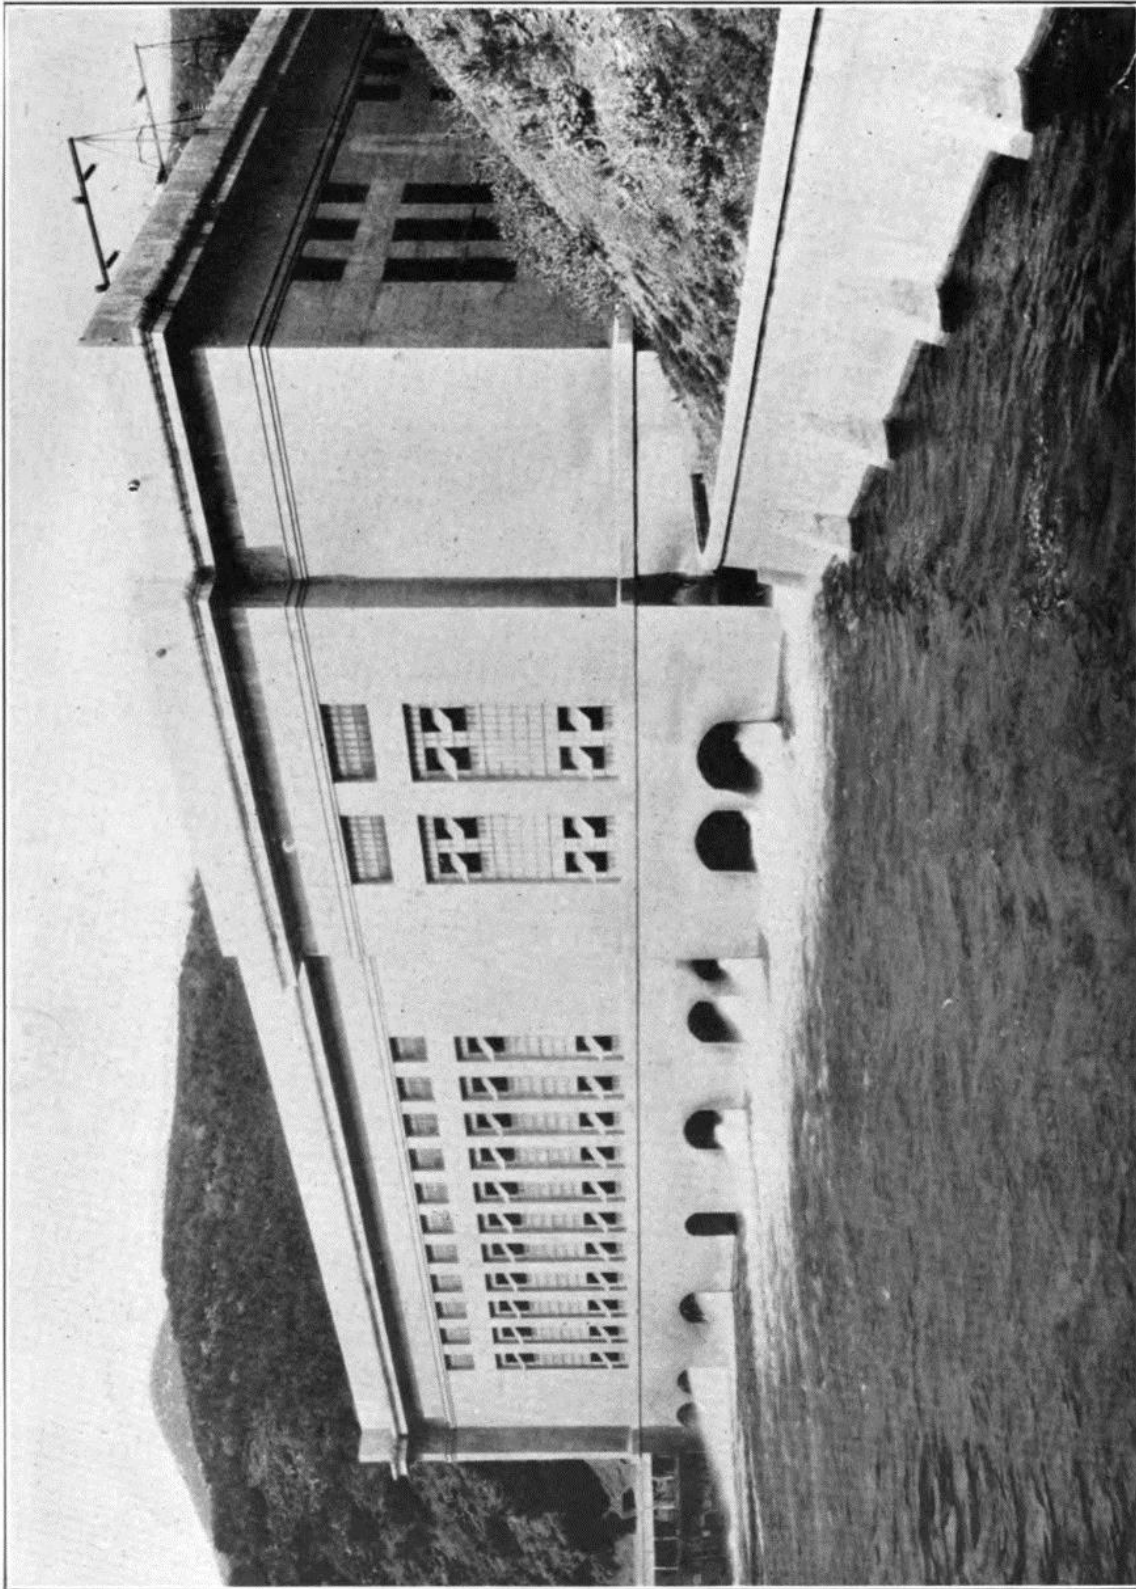
Los Angeles Bureau of Power and Light building that was carried away when the St. Francis dam broke and released 12 billion gallons of water.

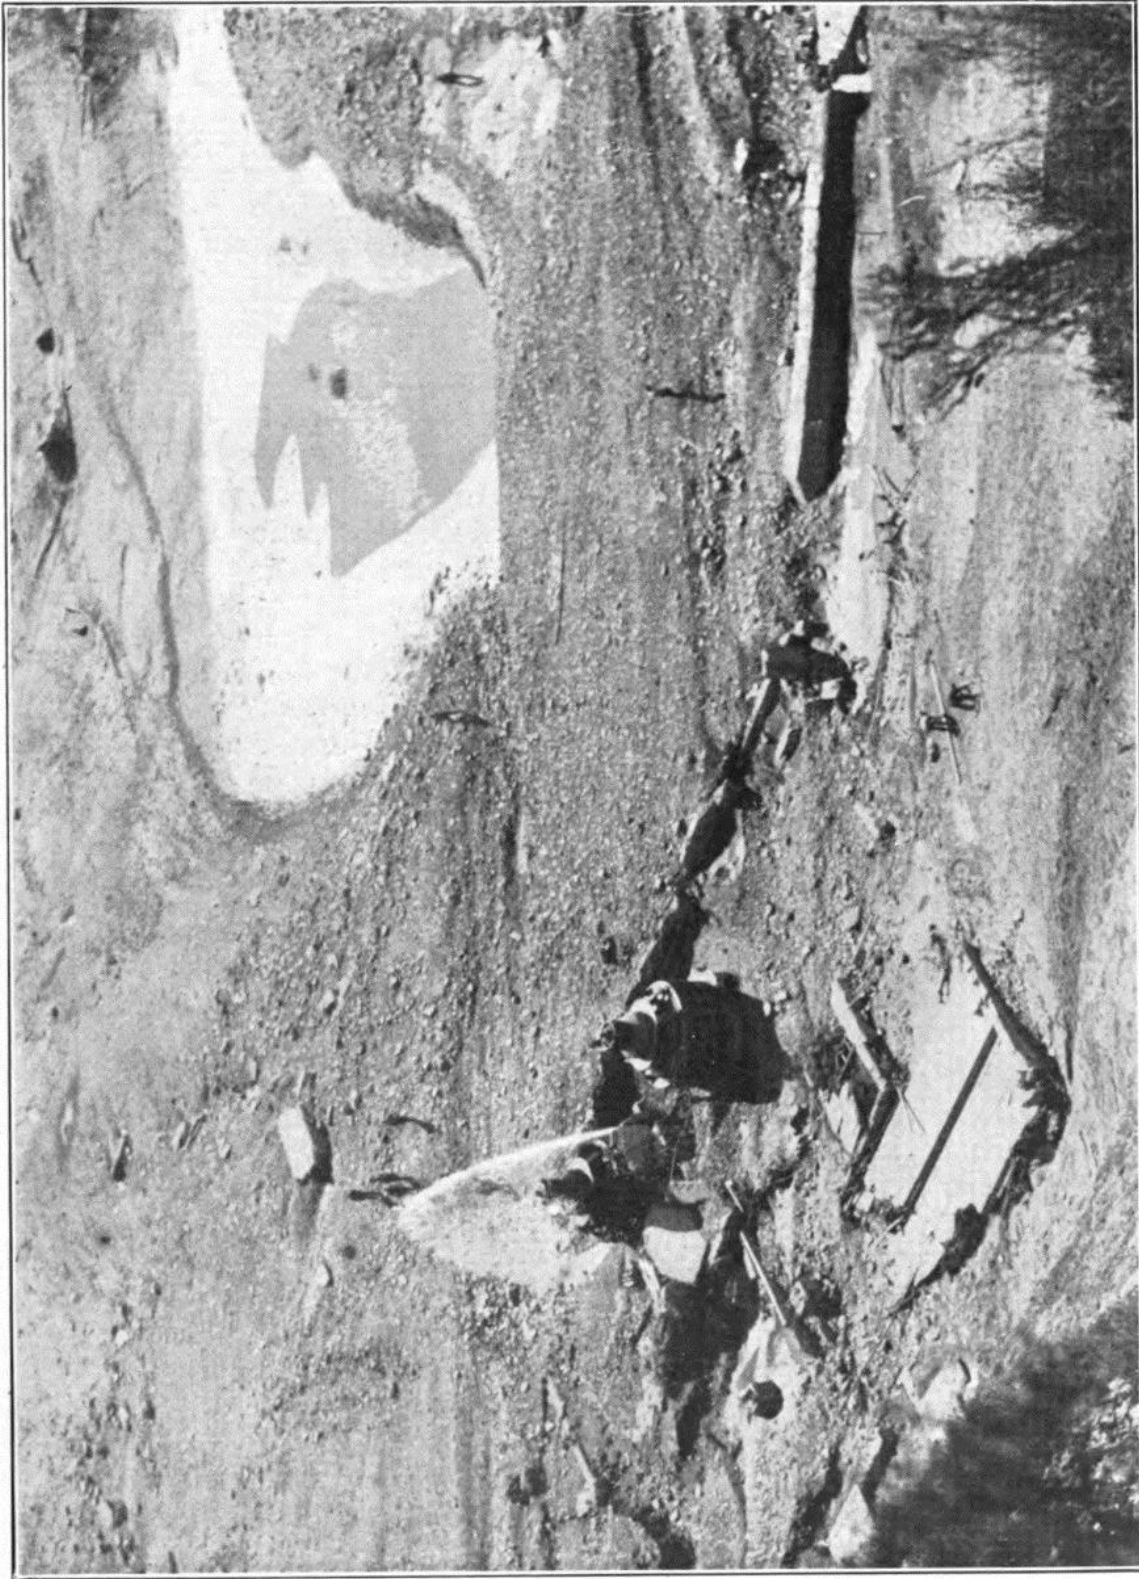
Another view of the power plant No. 2 at the site one and one-half miles down the canyon below the dam the morning after the dam failure. The stream of water spouting above the turbine comes from the pressure in the twin aqueduct tubes which led from the top of the canyon wall 200 feet above.

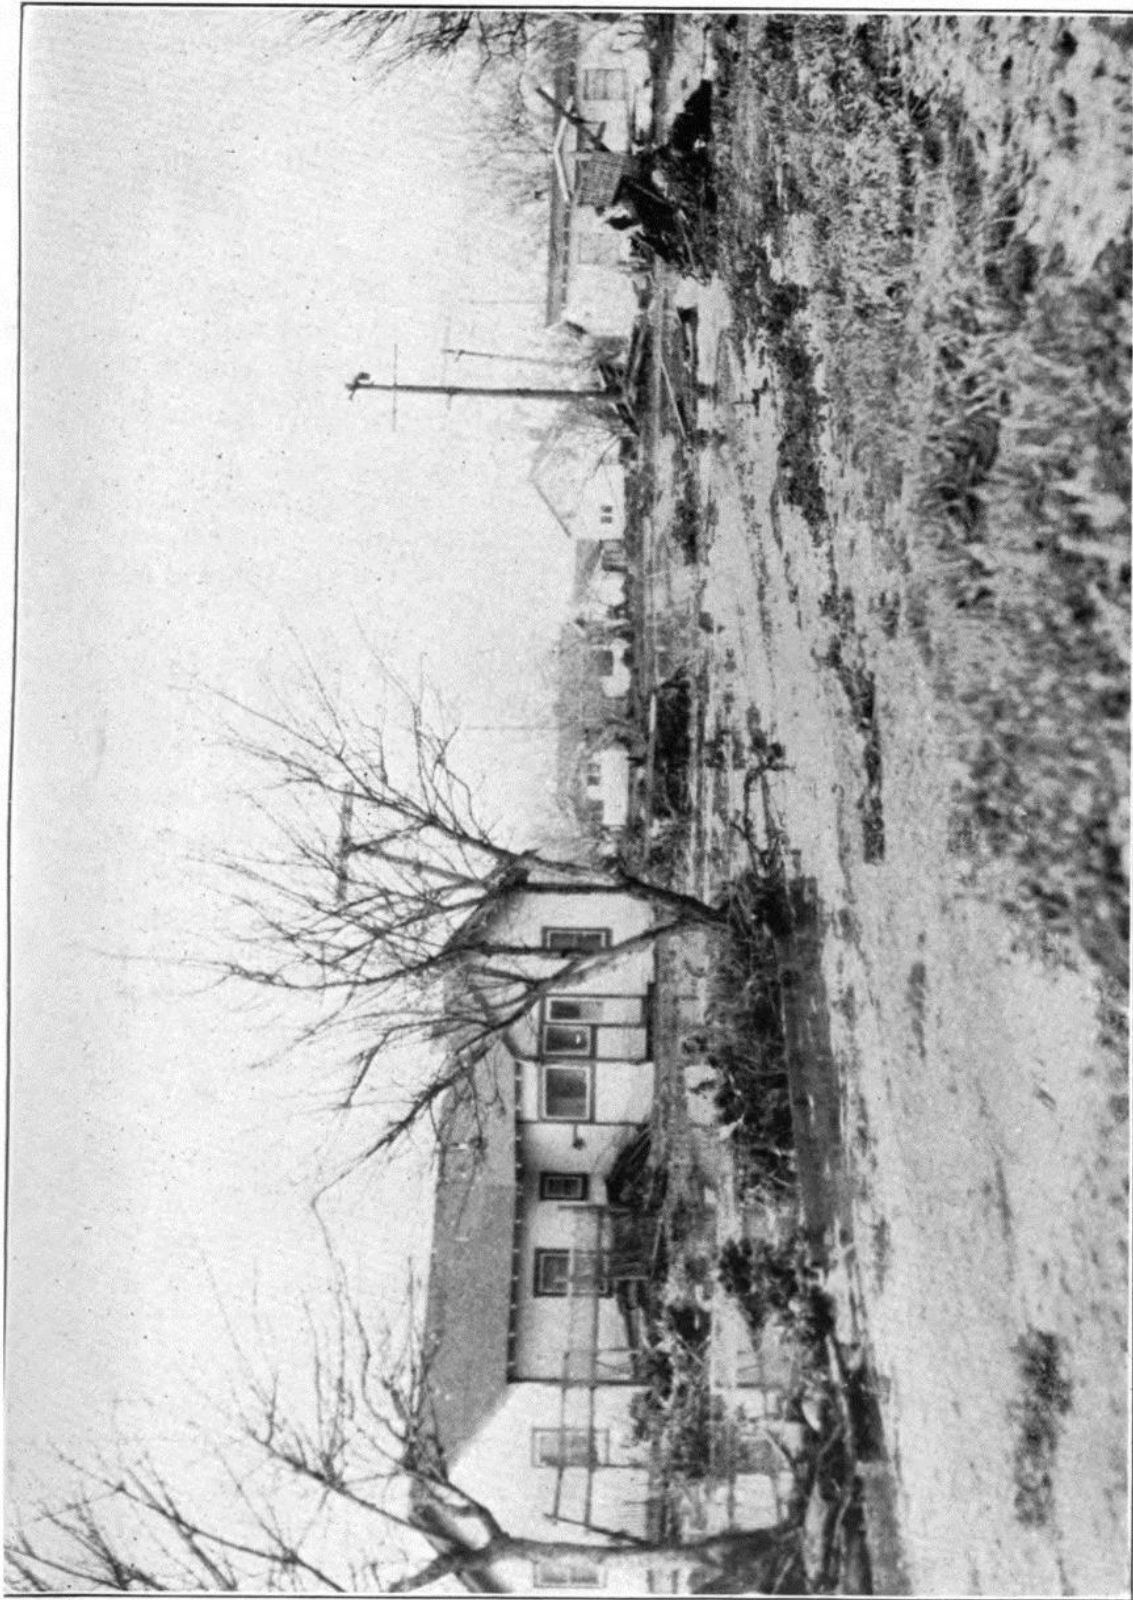
This picture was taken two blocks from the center portion of Santa Paula. Santa Paula is fifty miles down the Santa Clara River below the dam site.
