THE SECRETARY  
OF THE INTERIOR'S  
**STANDARDS FOR  
THE TREATMENT  
OF HISTORIC  
PROPERTIES**

WITH  
**GUIDELINES FOR  
PRESERVING,  
REHABILITATING,  
RESTORING &  
RECONSTRUCTING  
HISTORIC  
BUILDINGS**

U.S. Department of the Interior  
National Park Service  
Technical Preservation Services

2017

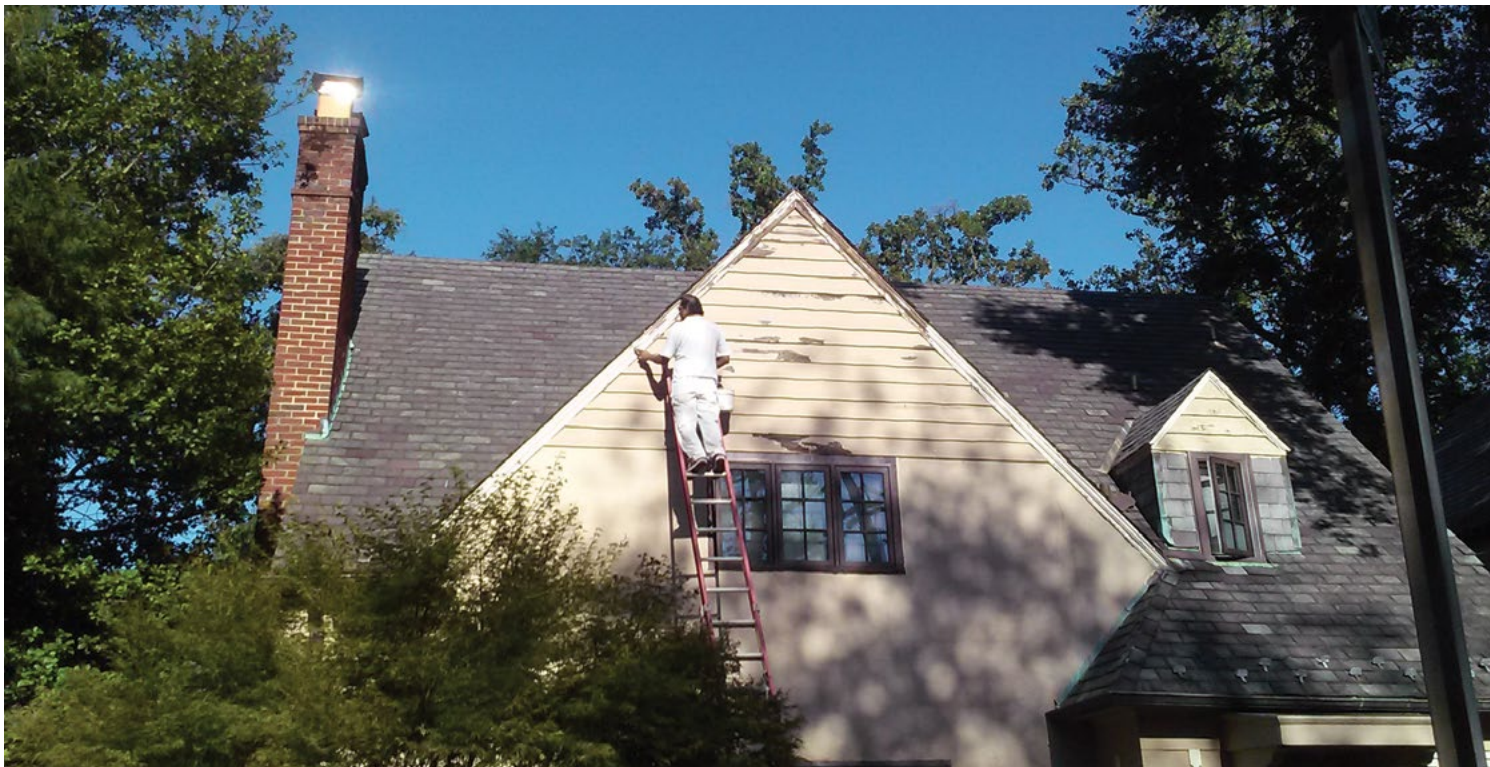
[4] Hand scraping to remove peeling paint from wood siding in preparation for repainting is an important part of regularly-scheduled maintenance.

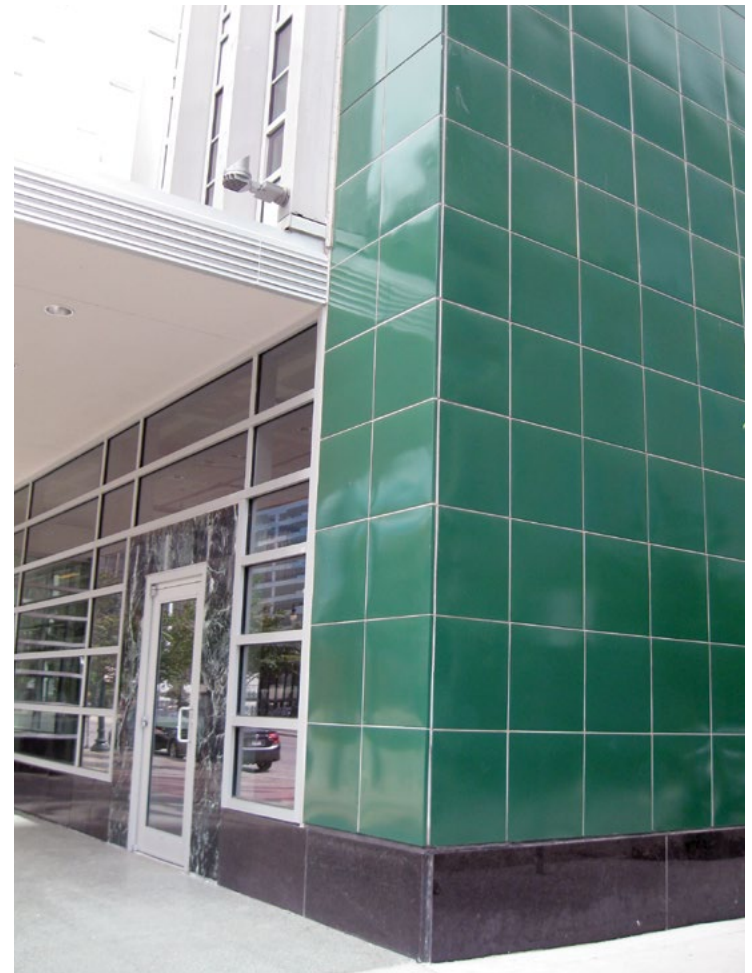
[15] New enameled-metal panels were replicated to replace the original panels, which were too deteriorated to repair, when the storefront of this early 1950s building was recreated.

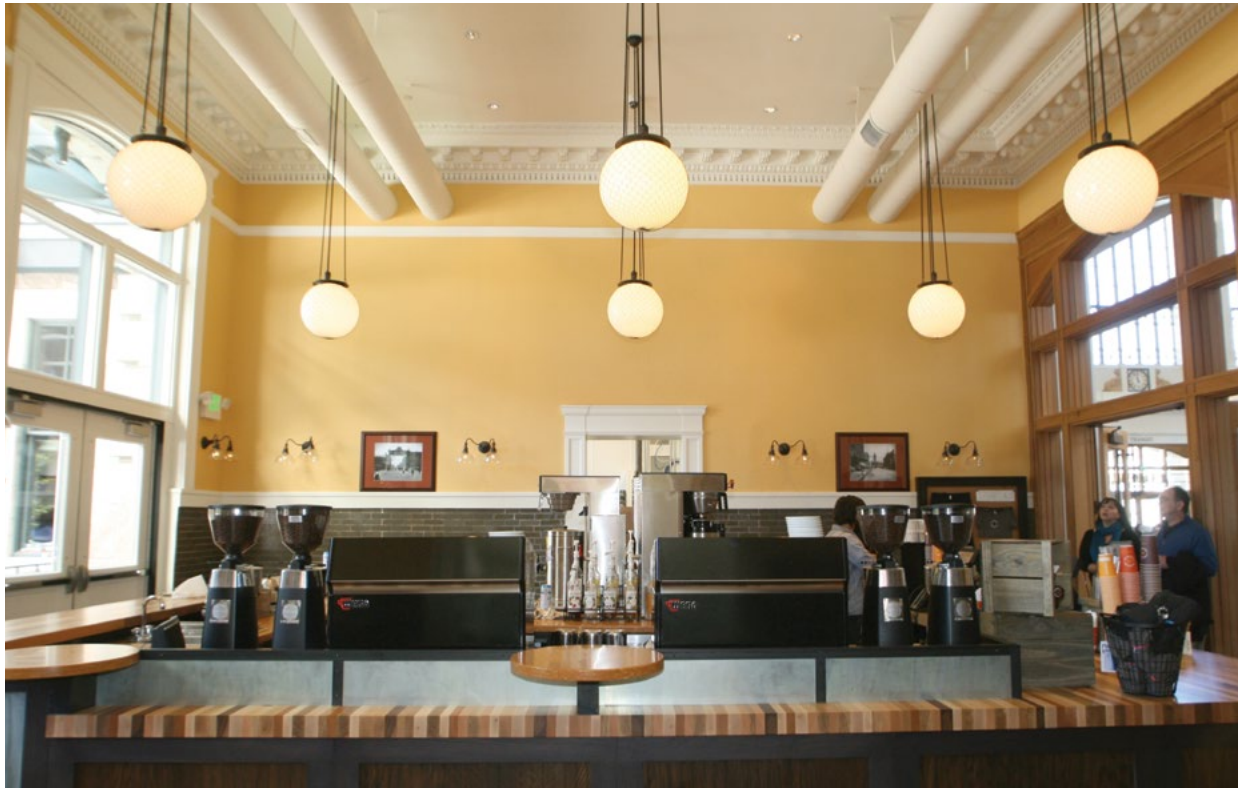
[37] Exposed and painted ducts were appropriately installed here in a retail space in Denver's historic Union Station after considering other options that would have impacted the ceiling height, or damaged or obscured the ornamental plaster crown molding. *Photo: Heritage Consulting Group.*

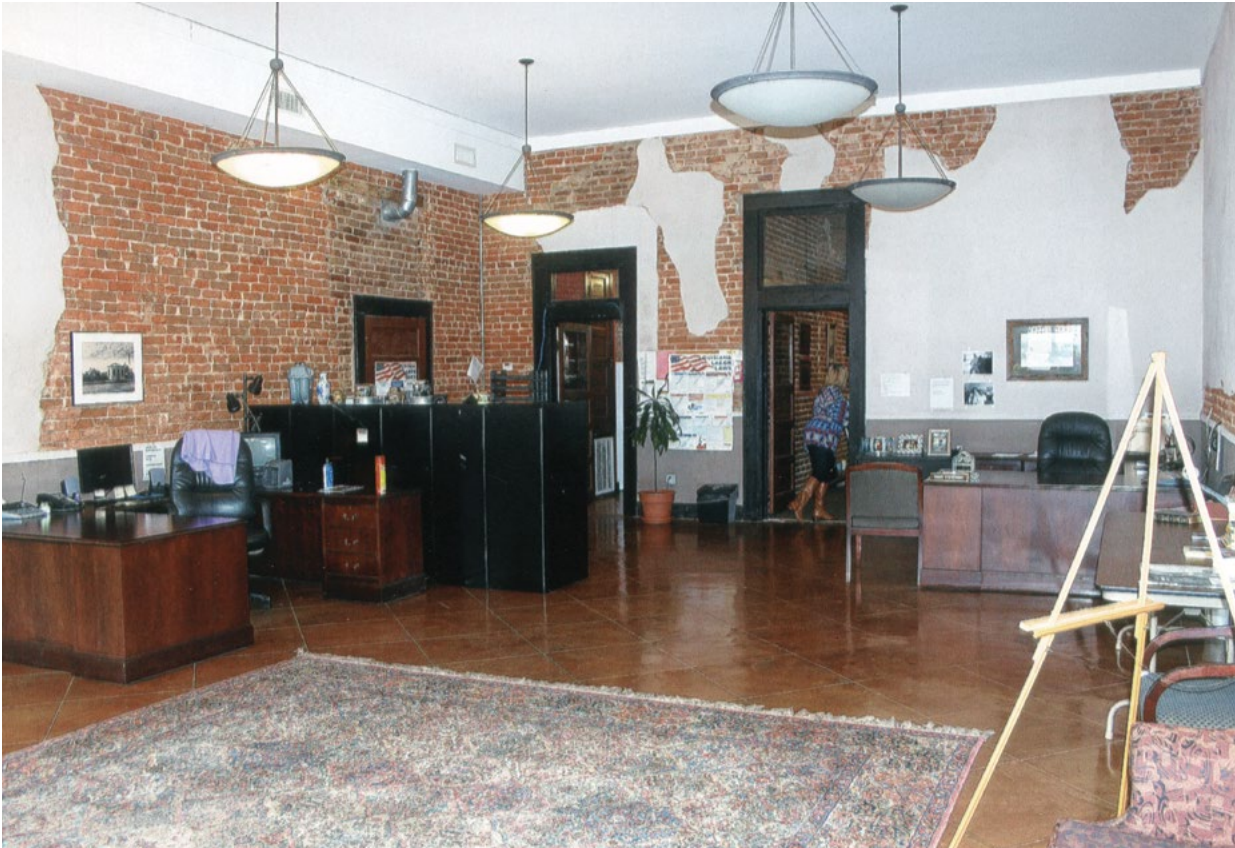
**[41] Not Recommended:** Leaving fragments of deteriorated or “sculpted” plaster is not a compatible treatment for either finished or unfinished interior spaces.

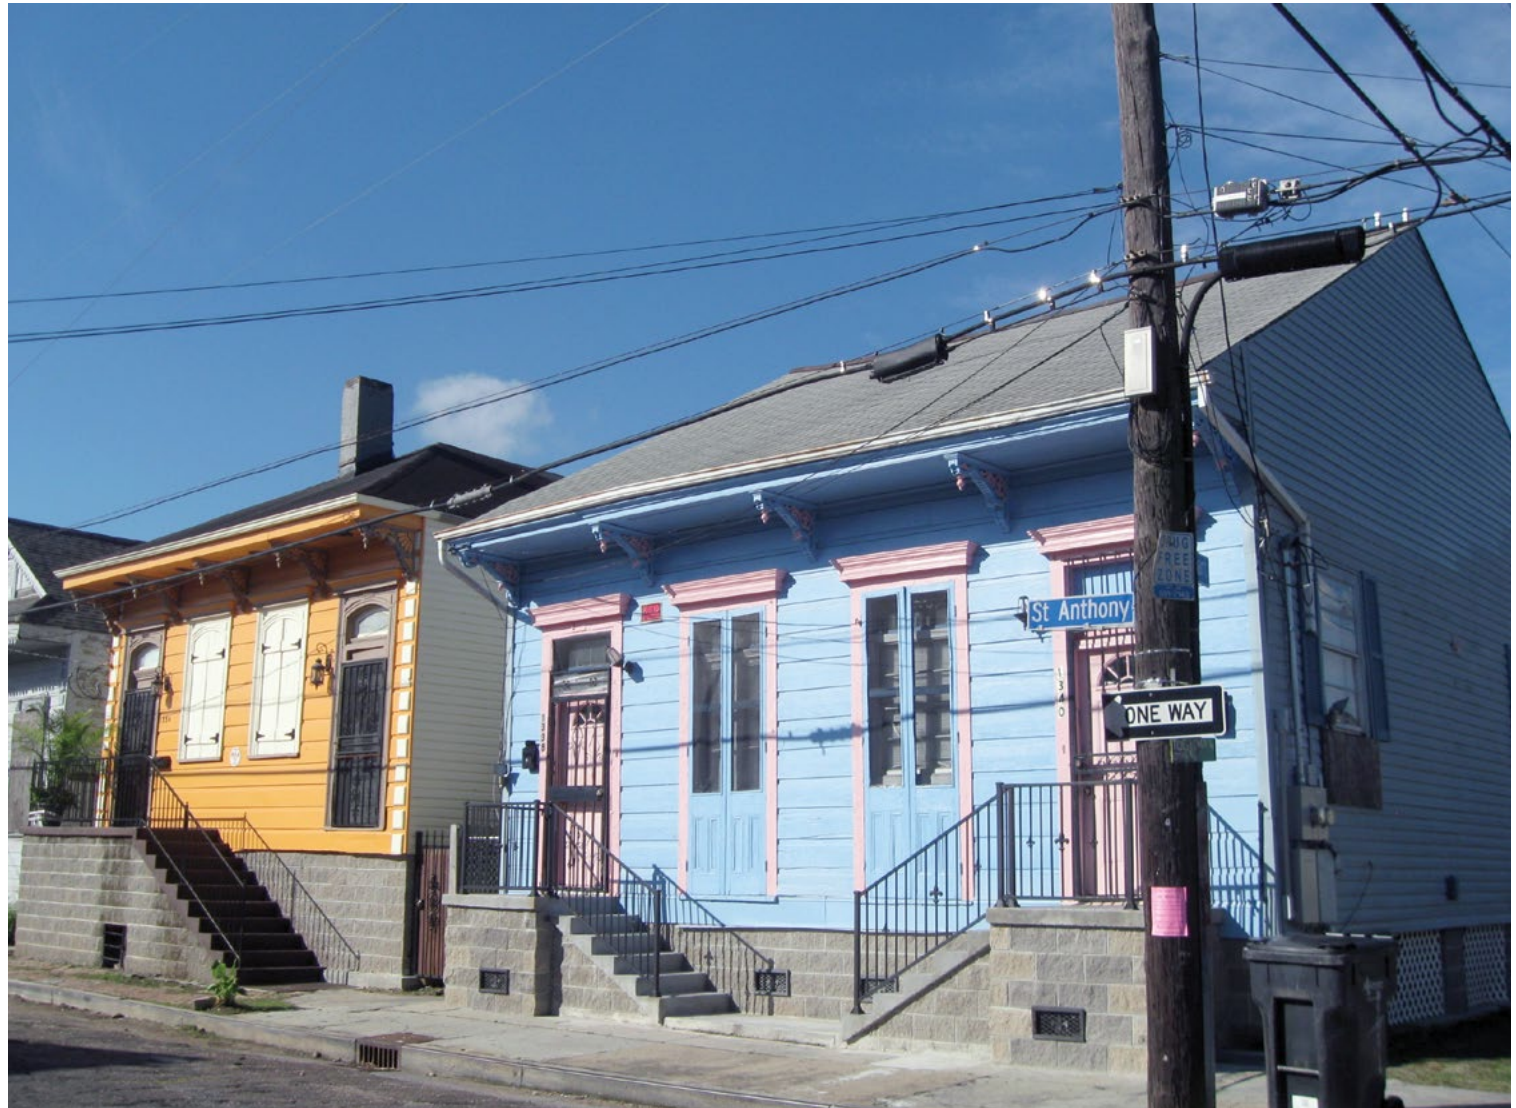
[60] In some instances, it may be necessary to elevate a historic building located in a floodplain to protect it. But this treatment is appropriate only if elevating the building will retain its historic character, including its relationship to the site, and its new height will be compatible with surrounding buildings if in a historic district. The house on the right, which has been raised only slightly, has retained its historic character. The house on the left has been raised several feet higher, resulting in a greater impact on the historic character of the house and the district.

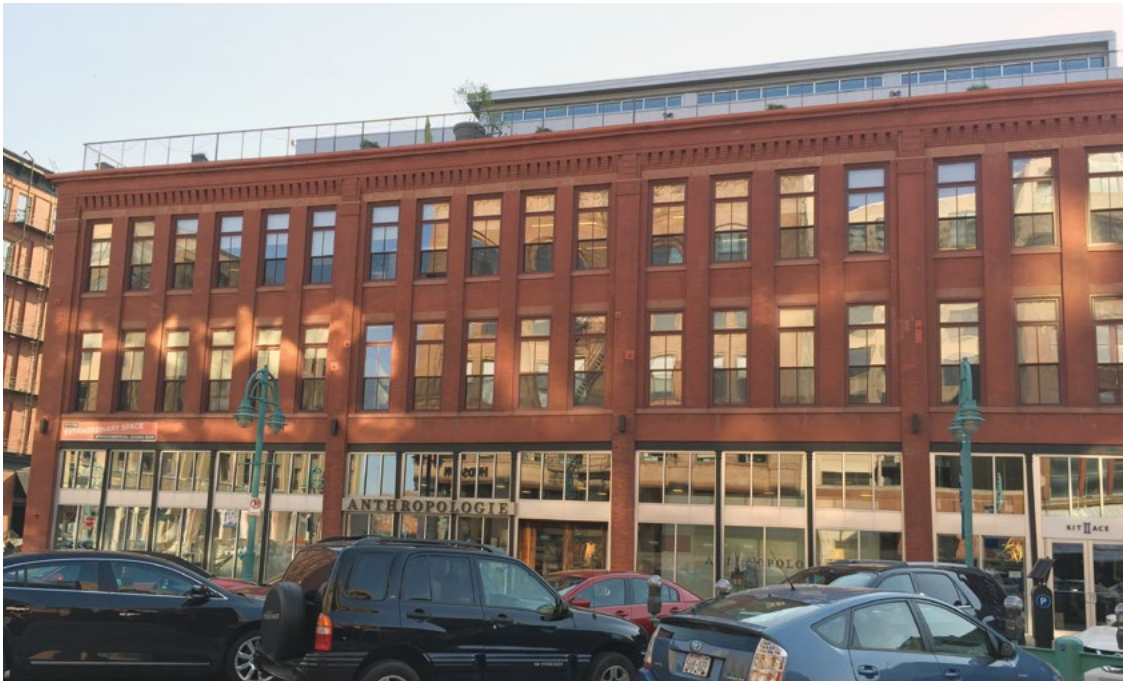
**[64] Not Recommended:**  
It is generally not appropriate to construct a rooftop addition on a low-rise, two- to three-story building such as this, because it negatively affects its historic character.

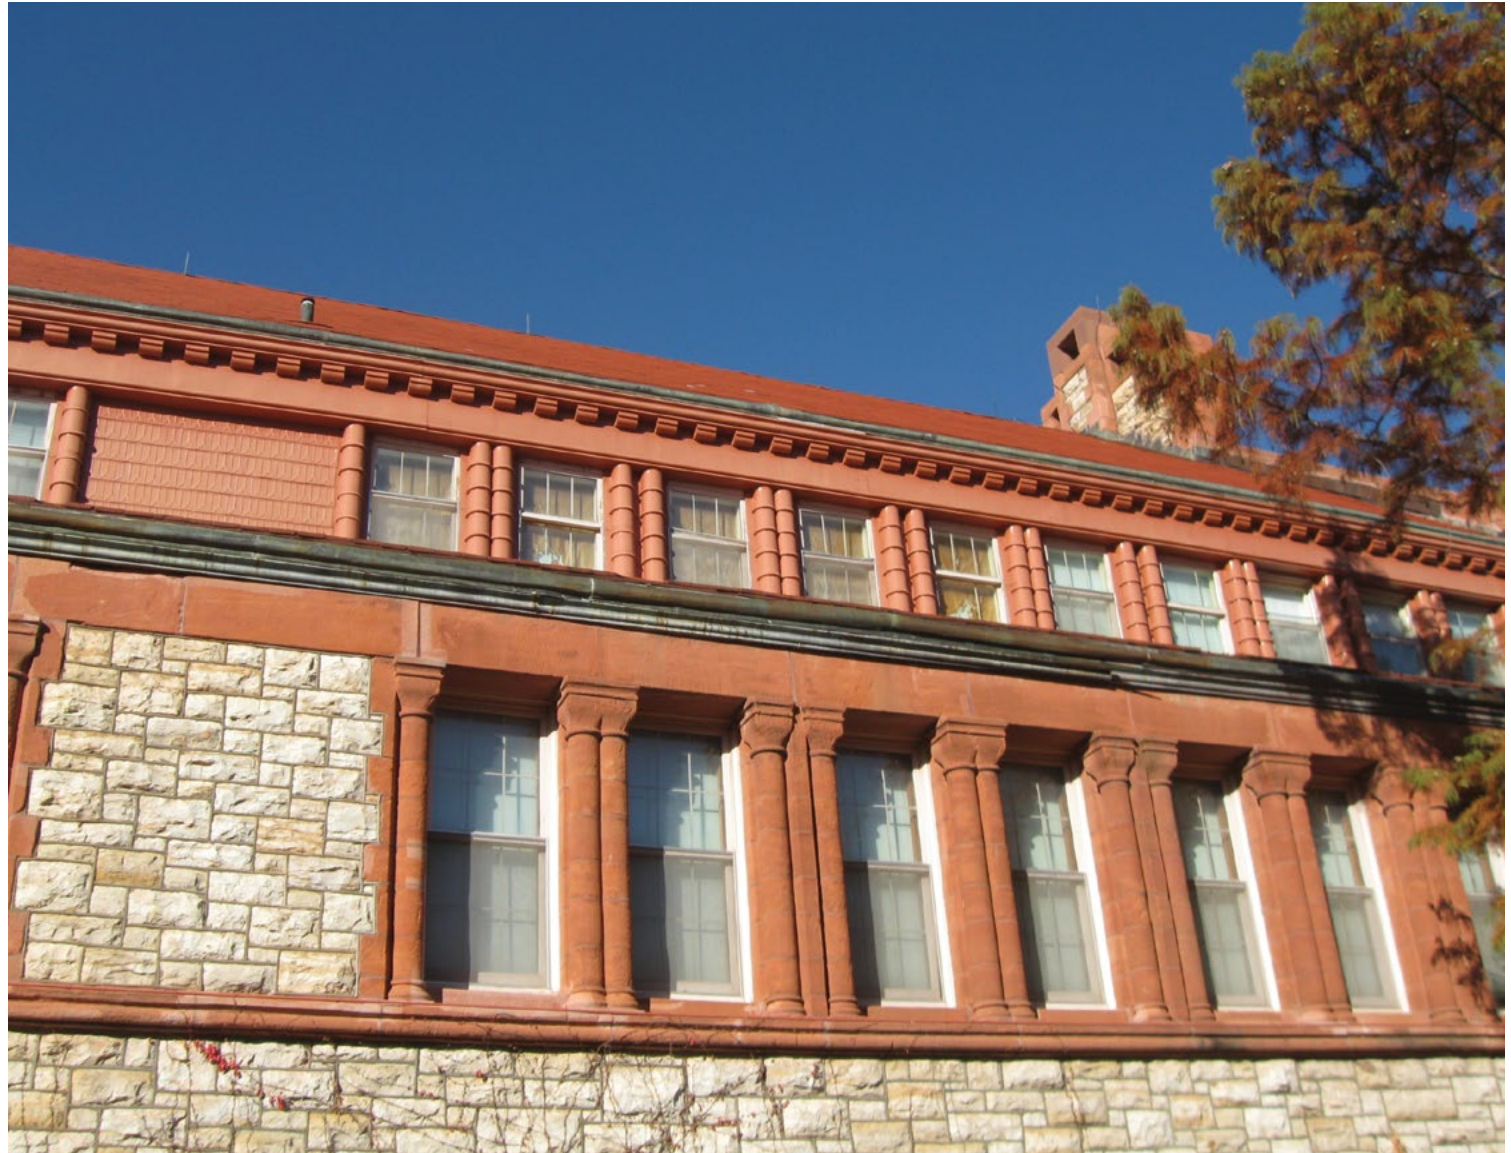
[6] Preliminary work before starting restoration revealed that the columns and the decorative shingles ornamenting the top floor of this historic building were fabricated of metal to imitate the red sandstone used elsewhere on the building.
