The Getty Conservation Institute

After the Quake: Historic Preservation in Los Angeles

Preserving Safety and History: The Getty Seismic Adobe Project at Work

By William S. Ginell and E. Leroy Tolles

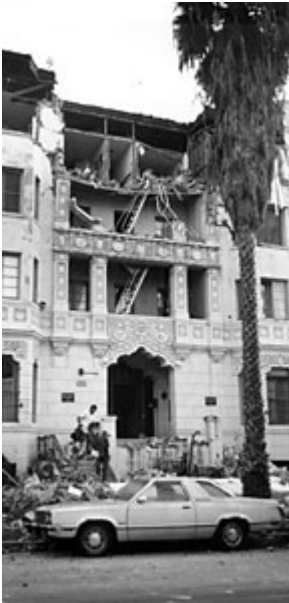
The El Cortez apartment house in Santa Monica just hours after the January 17 earthquake struck. The building, constructed in 1928, was awarded a technical assistance grant and is being repaired. Photo: Nancy Kaye 1994.

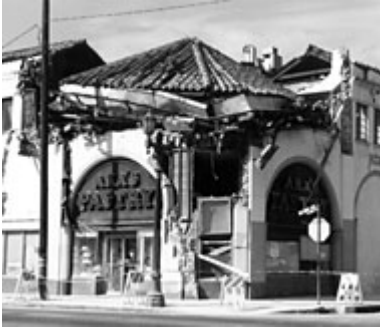
The Ara's Pastry building, located in Hollywood. Built around 1925, the structure has received grants for technical assistance, repair, and restoration, and work is under way. Photo: Lisa Snyder for the Los Angeles Conservancy.

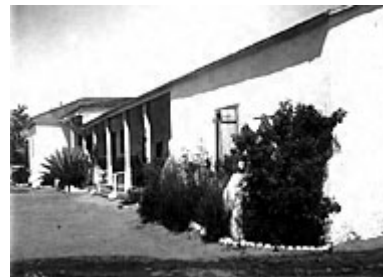
Rancho Camulos, as it appeared in 1895.

The earliest portion of the building, constructed in 1841, consists of three rooms that are one-and-one-half stories in height and a one-story, one-room extension. Over the years, the building evolved into a u-shaped complex with a central courtyard. The single-story room, known as Ramona's room, is situated at the southeast corner. During the earthquake, two walls of Ramona's room collapsed. The gable-end wall at the southeast corner was severely damaged but did not collapse; the stone walls at the north end of the west wing suffered severe cracks at the corners.

Crack damage occurred throughout the building, especially at corners and, because of pounding, at wall intersections. Spalling of interior and exterior plaster was extensive, as was the collapse of adobe in areas that had been weakened by previous repeated exposure to water. In many locations, the walls had pulled away from the ceiling joists, and damage to the walls further reduced their ability to support the joists. The severe damage to the building probably resulted from a combination of factors: the lack of structural elements either tying the walls together or tying the roof-ceiling system to the walls, the presence of pre-existing earthquake-related cracks, and water damage that weakened the lower sections of the adobe walls and foundation.

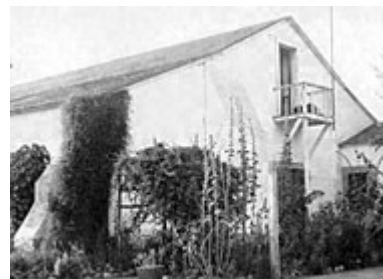
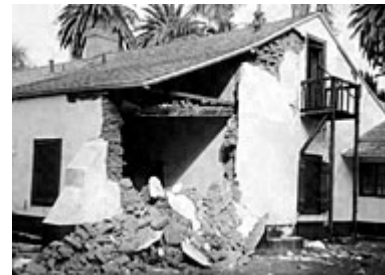
Two views of a section of Rancho Camulos, before and after the 1994 Northridge earthquake. Photos: Courtesy Shirley Lorentz.

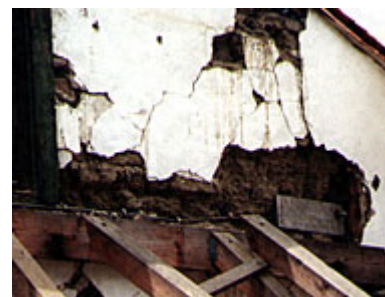
A detail of the east gable during

repair and seismic retrofitting. Visible is a horizontal steel cable with cable ties, and a stress distributing end plate. Photo: William S. Ginell.

These measures included horizontal cables around perimeter walls which, in some areas, were anchored to ceiling joists; vertical cables or straps on both sides of adobe walls that were either too thin or particularly vulnerable due to damage from past earthquakes; vertical center-core rods that were placed in newly constructed walls; and anchorage at the floor levels. To our knowledge, this was the first time that pretensioned, vertical stainless steel cables recessed into walls had been used on an adobe structure (they had been previously used to reinforce stone walls for which the height-to-thickness ratio was greater than eight).

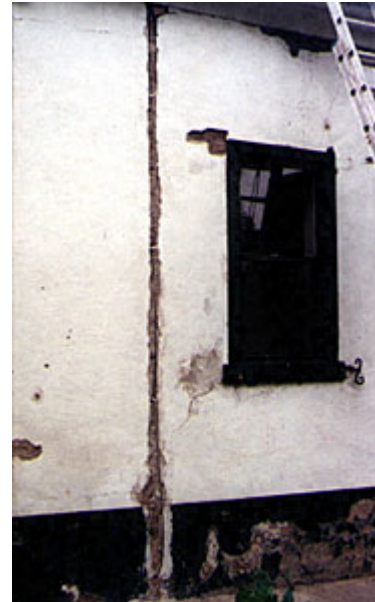
A vertical steel cable recessed into an exterior wall. The cable will be prestressed, then covered with adobe mortar.

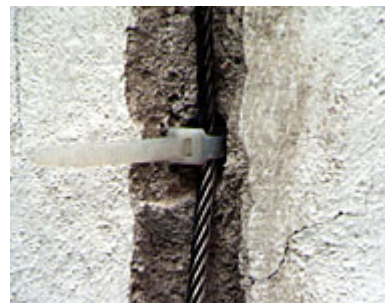
A detail of a steel cable and nylon tie.
