WHO DESIGNED THE ILL-FATED ST. FRANCIS DAM?

J. David Rogers, Ph.D., P.E., P.G., F.ASCE
Professor & Karl F. Hasselmann Chair in Geological Engineering
Missouri University of Science & Technology

May 23, 2017

**WORLD ENVIRONMENTAL & WATER RESOURCES
CONGRESS**

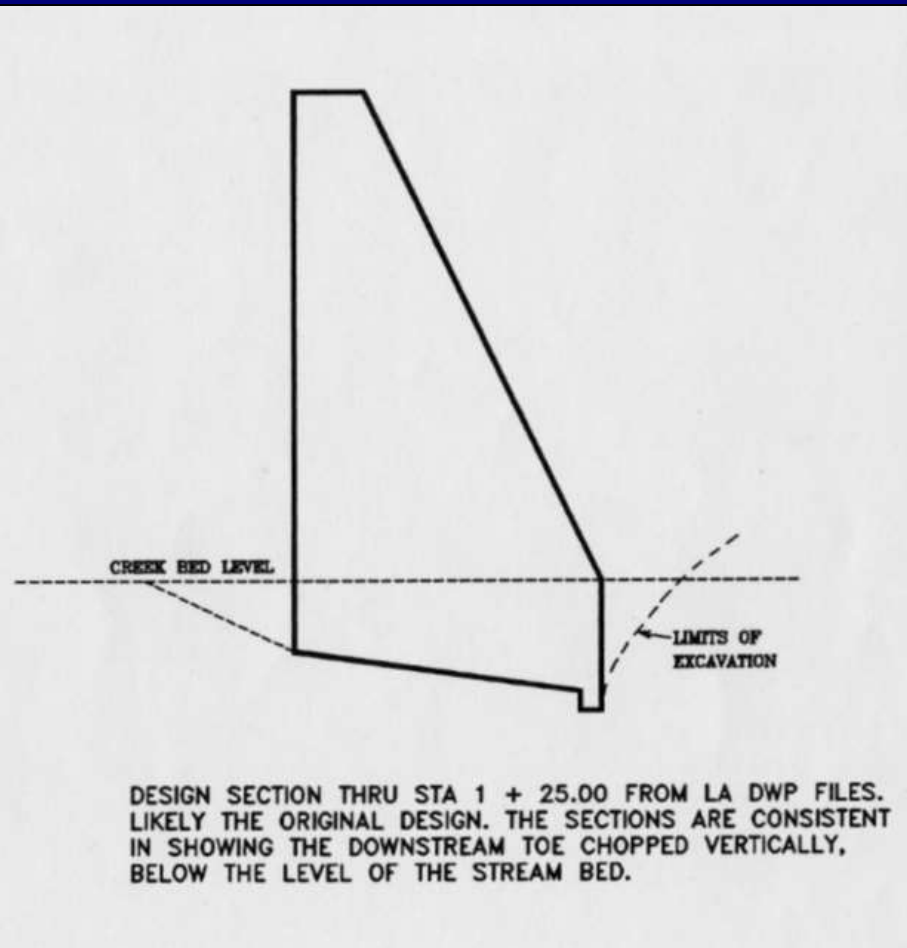
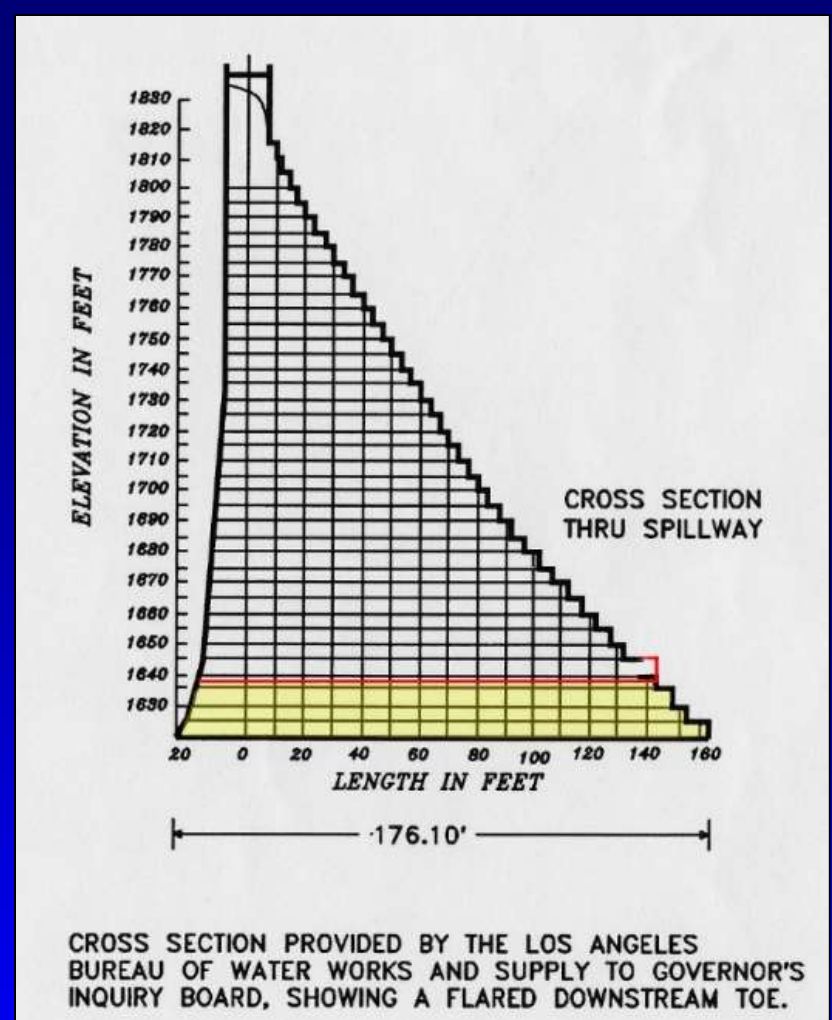
- Original (1923) design concept for the St. Francis Dam from the LA BWWS files, shown at left
- The cross section given to the Governor's Commission by BWWS is shown at right. It extends down to Elevation 1620. The red line approximates the actual limits of the dam.

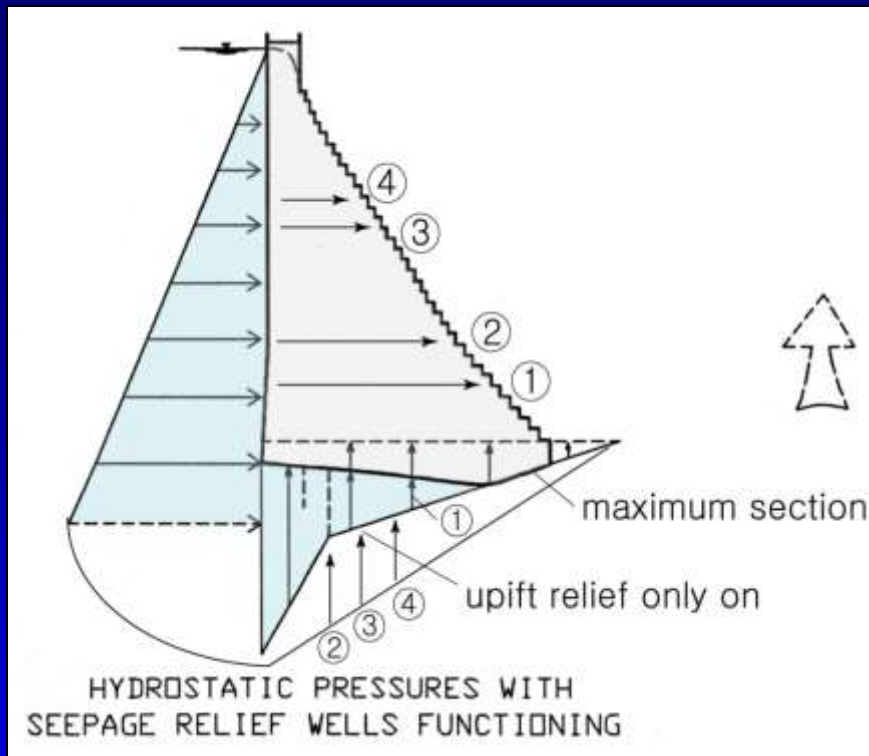
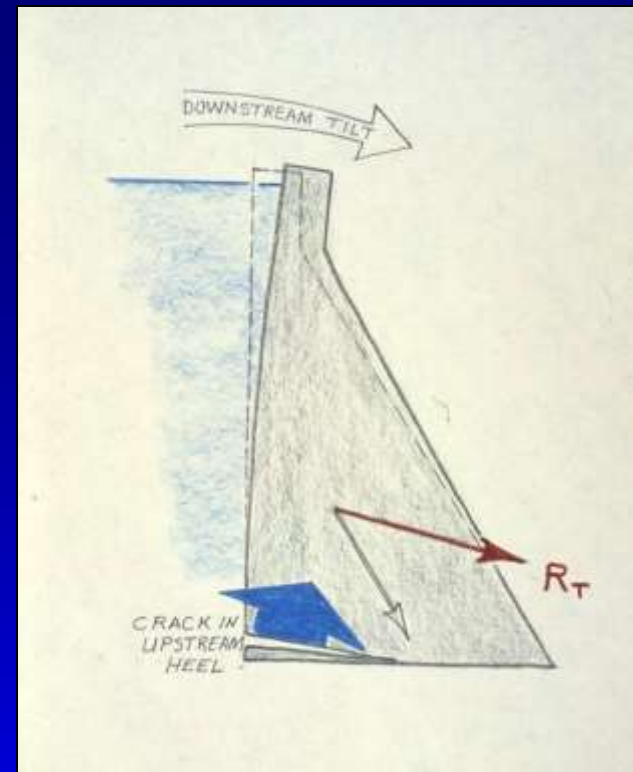
- **Hydrostatic, or uplift forces, act equally in all directions and serve to reduce the effective weight of the dam, and may cause it to become unstable.**
- **If the dam tilted forward $\frac{1}{2}$ degree, this would explain the 3.67 inch drop of the reservoir, recorded 40 minutes before the failure.**
- **When the dam separated at its upstream toe, the resultant thrust would have been shifted 240 feet downstream, indicative of overturning instability.**

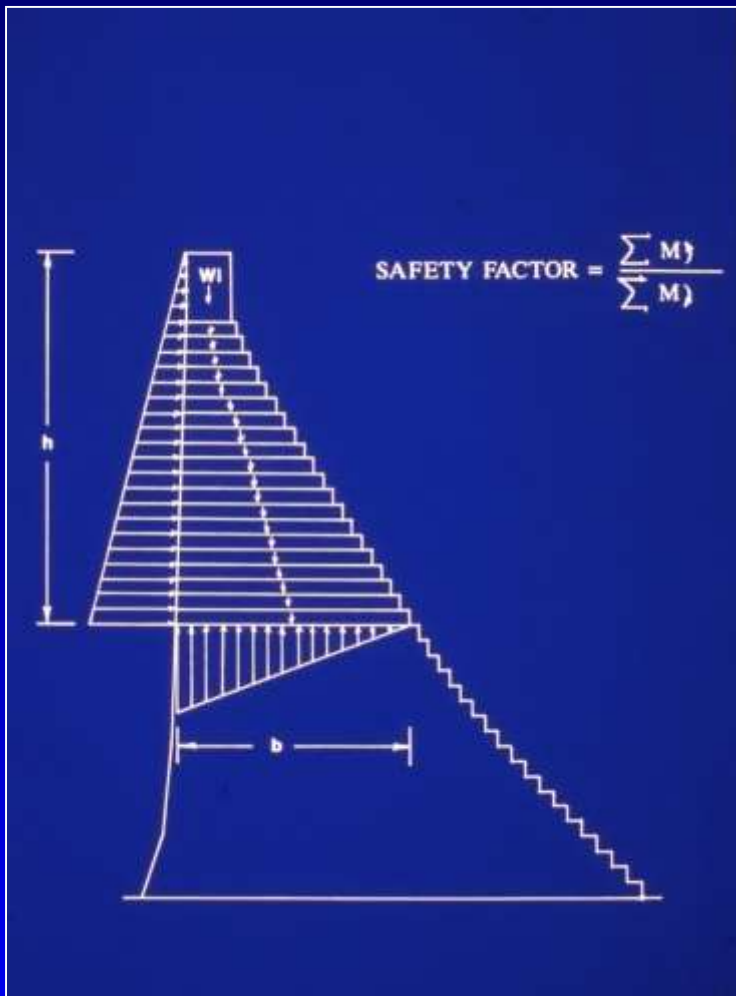
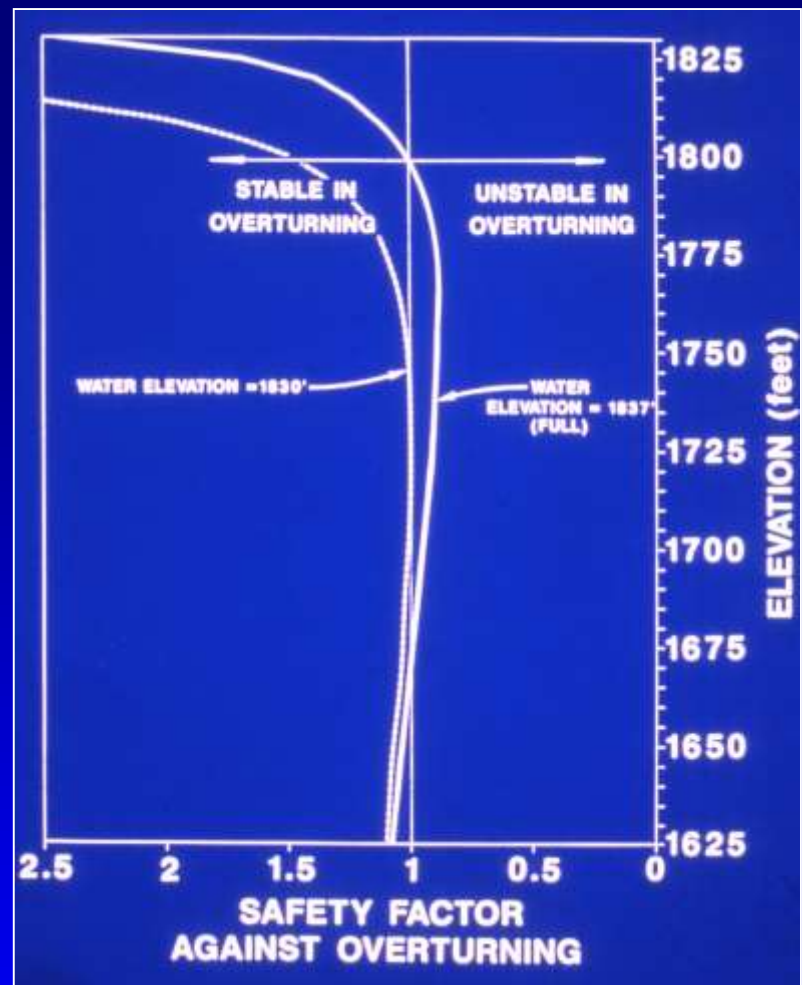
- In 1945 Karl Terzaghi published an article which demonstrated that water pressure could infiltrate mass concrete, saturating it.
- A conventional analysis of cantilever stresses in St. Francis Dam assuming full uplift reveals that the dam becomes unstable in overturning when the reservoir rose to within 7 feet of its crest! Full uplift may have developed beneath the sloping abutments, which were not afforded uplift relief wells.

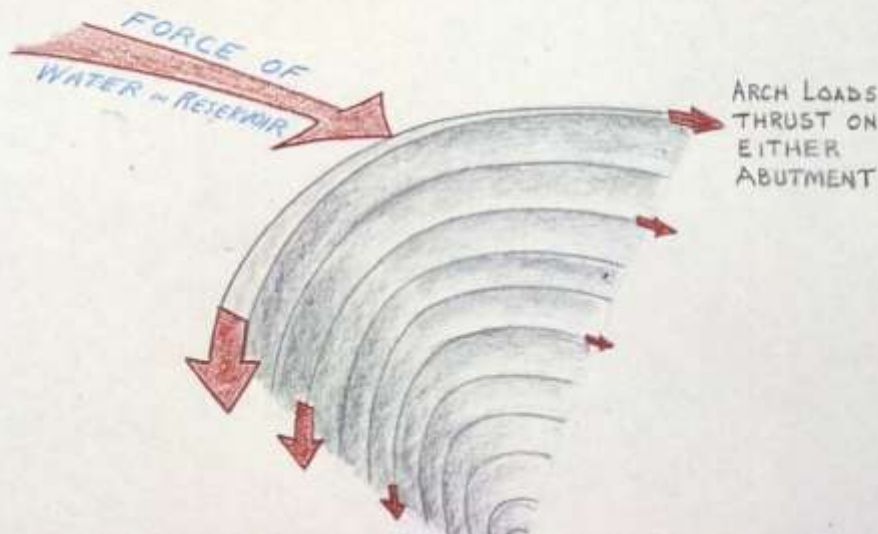
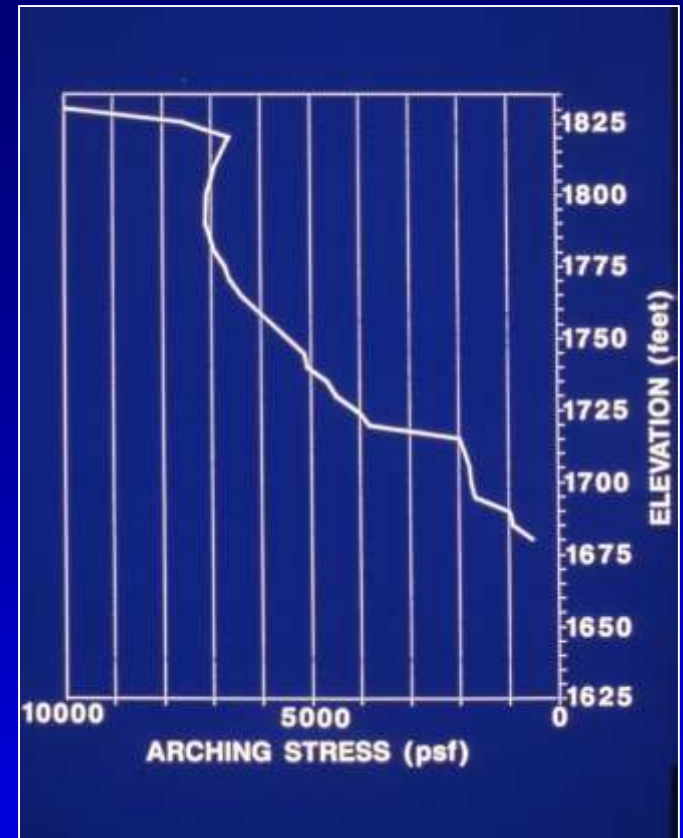
THE ACTION OF ARCHING
SPLITS LOADS TO BOTH SIDES.

- The arch stresses on the St. Francis Dam increase markedly when the reservoir rose to within 11 feet of the spillway crest.
- The dam was designed before the Trial Load Theory of Arch Stress Distribution was developed, so the contribution of arching to its stability was only assumed.

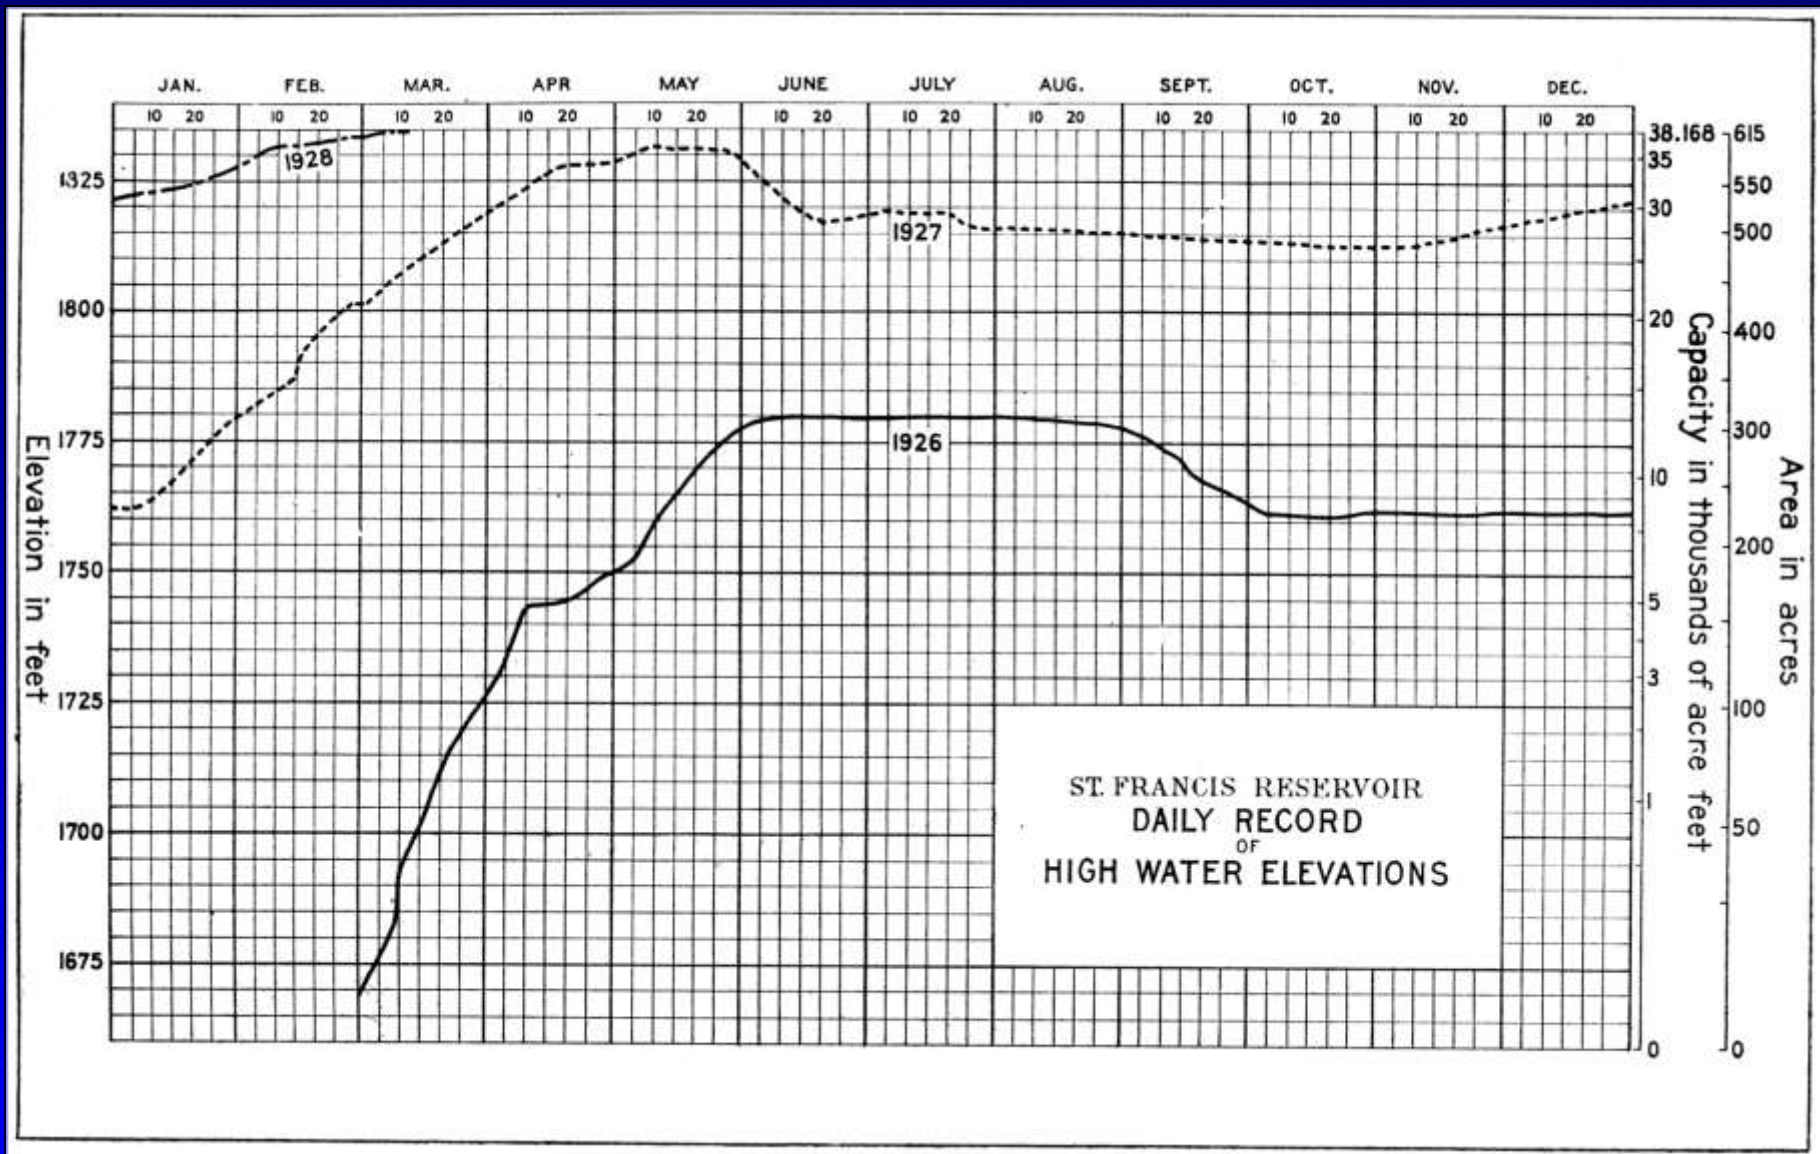
- Reservoir Stage Curves for St. Francis Reservoir between March 1, 1926 and March 13, 1928

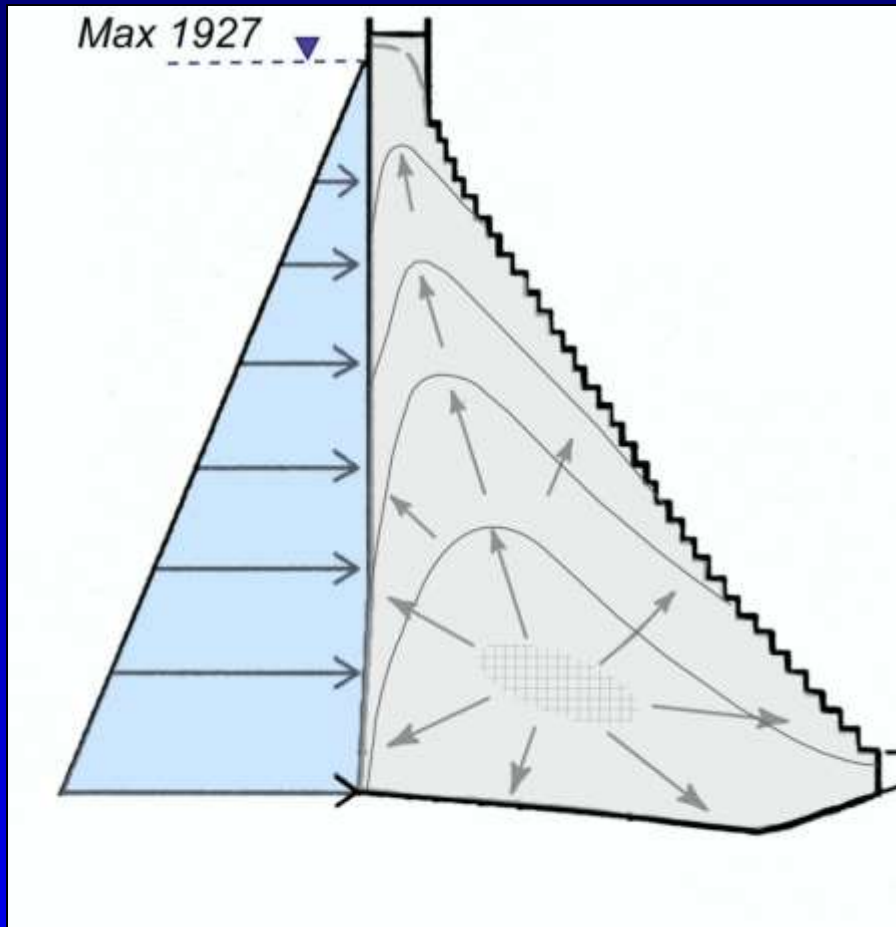
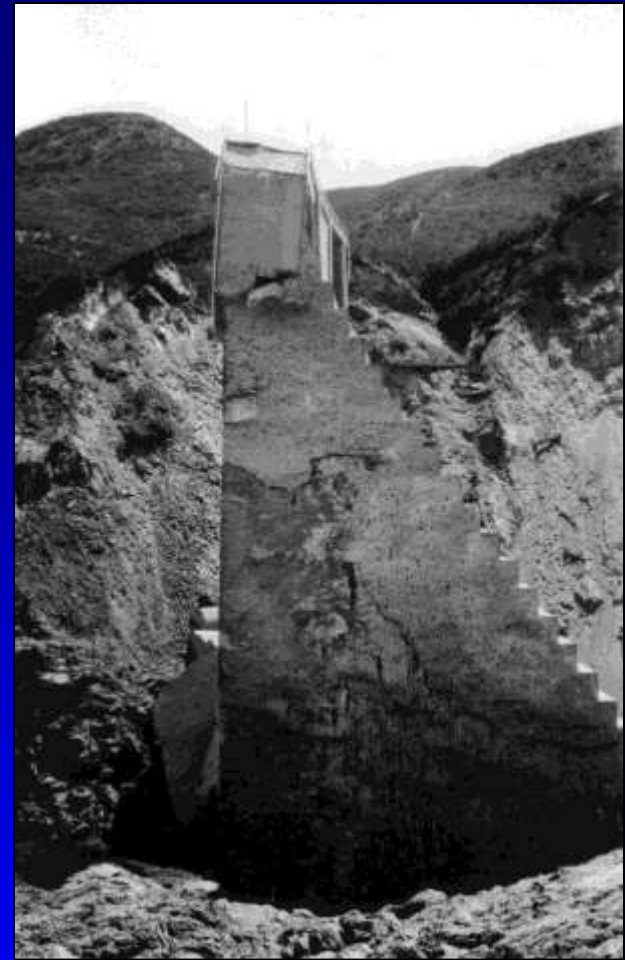
During the first year of operation several large tension cracks formed transverse to the dam's axis. These were likely in response to the cement heat of hydration, which would have been considerable for 130,000 yds³ of mass concrete.

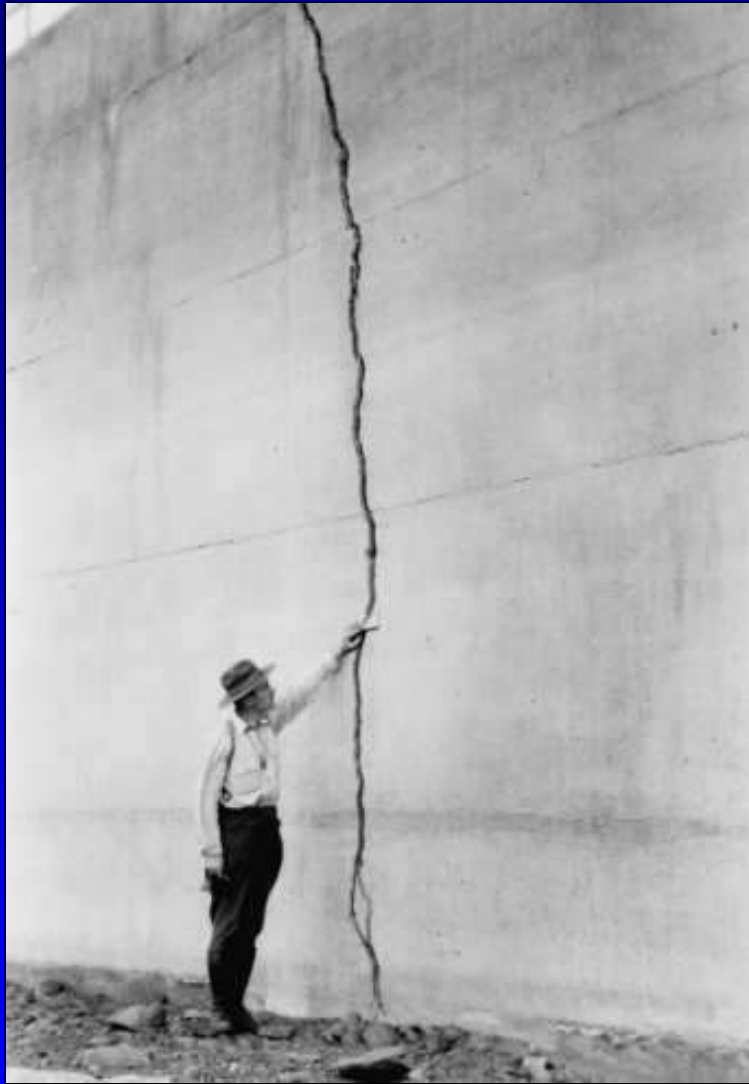
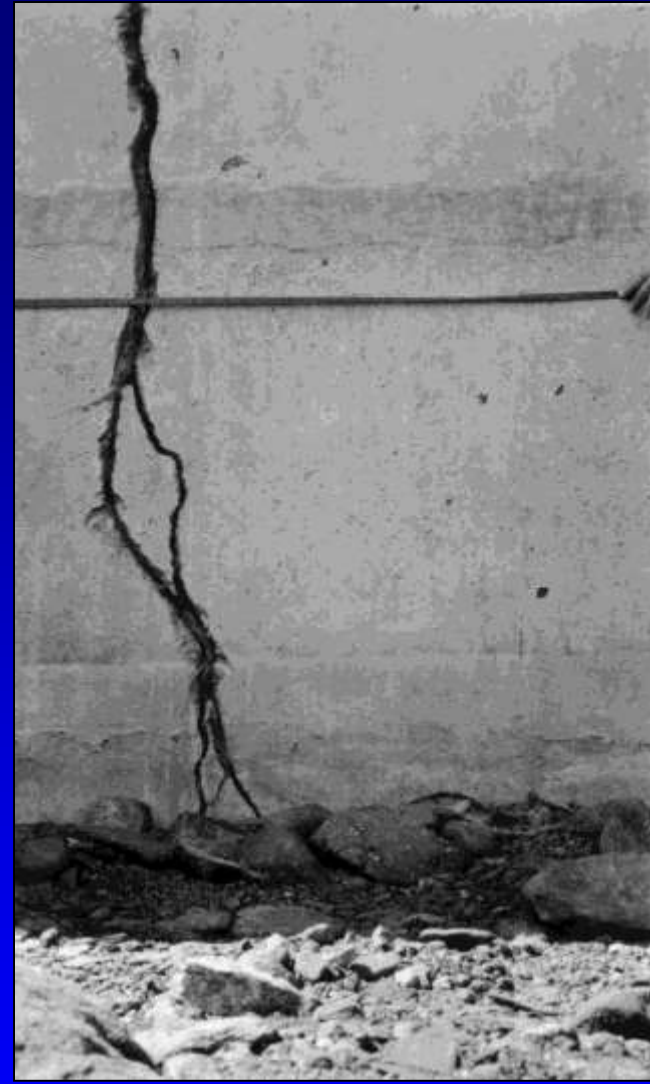
Several tension cracks also formed in the concrete dike section during the second year of operation, in 1927-28. These began leaking noticeably in early March 1928.

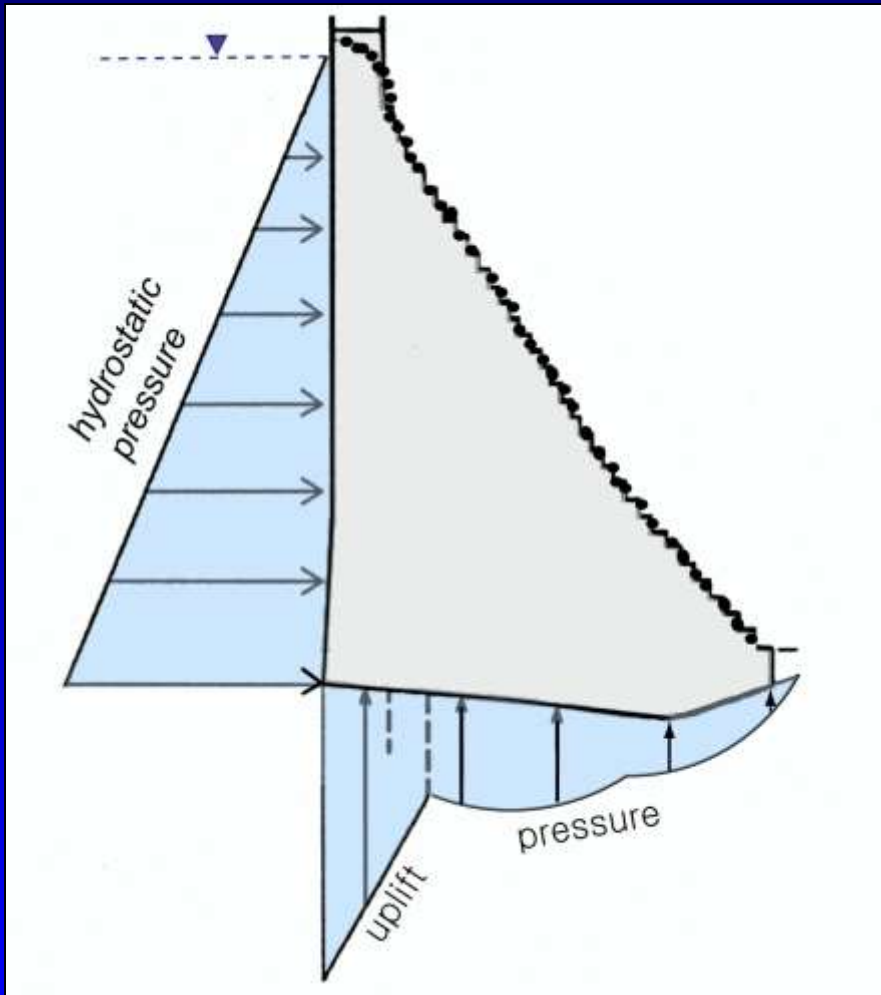
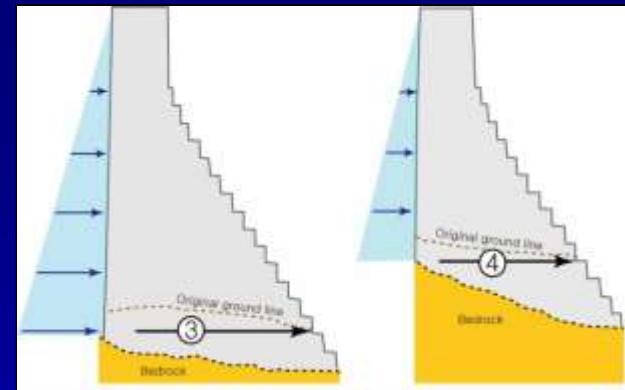
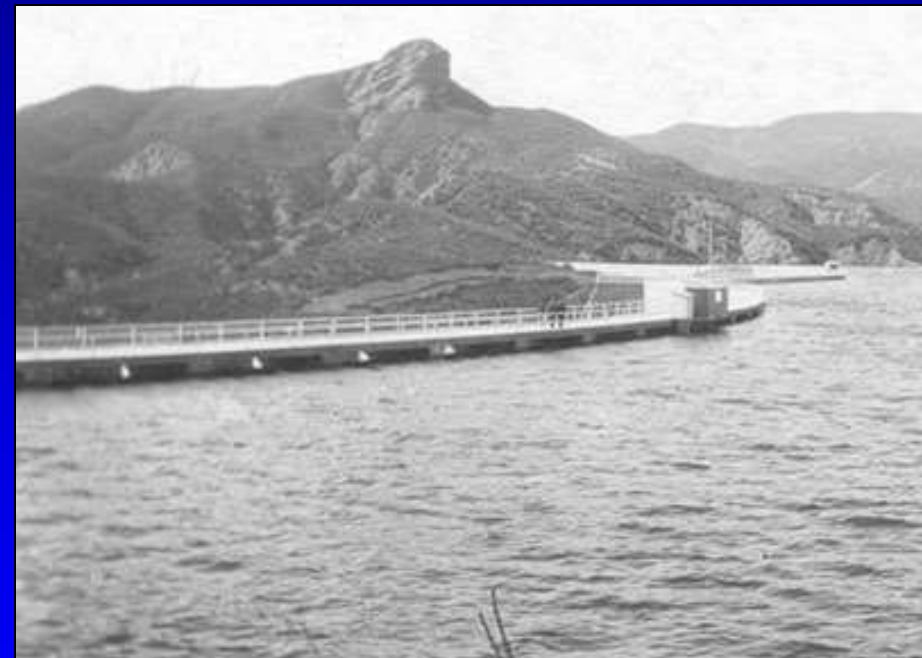
On March 2, 1928 the reservoir was raised to within three inches of the spillway sill elevation of 1835 feet, exerting the greatest hydrostatic forces on the dam

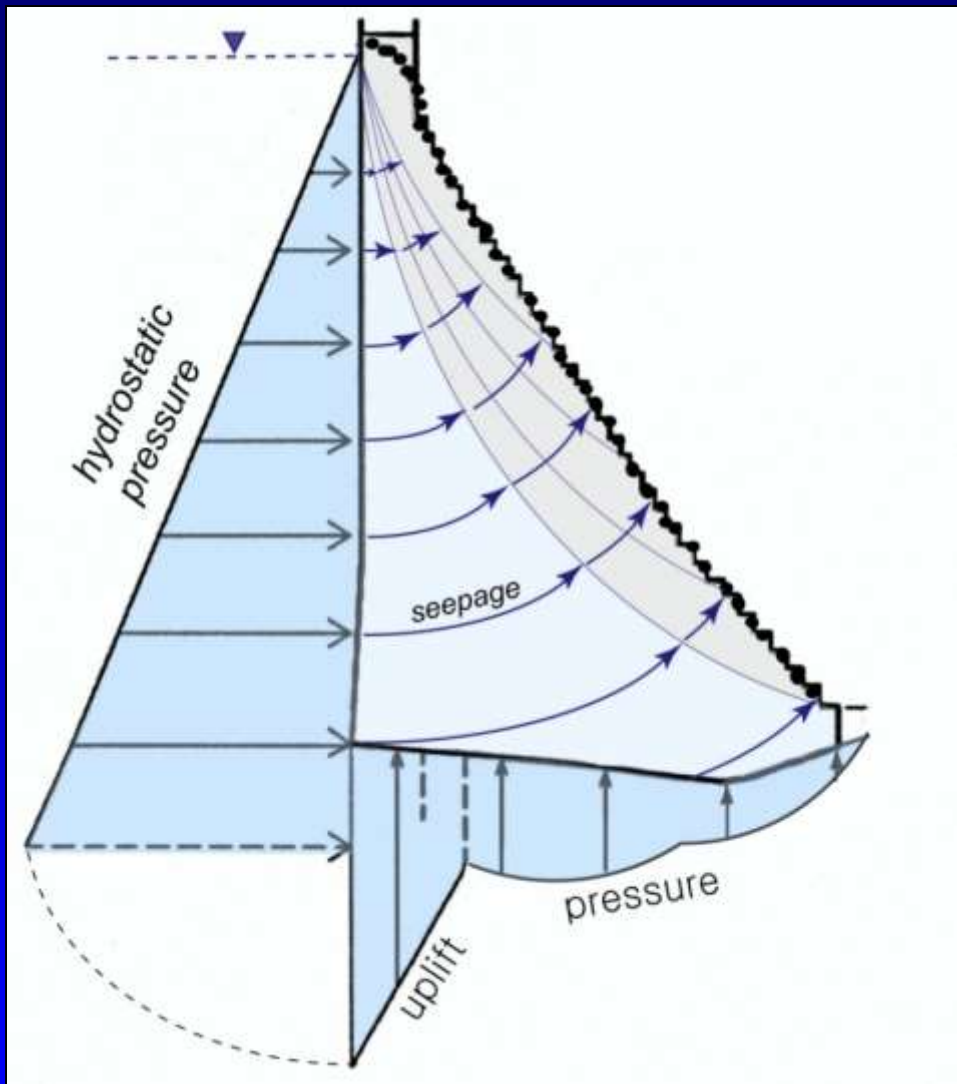
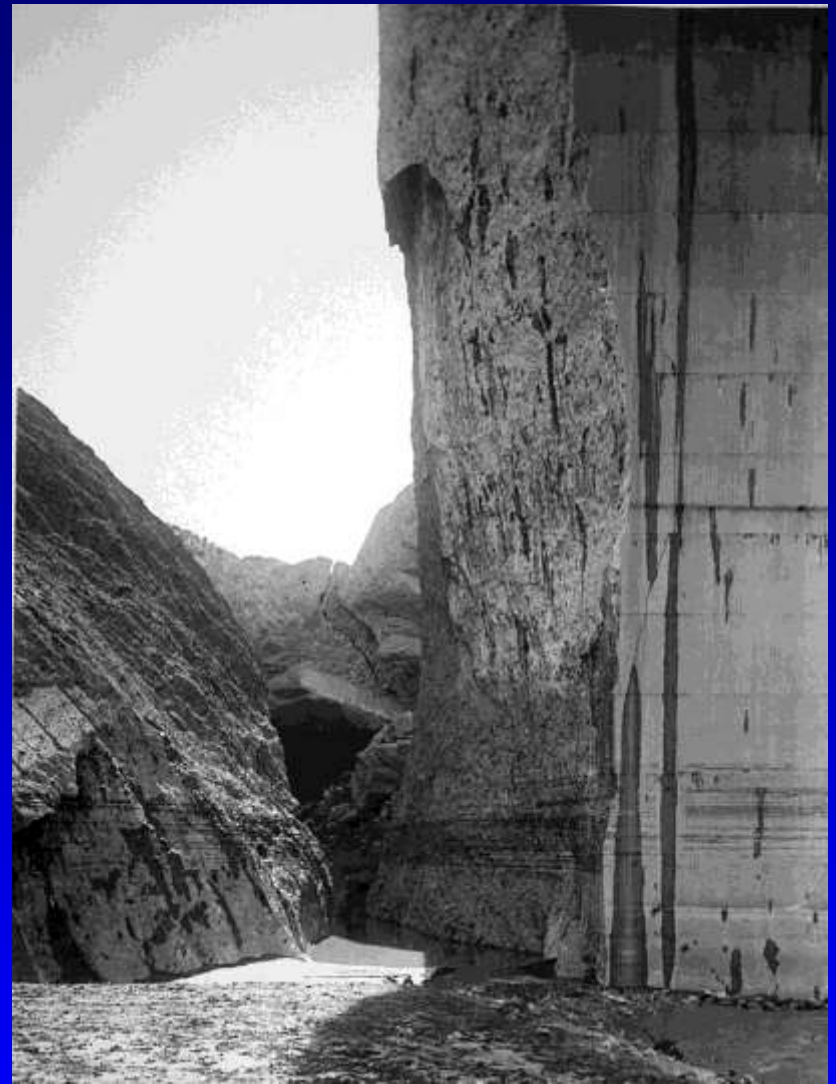
If the transverse shrinkage cracks were sealed at the dam's downstream face, full hydrostatic pressure would be expected to develop BETWEEN adjacent blocks of the dam.

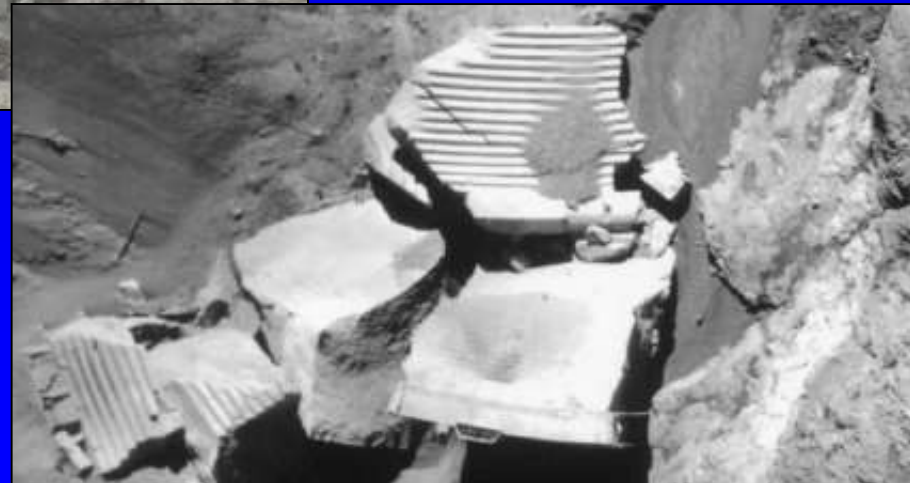
**Prominent
shrinkage
crack
observed
cutting
through Block
5, observed
after the
failure**

**The oakum caulking can be
discerned on the post-failure
images as dark lines across
the dam's downstream face**
