San Francisquito Canyon Dam Disaster

(California)

Report to His Excellency
Gov. George W. P. Hunt

BY
GUY L. JONES
MEMBER OF ARIZONA LEGISLATURE

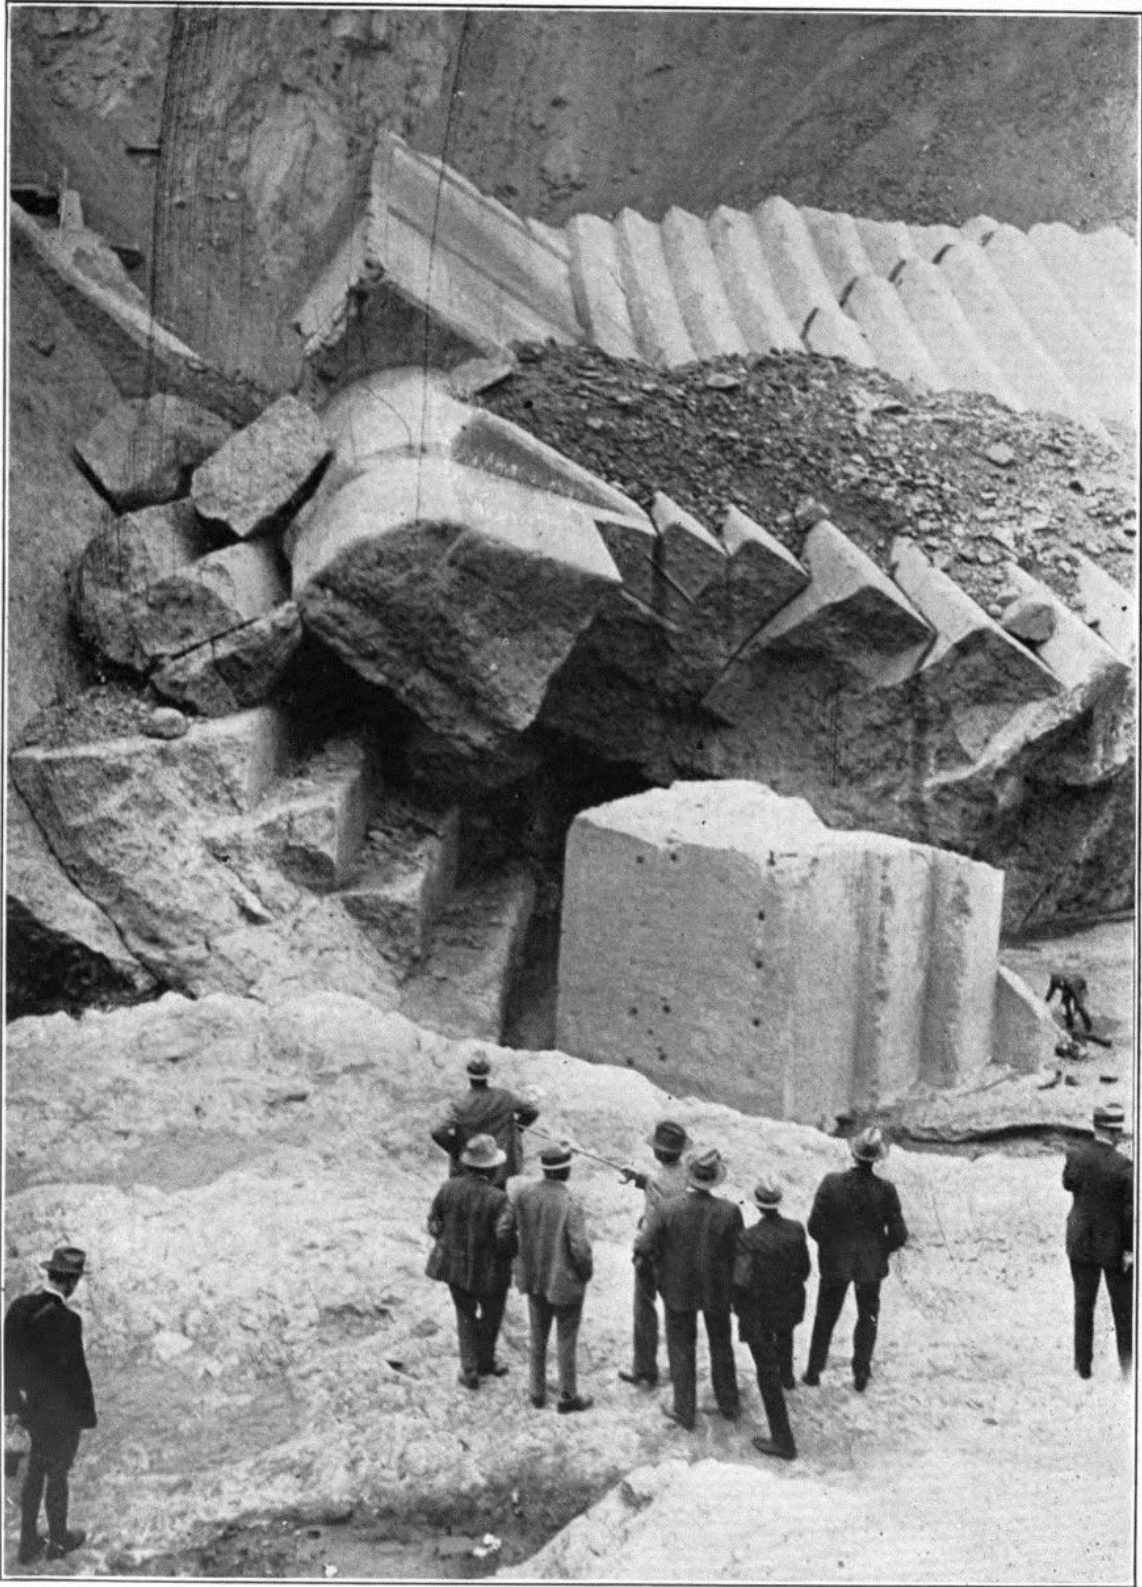
Their minds still fresh with the tales of flood disaster from the lips of survivors, the members of Coroner Frank Nance's inquest jury were taken to the scene of the wrecked dam.
