48 PRESERVATION BRIEFS

Preserving Grave Markers in Historic Cemeteries

National Park Service
U.S. Department of the Interior

Technical Preservation Services

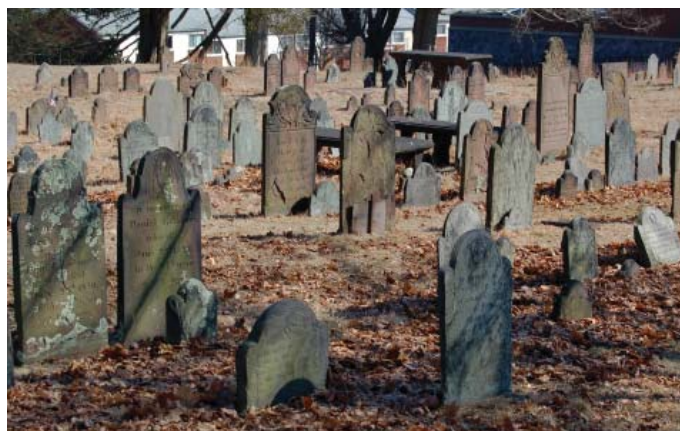
Figure 1. Sandstone and slate grave markers in the Ancient Burying Ground in New London, CT, display a variety of weathering conditions. Markers in the cemetery date from the mid-17th to the early 19th centuries. Photo: Jason Church.

While cemeteries are often considered to be perpetual, their most prominent feature—the grave markers—are not. They weather, naturally decay, often are poorly maintained and repaired and, on occasion, are vandalized (Fig. 1). Grave markers are usually noteworthy not only for their inscriptions but also for their craftsmanship. Exceptional markers are considered works of art.

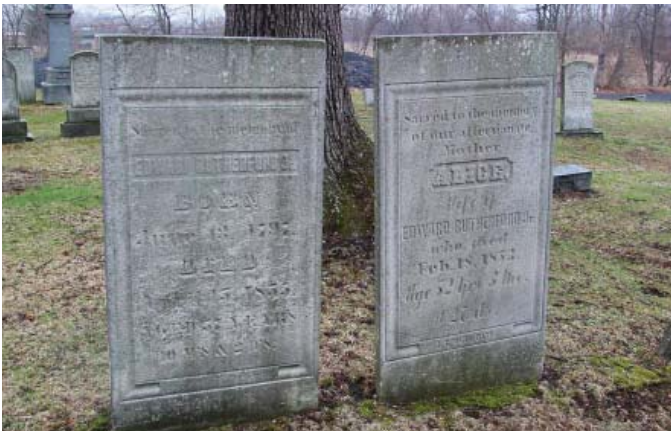
Figure 2. These mid-19th century, single-element stone grave markers in the Grove Cemetery in Bath, NY, are set in a vertical position. Photo: Jason Church.

The great variety in the types of grave markers is a fascinating aspect of the study and appreciation of historic cemeteries. Three broad categories can be used to describe grave markers—(1) single-element, (2) multiple-element, and (3) structures. Single-element grave markers are stone, cast iron, or wood elements that are set in a vertical position or placed as a horizontal slab on the ground (Fig. 2). Early examples of this simplest type of grave markers are field stone and basic wooden or wrought iron crosses, with the name of the deceased person scratched into or engraved on the marker. Often, these rudimentary grave markers are overlooked, significantly deteriorated, or lost. Vertical stone slabs and large stone ledgers laid horizontally over the gravesite are more sophisticated examples of this type.

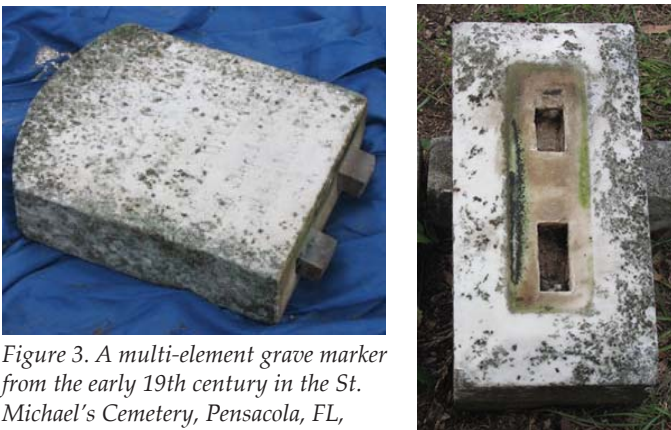
Figure 3. A multi-element grave marker from the early 19th century in the St. Michael's Cemetery, Pensacola, FL, consists of a vertical element with tabs (left image) into a slotted base (right image). Photo: Fran Gale.

Multiple-element grave markers are found in a number of different forms (Fig. 3). In the most typical form, a grave marker would consist of two stones—an upper headstone placed on top of a base stone. The upper headstone may be secured in a number of different ways to the base. In the simplest of forms, the upper stone was placed on the base, set in a bed of mortar on top of the base, or joined with pins and mortar. With a “tab-and-

slot" grave marker, the tabbed upper stone was set in a slotted base. More common today, the upper headstone is secured with a technique that uses small spacers set on the base and a setting compound. This technique or one that uses an epoxy adhesive may be found on older markers where the stones have been reset.

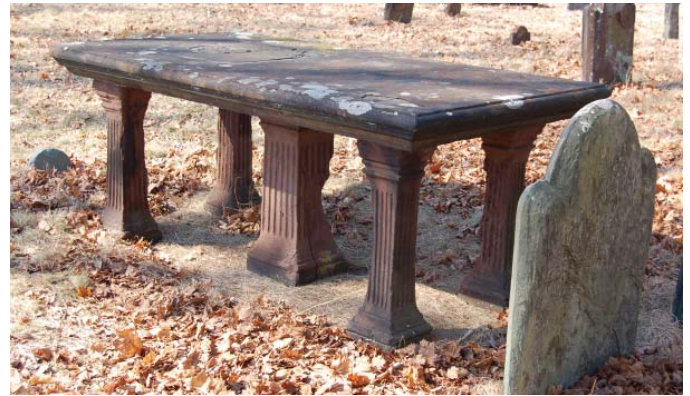
Figure 4. This sandstone table tomb, located in Cedar Grove Cemetery, New London, CT, is an engineered grave marker structure consisting of a horizontal stone tablet supported by four vertical table "legs" with and a central column,. Photo: Jason Church.

Grave markers can also be engineered structures. Examples of grave marker structures include masonry arches, box tombs, table tombs, grave shelters, and mausoleums (Fig. 4). The box tomb is a rectangular structure built over the gravesite. The human remains are not located in the box itself as some believe, but rather in the ground beneath the box structure. The table tomb is constructed of a horizontal stone tablet

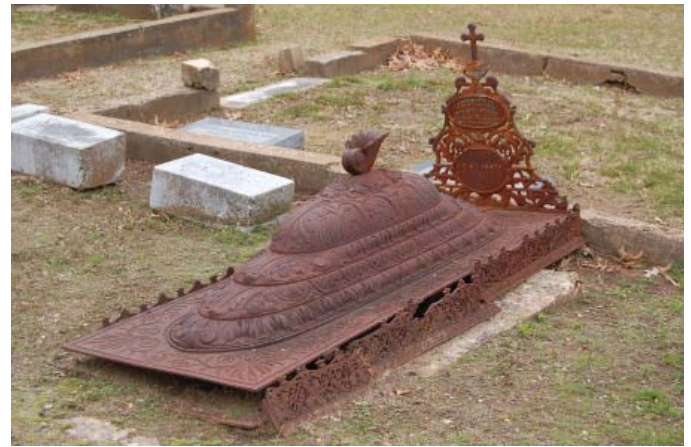
Figure 6. Decorative cast-iron grave markers like this late-19th century one in Oakland Cemetery in Shreveport, LA, are produced by heating the iron alloy and casting the liquid metal into a mold. Photo: Jason Church.

Metals are solid materials that are typically hard, malleable, fusible, ductile, and often shiny when new (Fig. 6). A metal alloy is a mixture or solid solution of two or more metals. Metals are easily worked and can be melted or fused, hammered into thin sheets, or drawn into wires. Different metals have varying physical

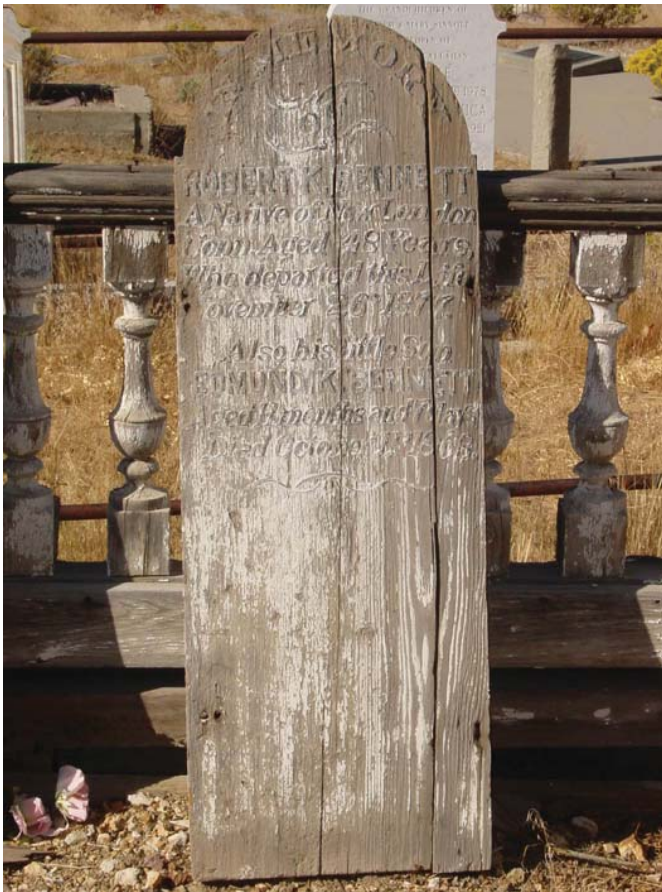
Figure 7. As shown by this 1877 marker in Silver Terrace Cemetery, Virginia City, NV, exposure to sunlight can damage wood grave markers, making the wood more susceptible to water damage and cracking. Photo: Jason Church.

appearance and influence wood properties. Wood-cell walls and cavities contain moisture. Oven drying reduces the moisture content of wood. After the drying process, the wood continues to expand and contract with changes in moisture content. The loss of water from cell walls causes wood to shrink, sometimes distorting its original shape (Fig. 7).

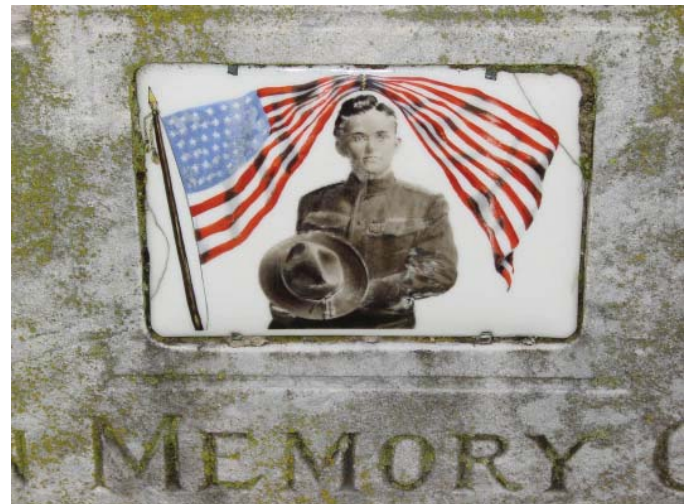
Figure 8. A fired ceramic, this cameo is set in a marble grave marker, located in Elmwood Cemetery, Memphis, TN. Different materials may require different conservation approaches. Photo: Mary Striegel.

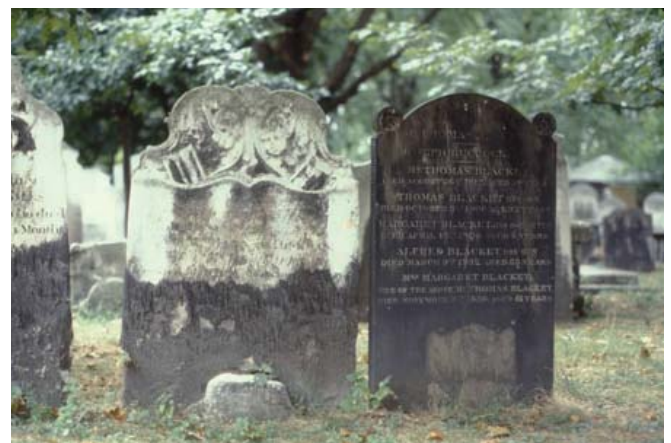
Figure 9. The limestone and sandstone grave markers in this historic cemetery have different weathering processes. On the left, the limestone shows surface loss in areas exposed to rainwater and gypsum crust formation below. The sandstone marker on the right displays uniform soiling, but surface hardening may be occurring. Photo: Fran Gale.

All grave marker materials deteriorate when they are exposed to weathering such as sunlight, wind, rain, high and low temperatures, and atmospheric pollutants (Fig. 9). If a marker is composed of several materials, each may have a different weathering rate. Some weathering processes occur very quickly, and others gradually affect the condition of materials. Weathering results in deterioration in a variety of ways. For example, when exposed to rainwater some stones lose surface material while others form harder outer crusts that may detach from the surface.

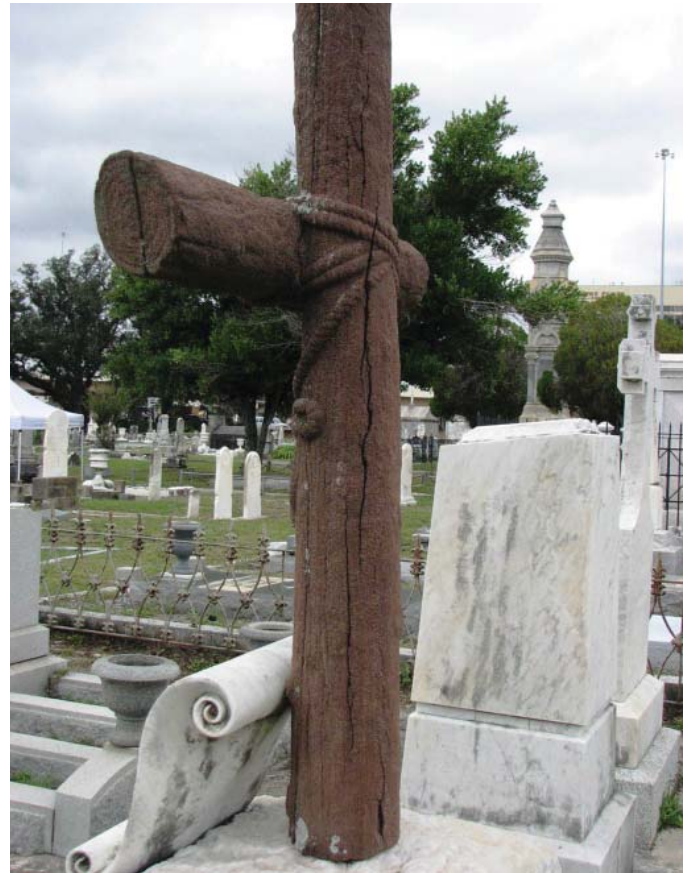
Figure 10. The sandstone cross (carved to look like wood) in this grave marker in St. Michael's Cemetery in Pensacola, FL, provides an example of inherent vice – the severe delamination affecting the sandstone has occurred along its natural bedding planes.

The term "inherent vice" is used to describe a material with a naturally occurring problem that leads to premature deterioration (Fig. 10). An example of this problem is marble that has cracked due to natural locked-in stresses. Inherent vice also describes grave markers that are composed of incompatible materials, where decay is accelerated in one or both materials because of chemical interactions caused by their close proximity. An example is the galvanic corrosion that occurs when dissimilar metals, such as copper and iron, are in contact and exposed to moisture.

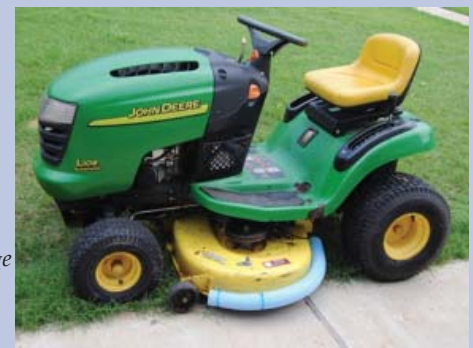
Figure B. A pool ‘noodle’ can be fitted to the deck of a lawnmower to prevent damage to grave markers. Photo: Debbie Dietrich Smith.

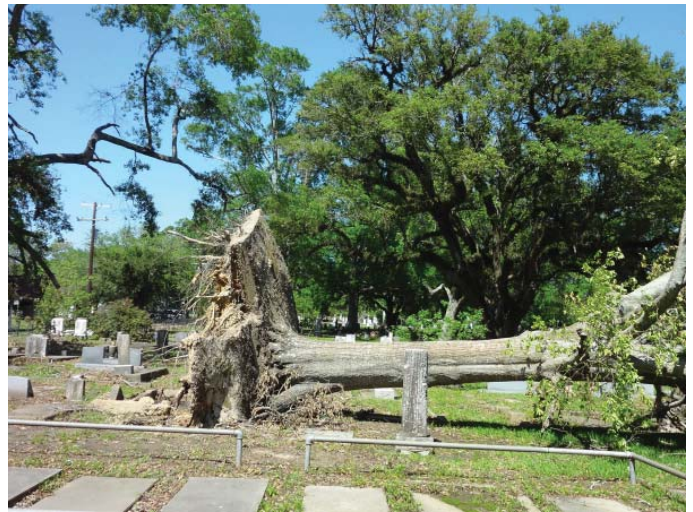
Figure 11. Woody vegetation can damage grave markers and pose a risk to visitors unless well managed and maintained. Photo: Jason Church.

Woody vegetation can damage grave markers in a variety of ways (Fig. 11). Trees, bushes, and vines can shade grave markers, extending the time that the markers are exposed to moisture. Tendrils and roots may burrow into mortar joints and openings, causing mechanical damage and large plants may lift up or shift markers. Even leaves and twigs, when allowed to collect on the ground near grave markers, can affect water drainage and evaporation (Fig. 12).

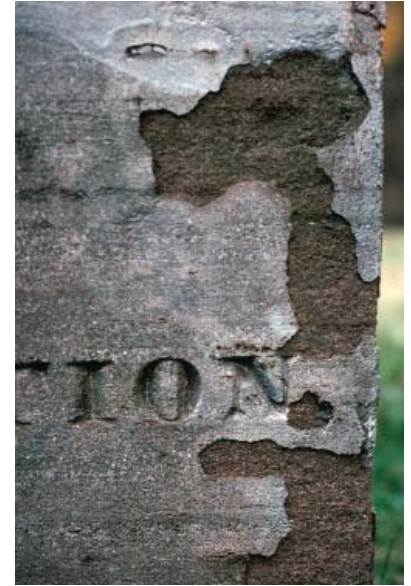
Figure 13. The impervious coating used to "protect" this sandstone grave marker trapped moisture within the stone, eventually resulting in deterioration and surface loss. Photo: Fran Gale.

Repointing masonry grave markers using Portland cement mortars that are harder than historic mortars often results in accelerated deterioration of the masonry material. Mortar should be softer than the adjacent masonry, enabling trapped moisture to migrate out, and serve as the sacrificial material when cracking occurs to relieve excessive stress. Problems also result when using impervious "protective" coatings that can trap moisture within the masonry, resulting in damage during wet/dry and freeze/thaw cycles (Fig. 13).

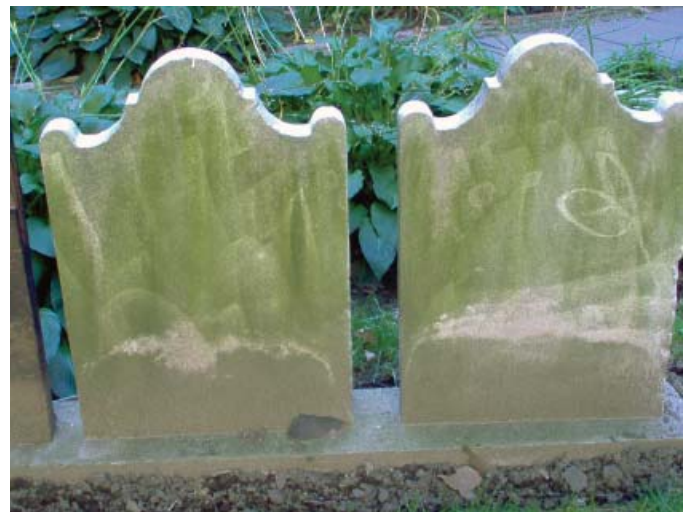
Figure 14. High-pressure water washing can damage grave markers. The photograph shows "wand marks" on the headstones produced by inappropriate pressure washing. Photo: Jason Church.

Harsh cleaning products and techniques can have a detrimental effect on grave markers. Acidic cleaners such as muriatic acid can dissolve minerals in many masonry materials and can attack metals. Alkaline cleaners, such as bleach, are notorious for leaving residual salts that are deposited on the surface (a process called efflorescence). Both acidic and alkaline cleaning can result in staining, especially if rinsing is inadequate. Using high-pressure water, above 500 to 1,000 psi, can needlessly damage masonry materials as well, increasing their vulnerability to weathering (Fig. 14). If the marker is fragile, even low pressure water can be damaging. Techniques to avoid include aggregate blasting with sand or other harsh media and the use of power tools with abrasive wire or Nylox™ brushes.

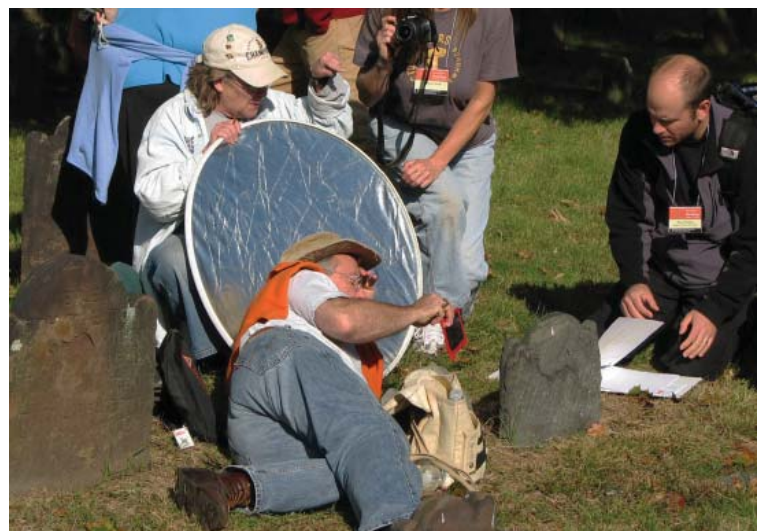
Figure 15b. Photographs are used to document the condition of the grave marker as part of a condition assessment. Photo: Fran Gale.

A tool kit for the condition assessment may include binoculars, digital camera, magnifying glass, measuring tape, clipboard, carpenter's rule, level, magnet, and flashlight. For large monuments, a ladder or aerial lift may be required. Photographs of each marker, including overall shots and close-up details, are an essential part of the documentation process. Photo logs are helpful for

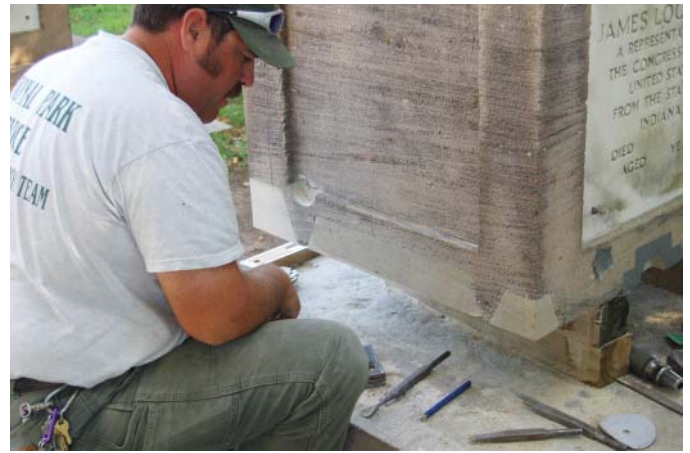
Figure 16. A professional mason works to insert a new piece of stone. Often referred to as a “dutchman”, this repair technique requires replacing the deteriorated stone section with a new finished piece of the same size and material. Photo: Jason Church.

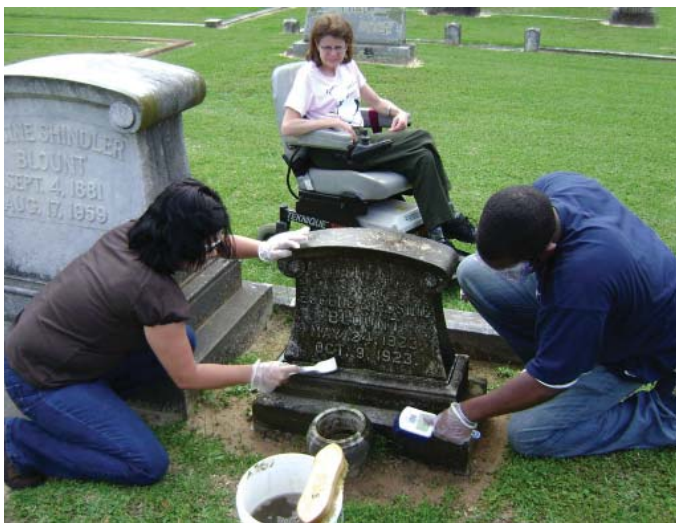
Figure 17. Volunteers can undertake cleaning of grave markers once they have received initial training. Cleaning methods may include wetting the stone, using a mild chemical cleaner, gently agitating the surface with a soft bristle brush, and thoroughly rinsing the marker with clean water. Photo: Jason Church.

General maintenance may involve low-pressure water washing. In most cases, surface soiling can be removed with a garden hose using municipal water or domestic

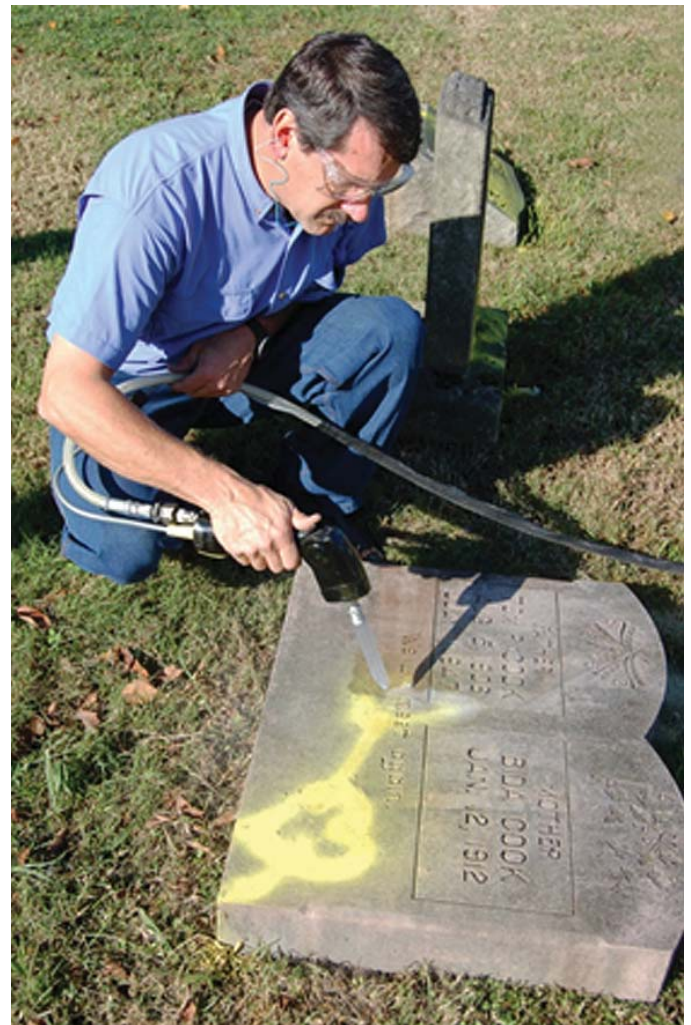
Figure 18. Graffiti is carefully removed using a low-pressure dry-ice misting instrument. Photo: Jason Church.

If the graffiti is water soluble, it can be removed using water and a soft cloth or towel. Rinsing the cloth frequently helps to avoid smearing graffiti on unaffected areas. If the graffiti is not water soluble, organic solvents or commercial graffiti removal products suitable for the grave marker material are recommended. Products should be tested prior to use. General cleaning of the entire marker is a good follow-up for a more even appearance. For deep-seated graffiti, poultice cleaning (previously described) may be required to extract staining materials.

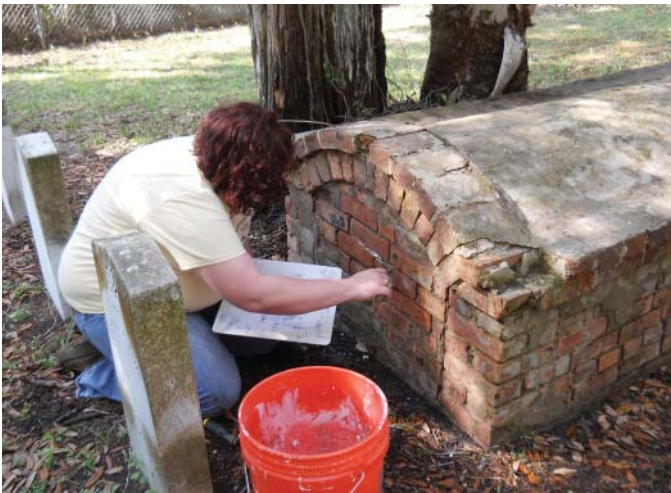
Figure 19. Masonry markers like this box tomb may require the repointing of mortar joints. It is important to use a mortar that is softer than the historic brick. In this case a conservator uses a lime putty-based mortar to repoint. Photo: Jason Church.

Missing and deteriorated mortar in old cemetery grave markers is a common condition, and the mortar should be replaced to prevent water intrusion and potential damage (Fig. 19). Several questions should be considered when selecting materials for repointing.

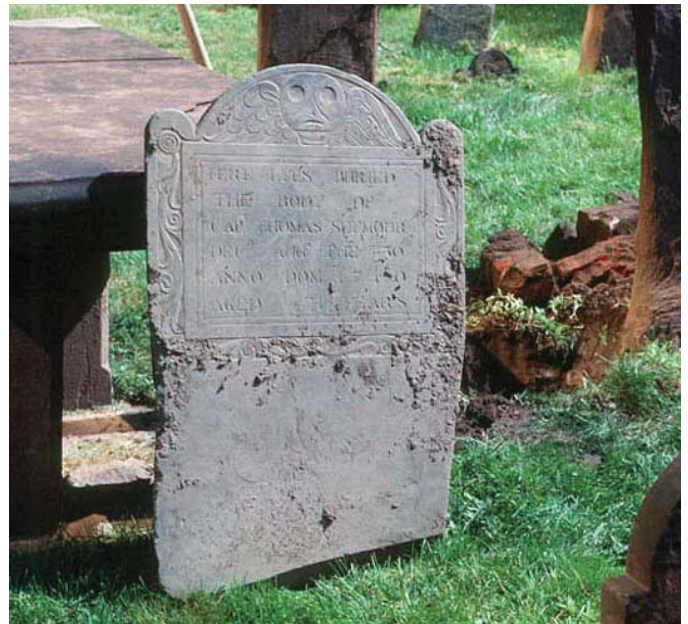
Figure 20a. This slate grave marker in the Ancient Burying Ground in Hartford, CT, is a ground-support stone. Resetting requires digging a hole that will hold the base of the stone and then compacting the soil at the bottom of the hole by hand. Photo: Fran Gale.

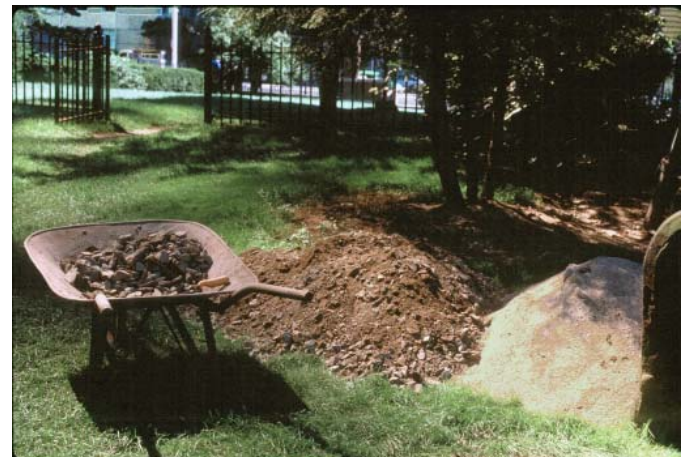
Figure 20b. To facilitate drainage, crushed stone, gravel, and sharp sand line the hole and are hand-tamped around the stone after placement. Photo: Fran Gale.

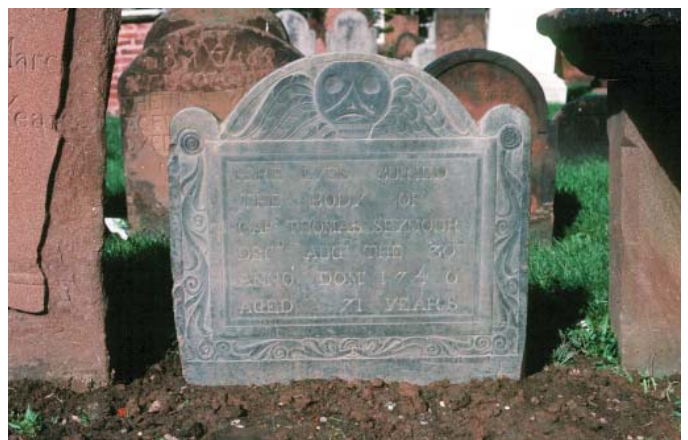
Figure 20c. The reset ground-supported grave marker should be level and plumb. Photo: Fran Gale.

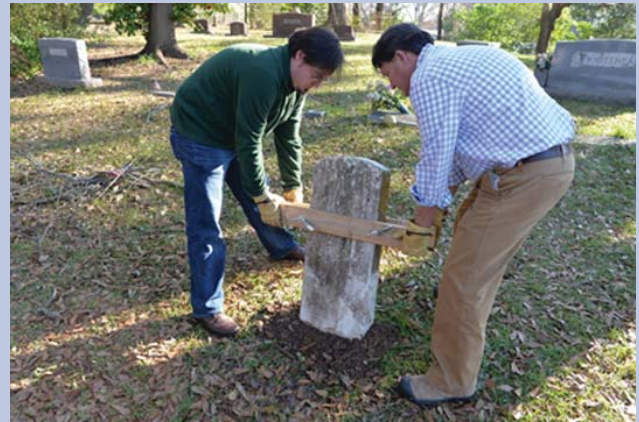
Figure E1. The simple wooden clamp system allows two people to safely lift a marble grave marker. Photo: Sarah Jackson.

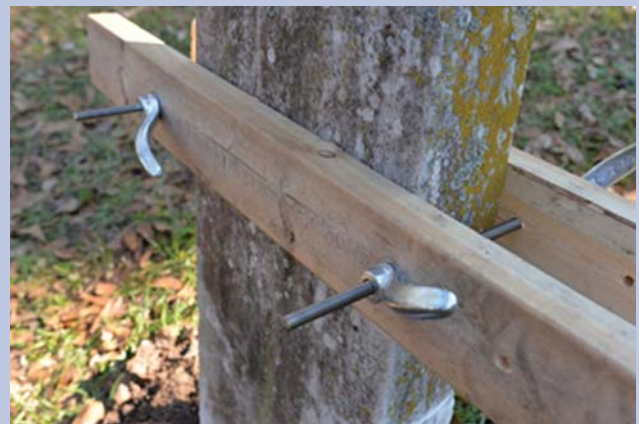
Figure E2. The clamp system is constructed from off-the-shelf wooden boards. Photo: Sarah Jackson.

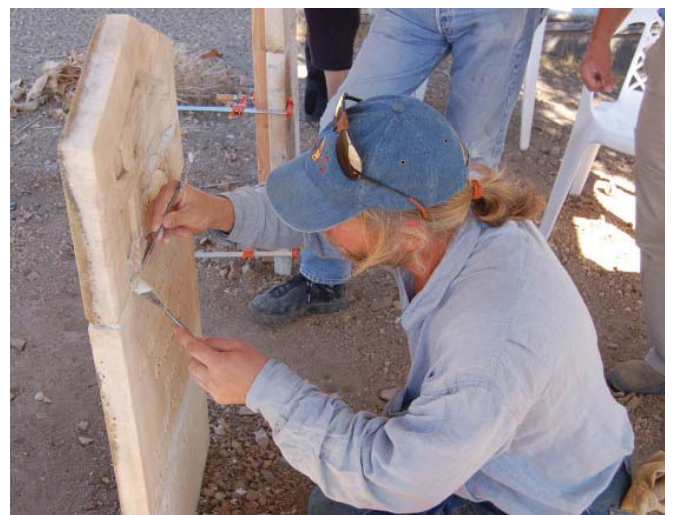
Figure 21. Cracks in a stone marker should be filled to keep water and debris out and prevent the crack from becoming larger. A patching mortar is designed to be used, in this case, with historic marble. Photo: Mary Striegel.

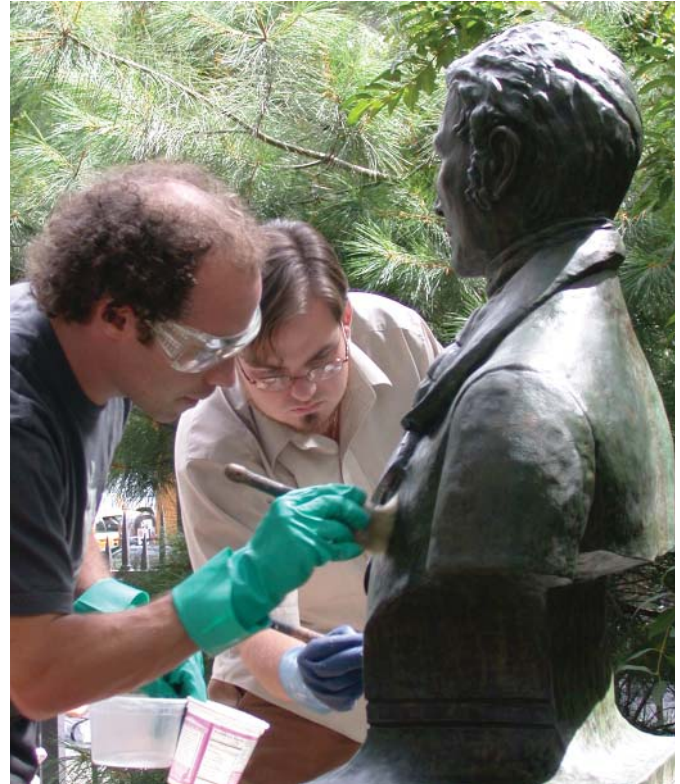
Figure 22. A protective coating must be maintained on metal elements. Wax or lacquer coatings help preserve the bronze patina and slow corrosion. Conservators apply a microcrystalline wax to this bust at St. Mark's Church in-the-Bowery, New York, NY. Photo: John Scott.

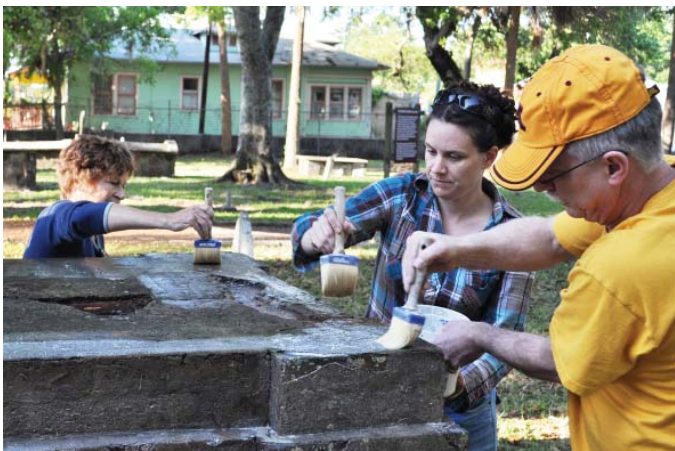
Figure 23. Limewash is a breathable coating sometimes used to protect the surface of the grave marker and provide a decorative finish. Limewash is applied by brush in five to eight thin coats (with each coat about the consistency of skim milk). The surface is allowed to slowly dry between coats. Sometimes the surface is covered by damp burlap to slow the drying process. Photo: Sarah Jackson.

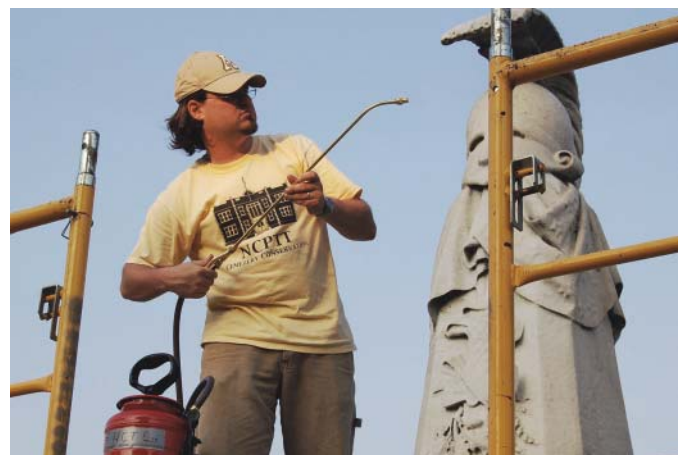
Figure 24. A severely deteriorating monument or grave marker can be treated with a stone consolidant. The treatment is usually applied using a spray system. The consolidant soaks into the stone and replaces mineral binders that hold the stone together. On-site and laboratory testing and evaluation are performed prior to using this non-reversible type of treatment. Photo: Lucas Flickinger.
